**CYCLONE WINSTON PRELIMINARY ASSESSMENT
SCHOOLS, HEALTH FACILITIES AND PUBLIC BUILDINGS
FOR
FIJI INSTITUTION OF ENGINEERS &
DEPARTMENT OF NATIONAL PLANNING
(MINISTRY OF FINANCE)**

NAME OF FACILITY: Nalaba District School
TYPE: Primary School
LOCATION: Rakiraki
DATE OF ASSESSMENT: 22 March 2016

JOB NO: 16-111
GOVERNMENT FACILITY NUMBER: GFN-113

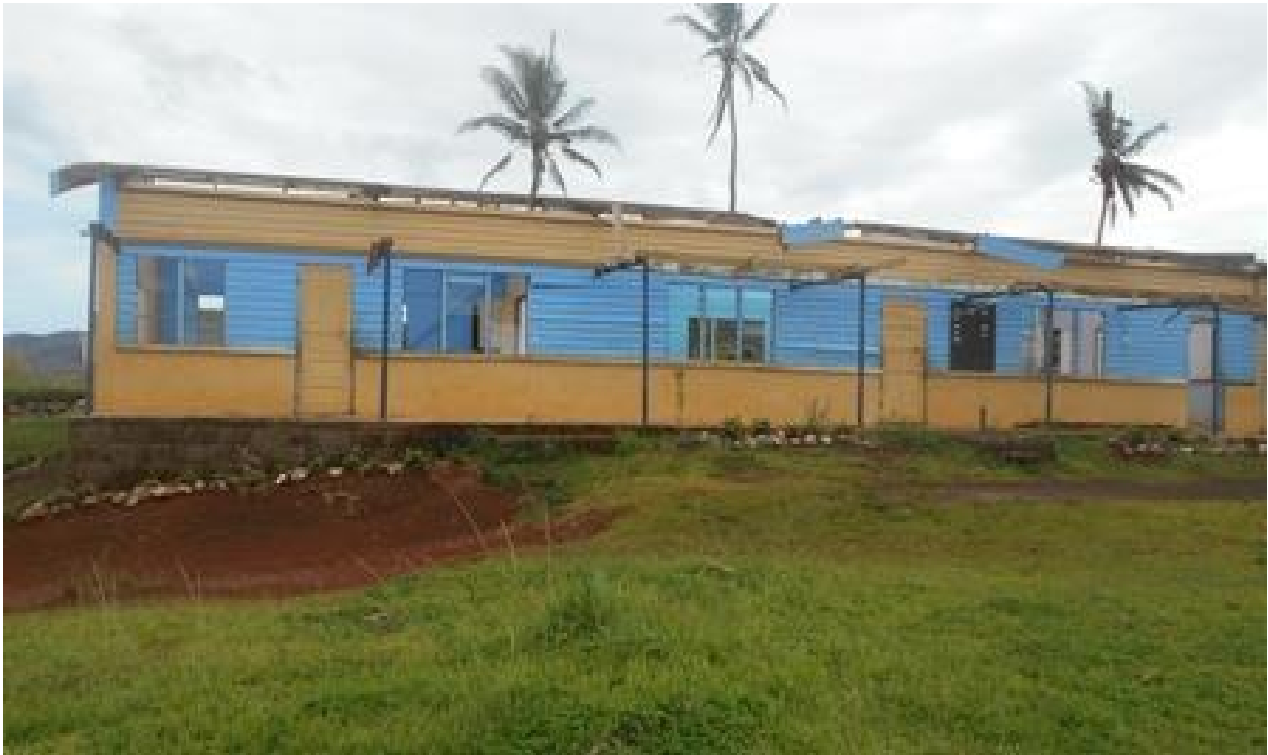
Photo 1:View of the Damaged School Block

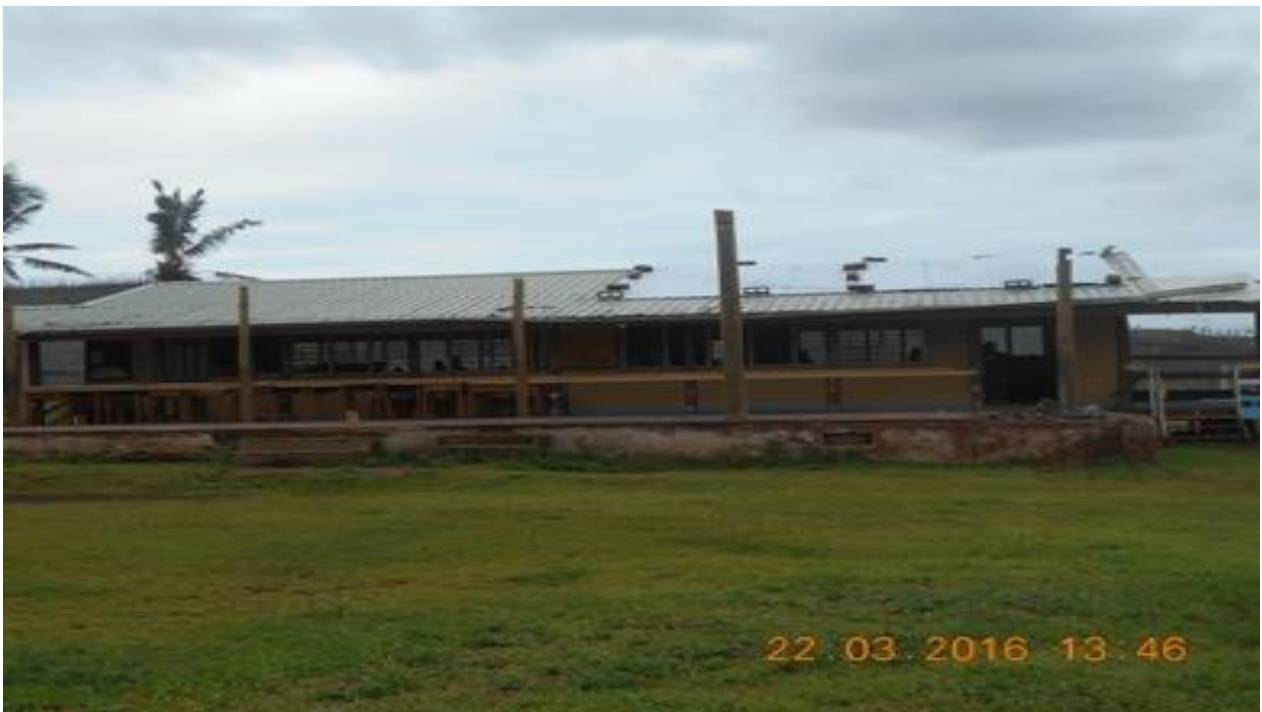
Photo 2: View of Damaged School Building

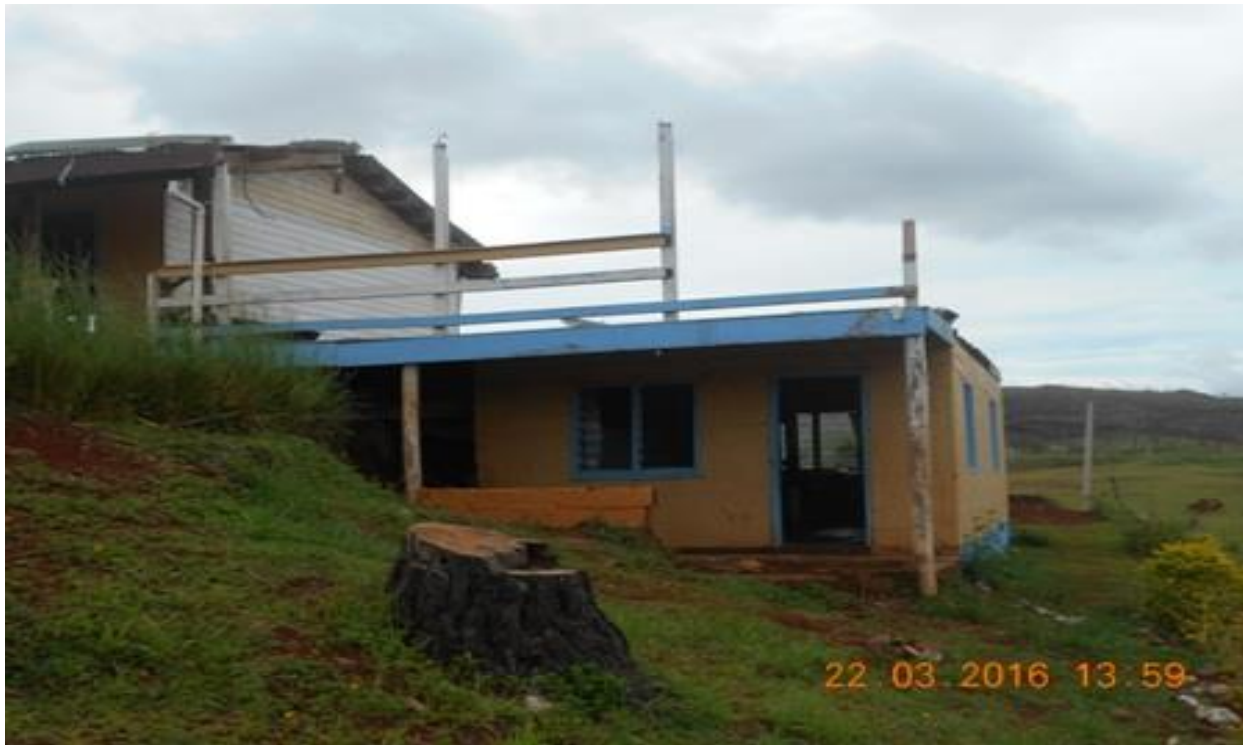
Photo 3: View of Damaged School Basement

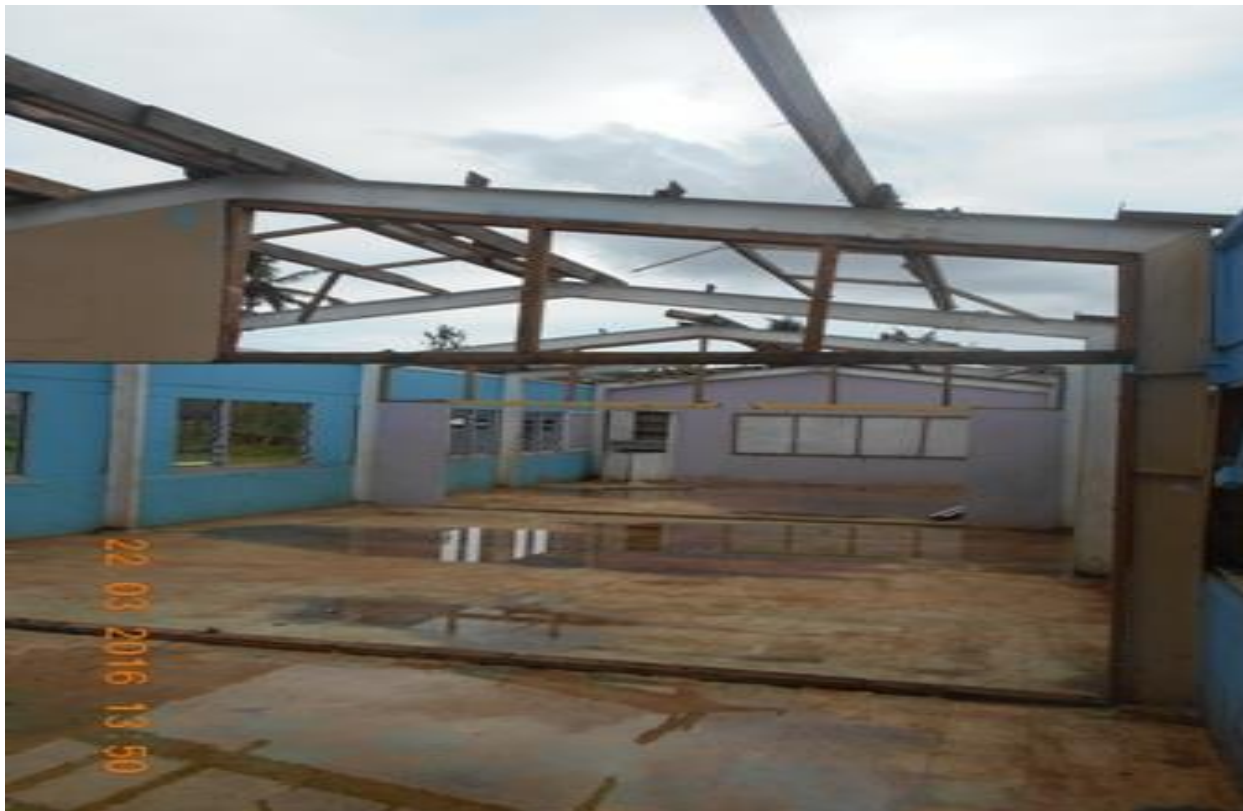
Photo 4:View of the Steel Columns and Beam in School Building

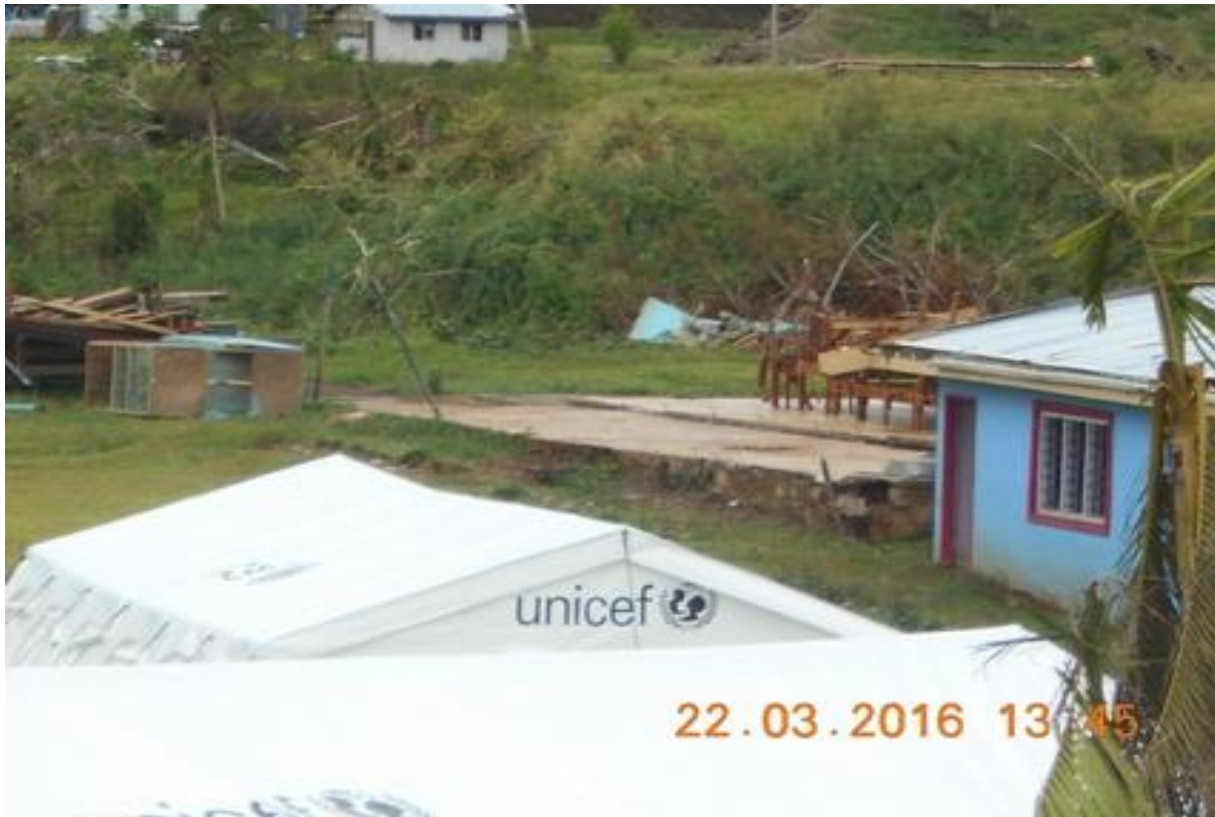
Photo 5: Overall View of Damaged Dining Hall

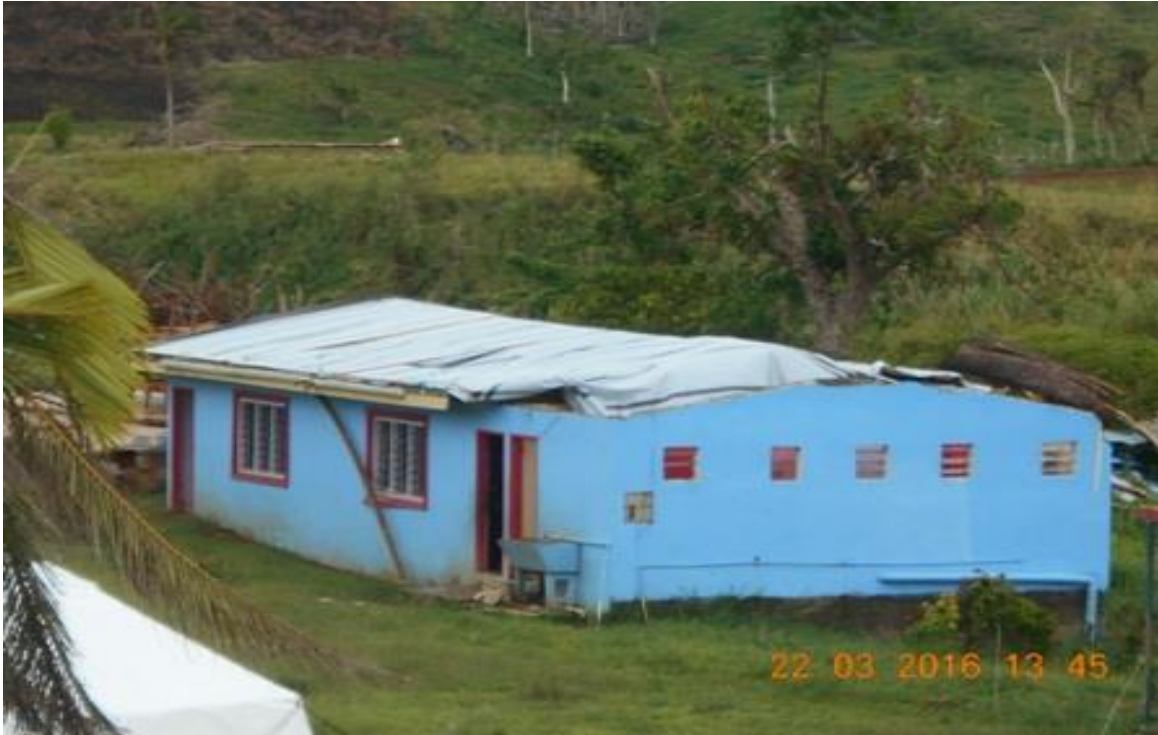
Photo 6: View of the Damaged Boys Dormitory

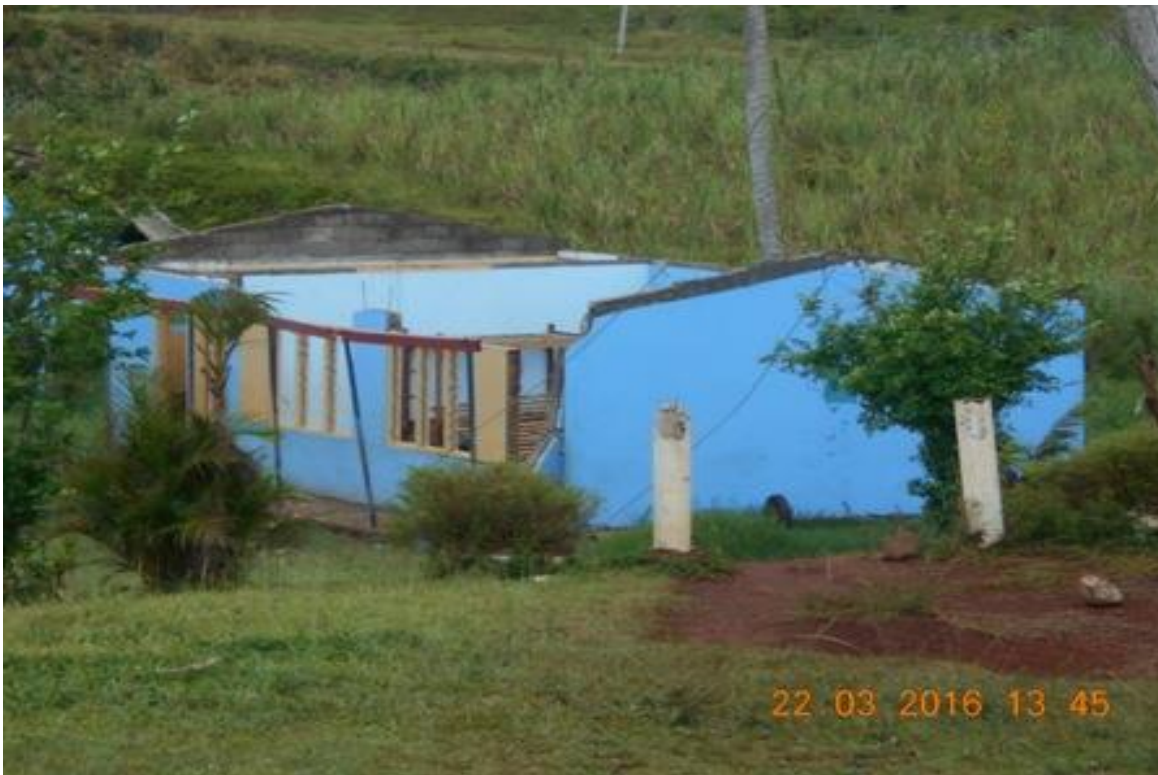
Photo 7: View of the Damaged Girls Dormitory

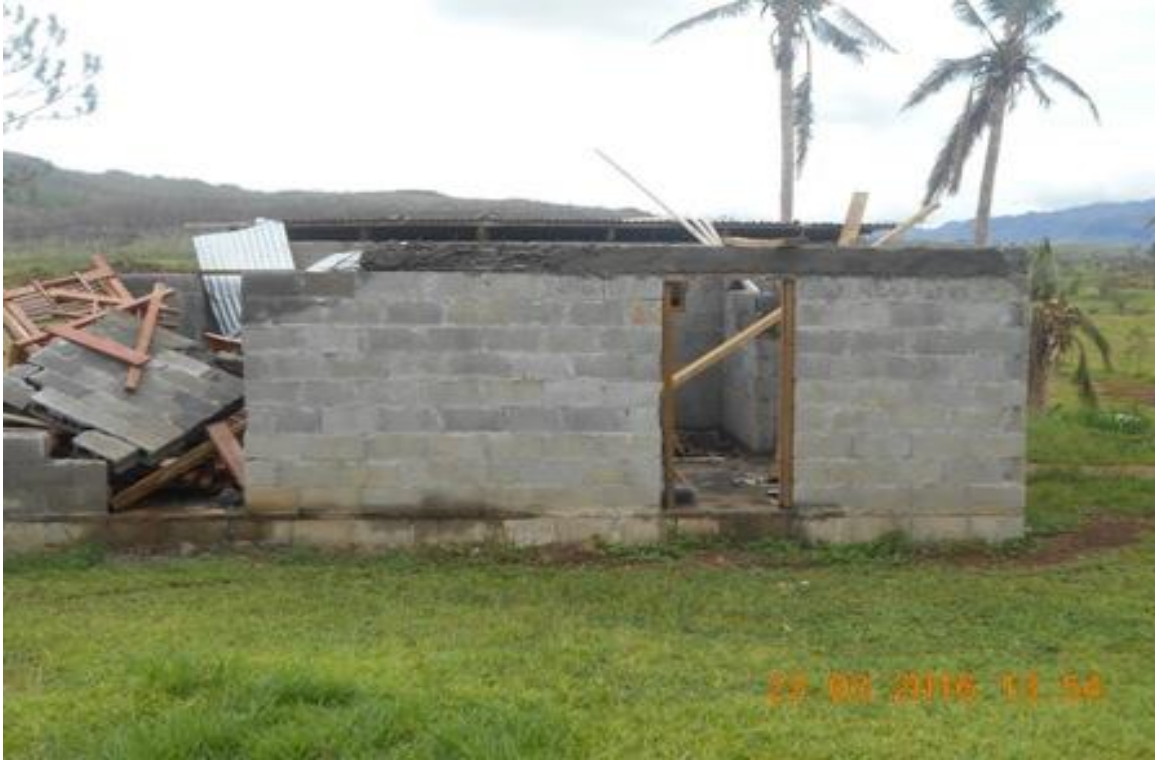
Photo 8: View of the Toilet Blocks

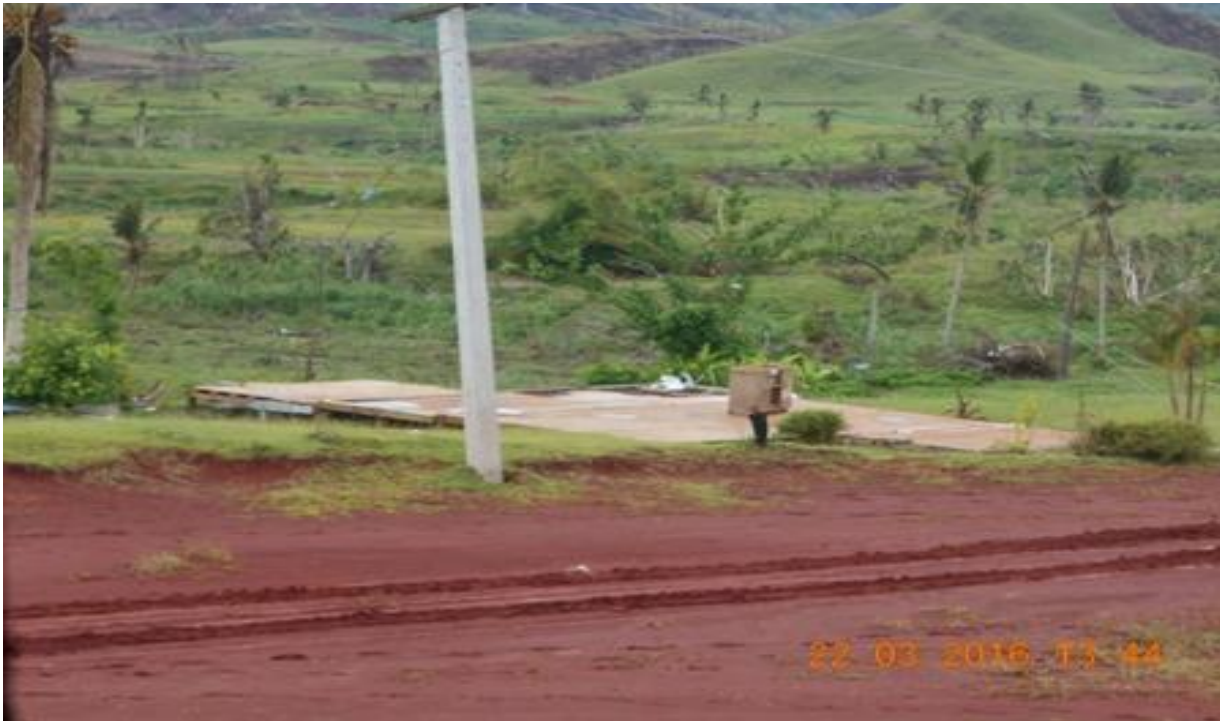
Photo 7: View of the Teachers Quarters

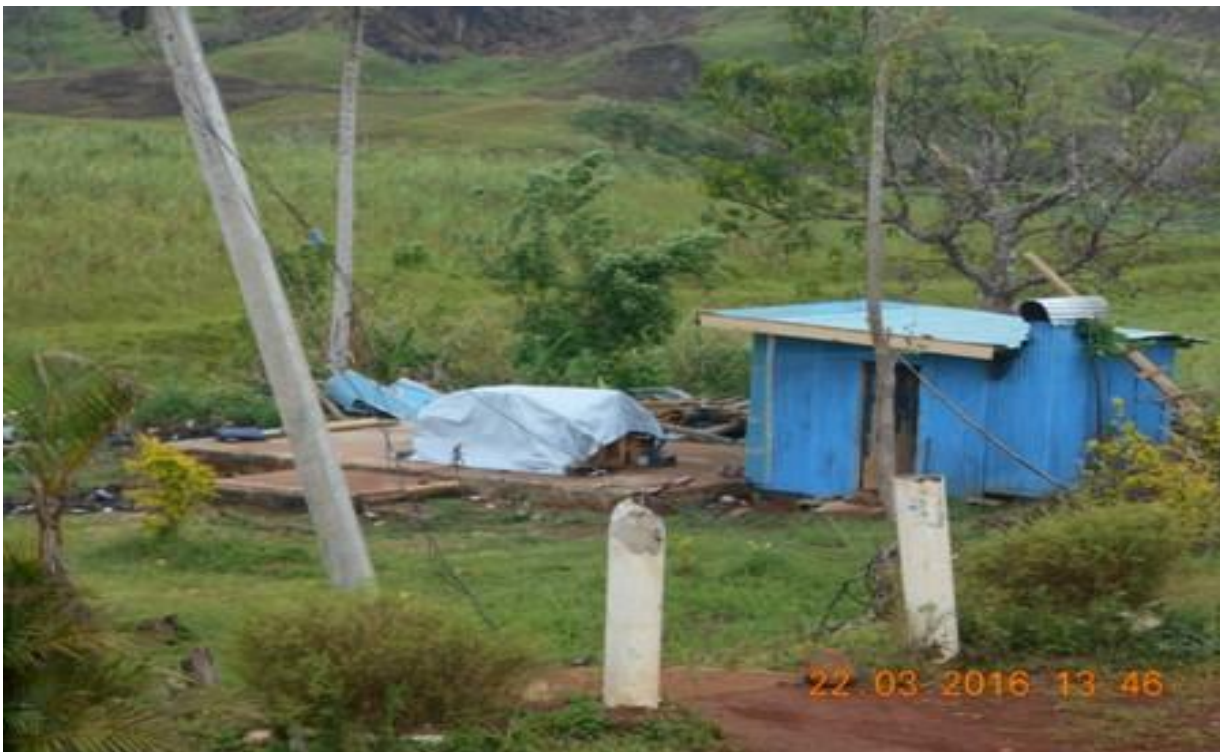
Photo 10: View of the Teachers Quarters

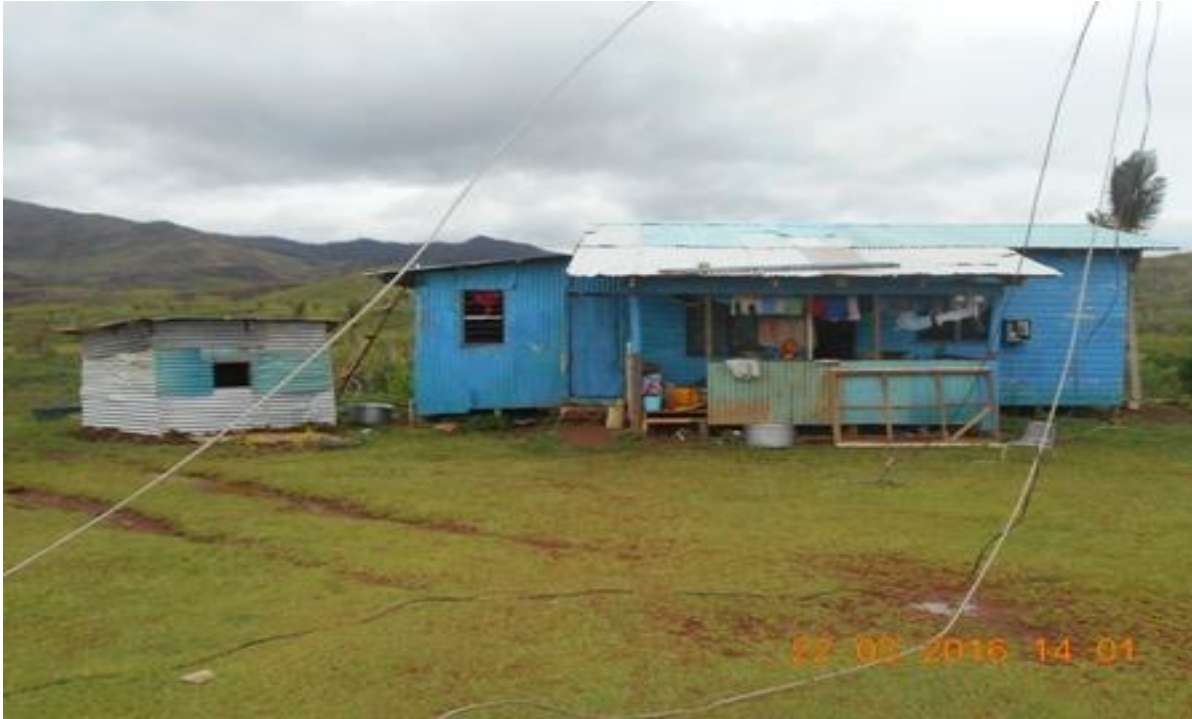
Photo 11: View of the Teachers Quarters

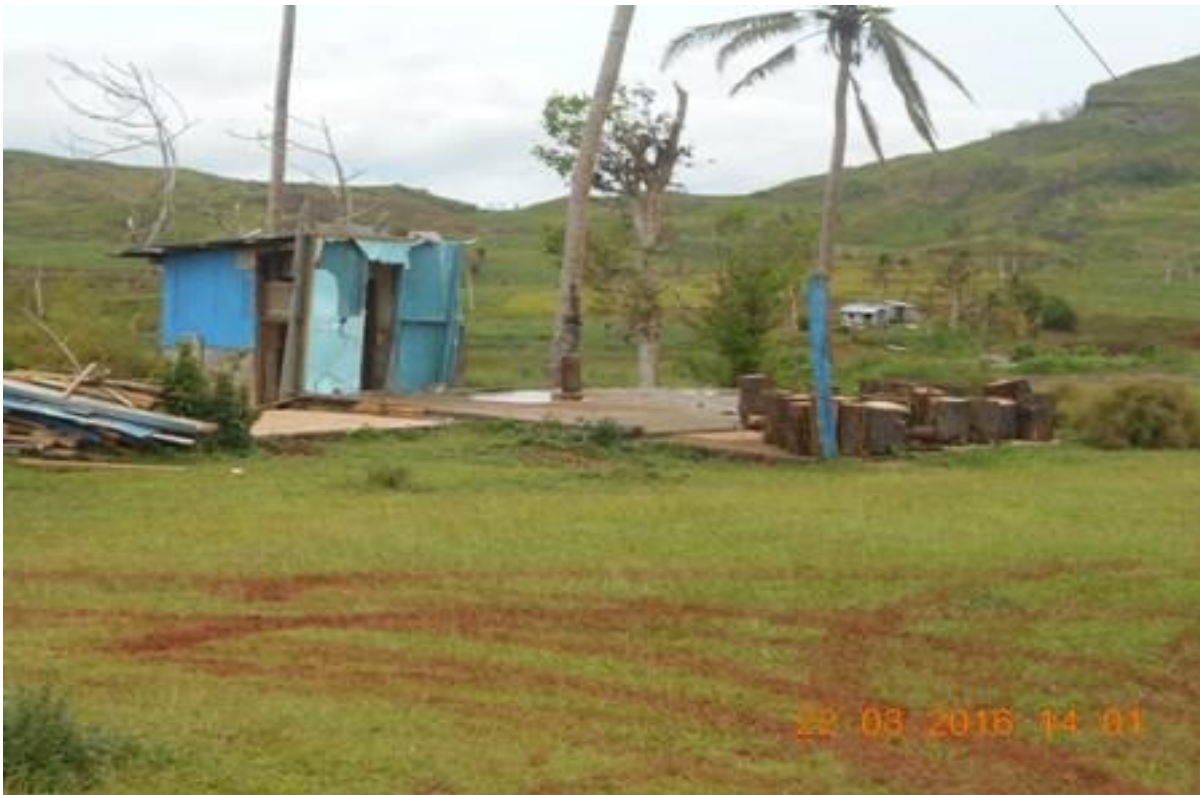
Photo 12:View of the Damaged Teachers Quarters

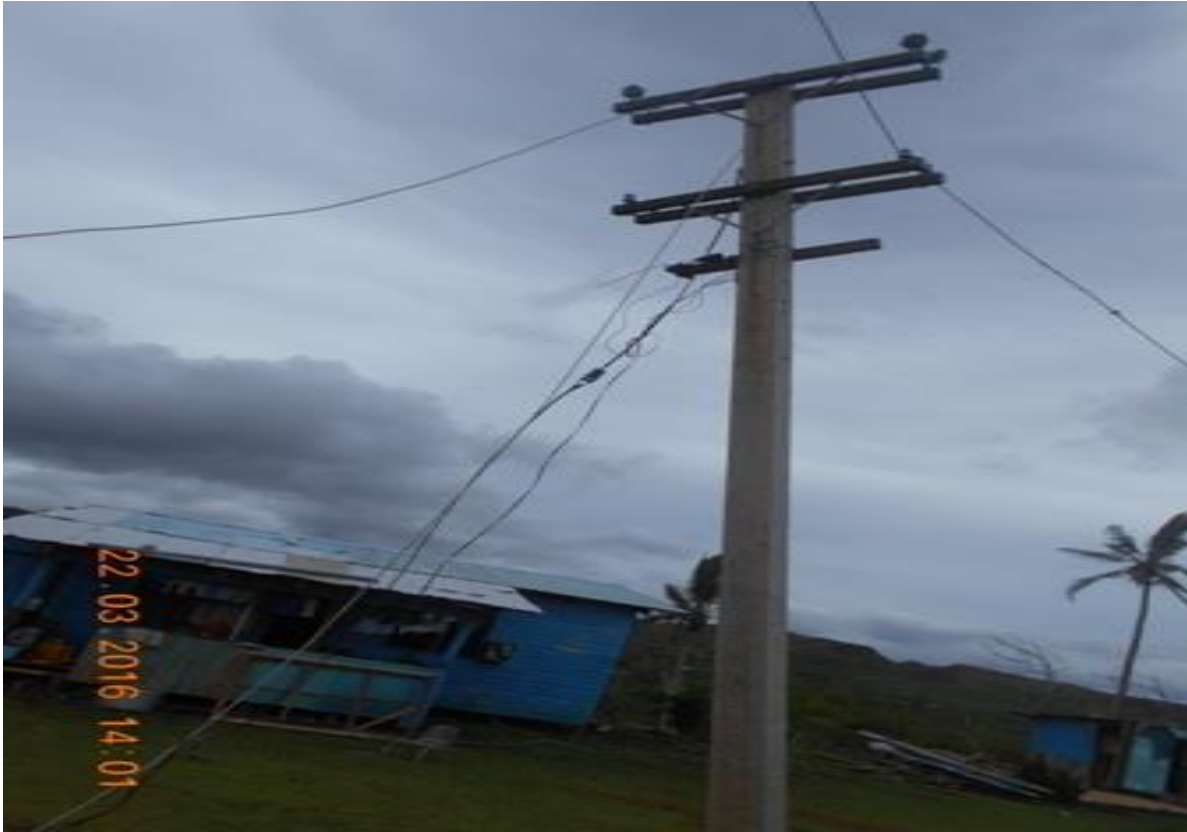
Photo 13: View of Damaged FEA Post and Electric Cables

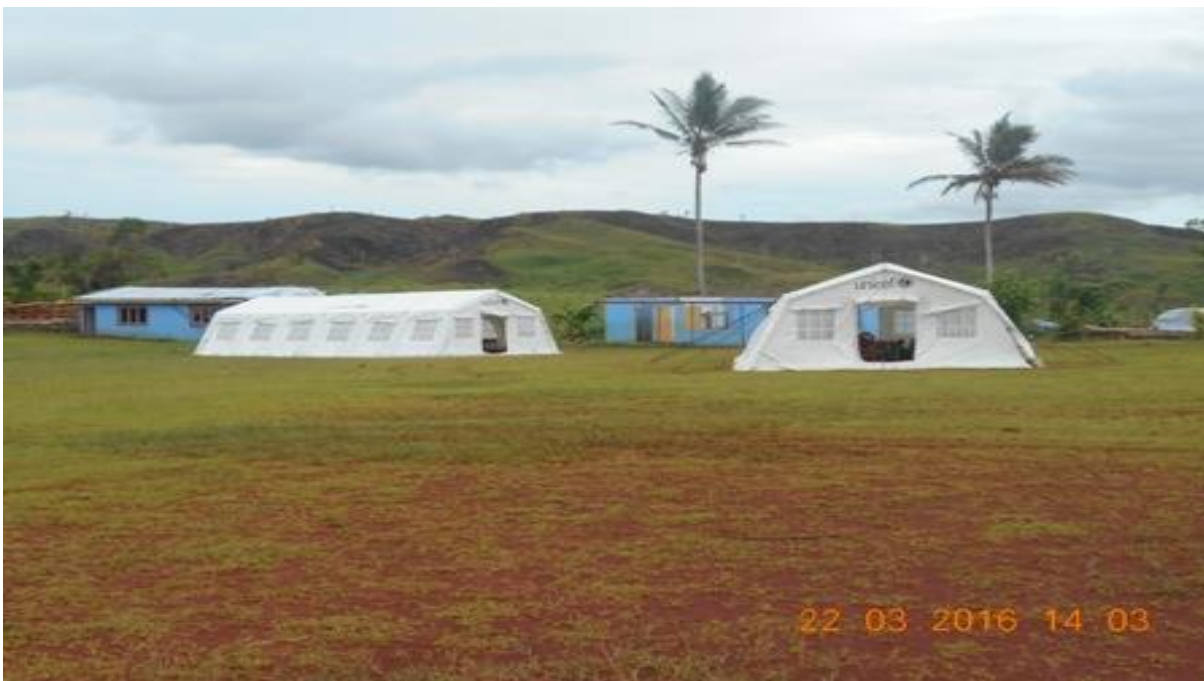
Photo 14: Tents are used as Temporary Classrooms
