**CYCLONE WINSTON PRELIMINARY ASSESSMENT  
SCHOOLS, HEALTH FACILITIES AND PUBLIC BUILDINGS  
FOR  
FIJI INSTITUTION OF ENGINEERS &  
DEPARTMENT OF NATIONAL PLANNING  
(MINISTRY OF FINANCE)**

NAME OF FACILITY: Burievanua District School  
TYPE: Primary School  
LOCATION: Rakiraki  
DATE OF ASSESSMENT: 14 April 2016

JOB NO: 16-122  
GOVERNMENT FACILITY NUMBER: GFN-119

**RAPID ASSESSMENT TEMPLATE: CYCLONE WINSTON DAMAGED BUILDINGS  
SCHOOLS, PUBLIC BUILDINGS & HEALTH FACILITIES**

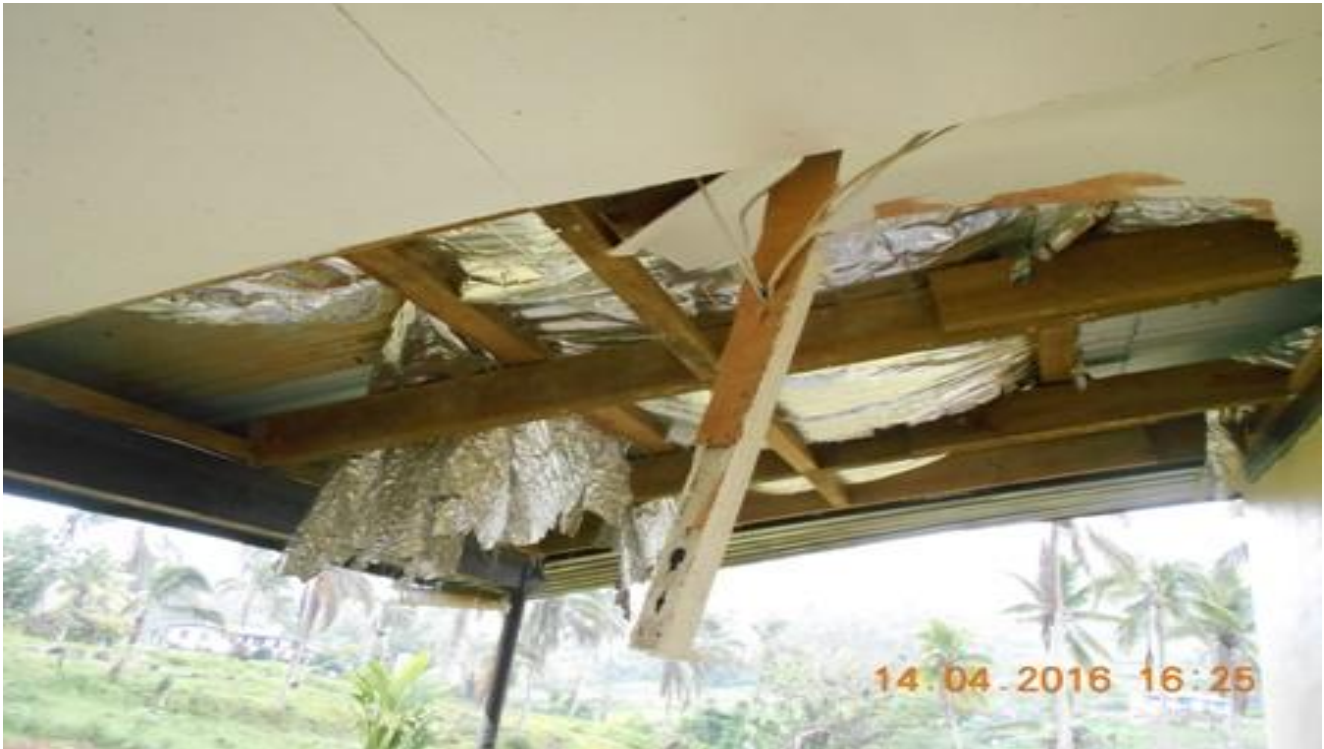
**Photo 1: Portion of roof damaged with ceiling**

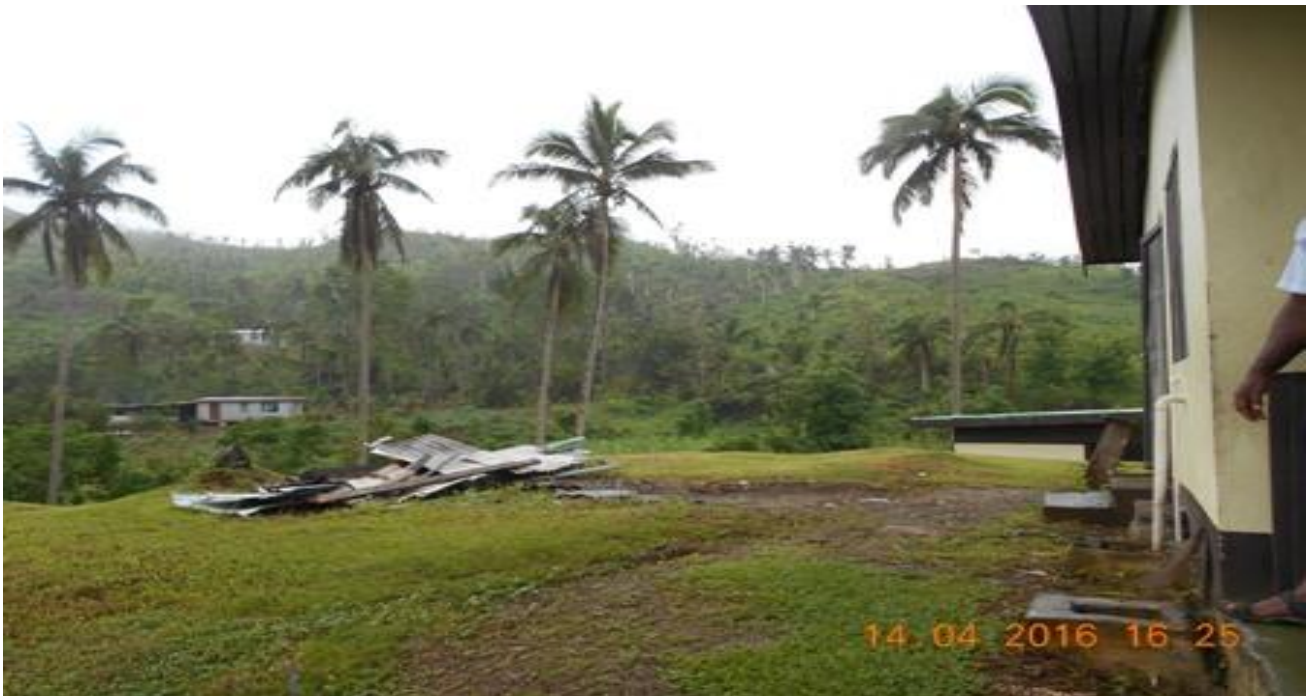
**Photo 2: Kitchen Portion of Dining been blown away**

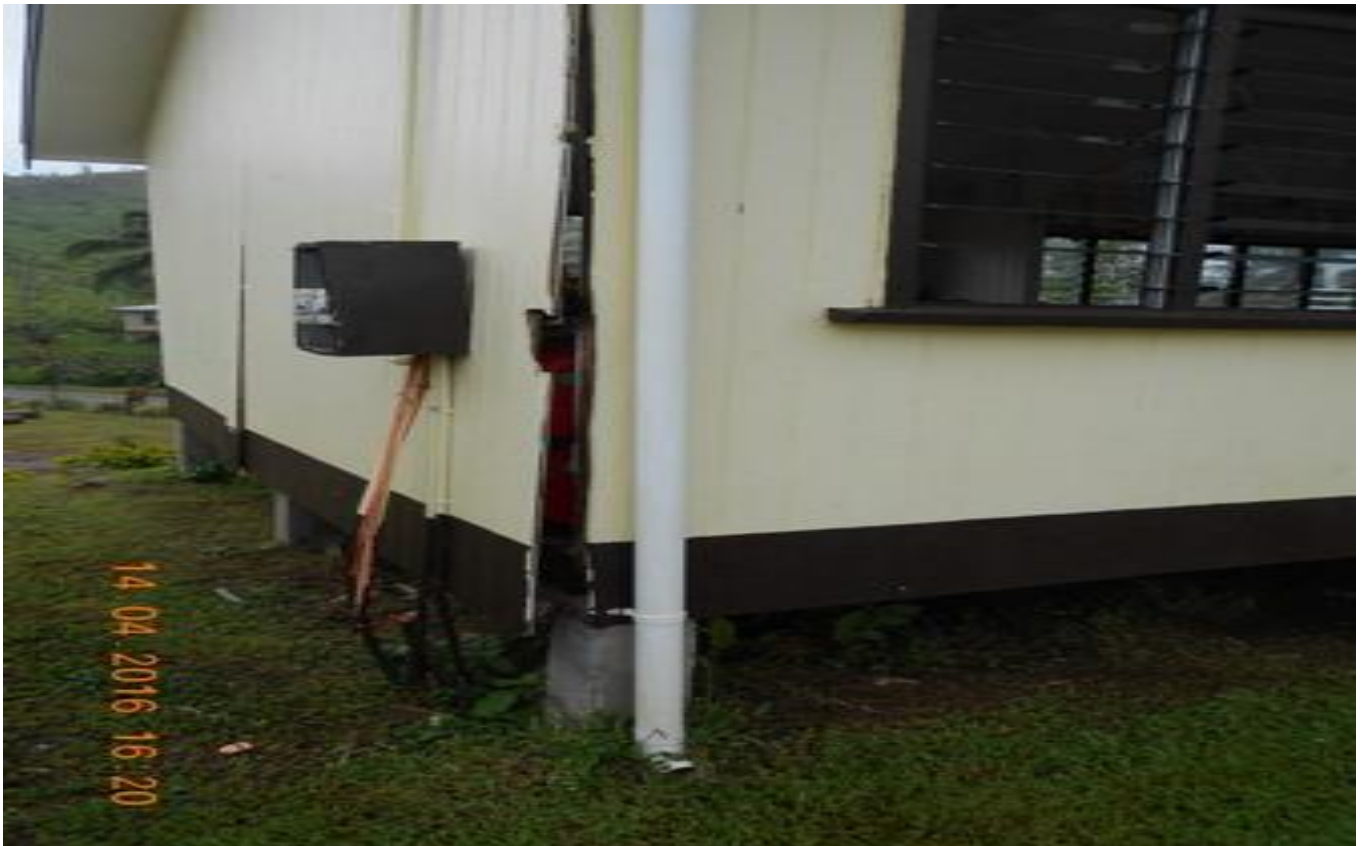
**Photo 3: Damaged side wall of Kindergarden**

<b>Possible Long Term Solution</b>	1 Kindergardern from timber to Concrete as per cyclone standards- \$114,300.00 1 Library from timber to Concrete as per cyclone standards- \$254,000.00

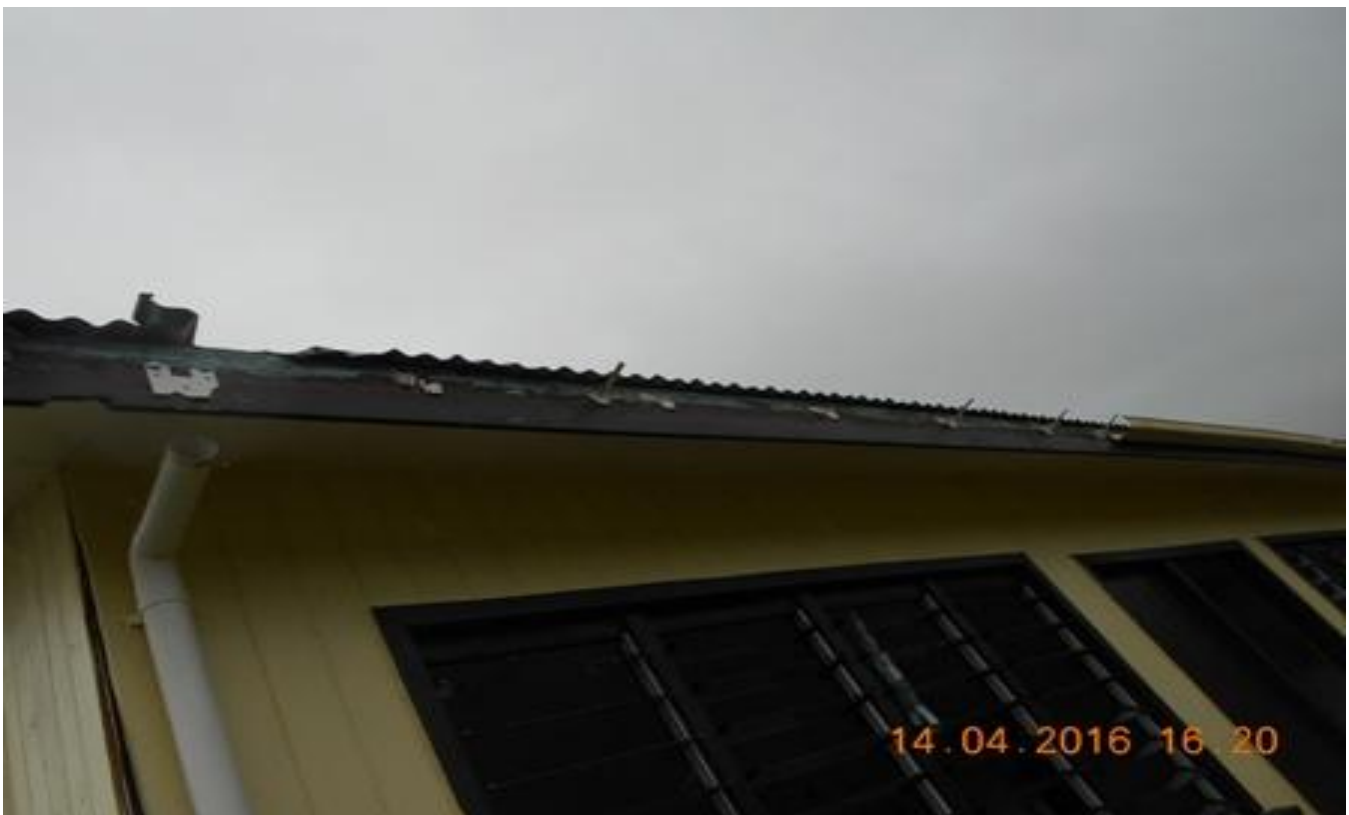
**Photo 4: Damaged Gutters & Down pipes**

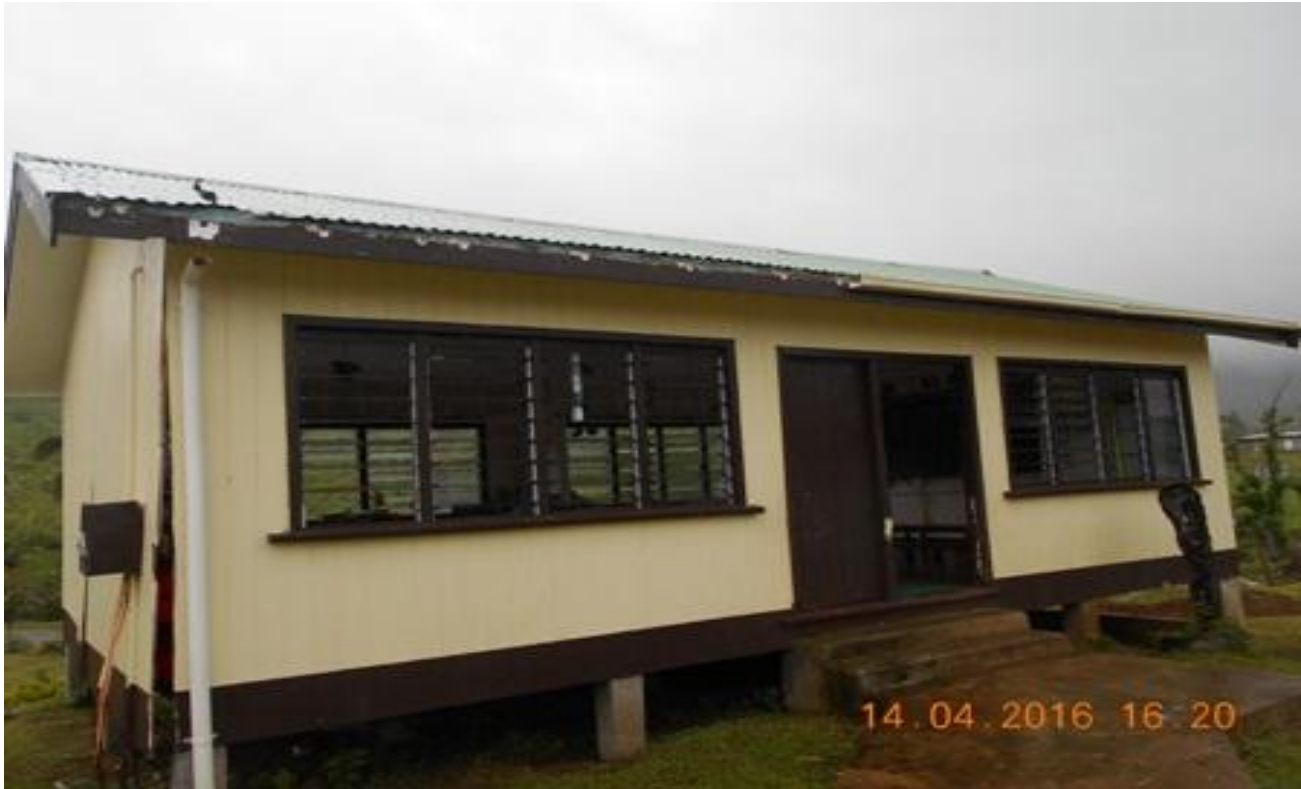
**Photo 5: Damaged Gutters**

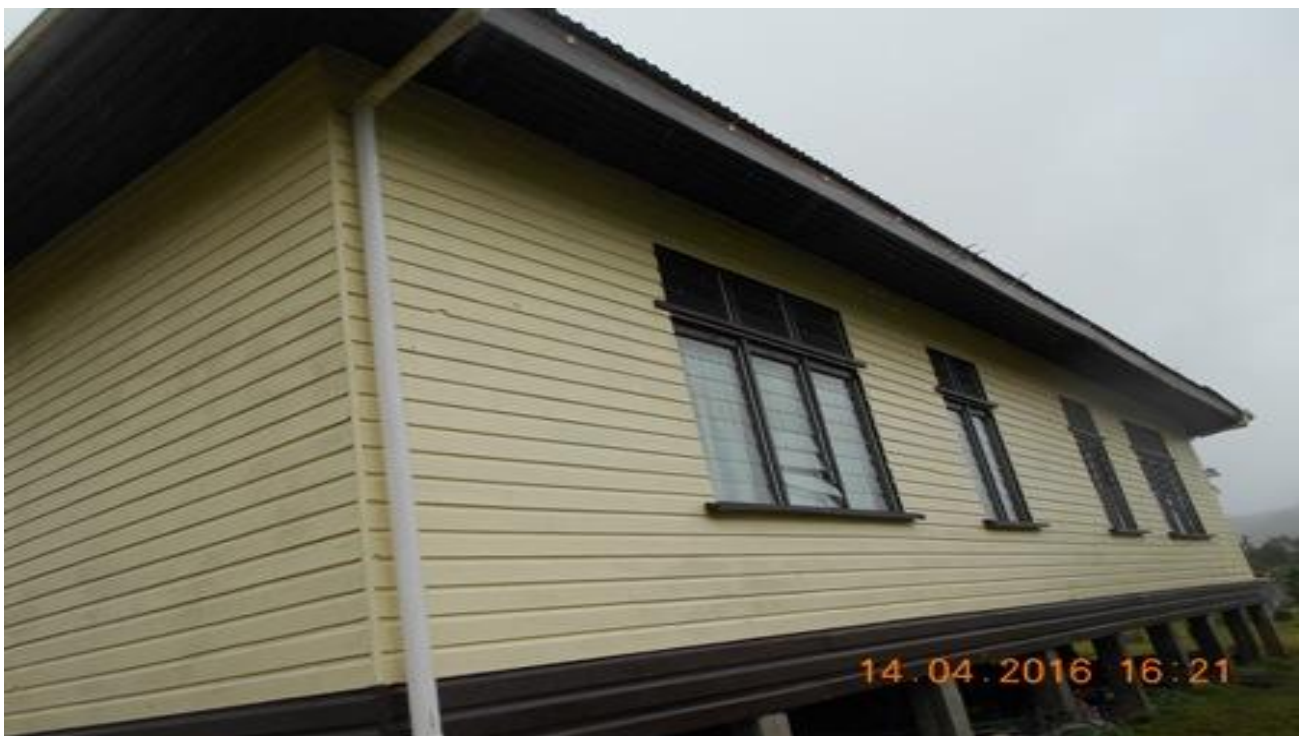
**Photo 6: View of the Walkway with Damaged Fascia, Gutters**

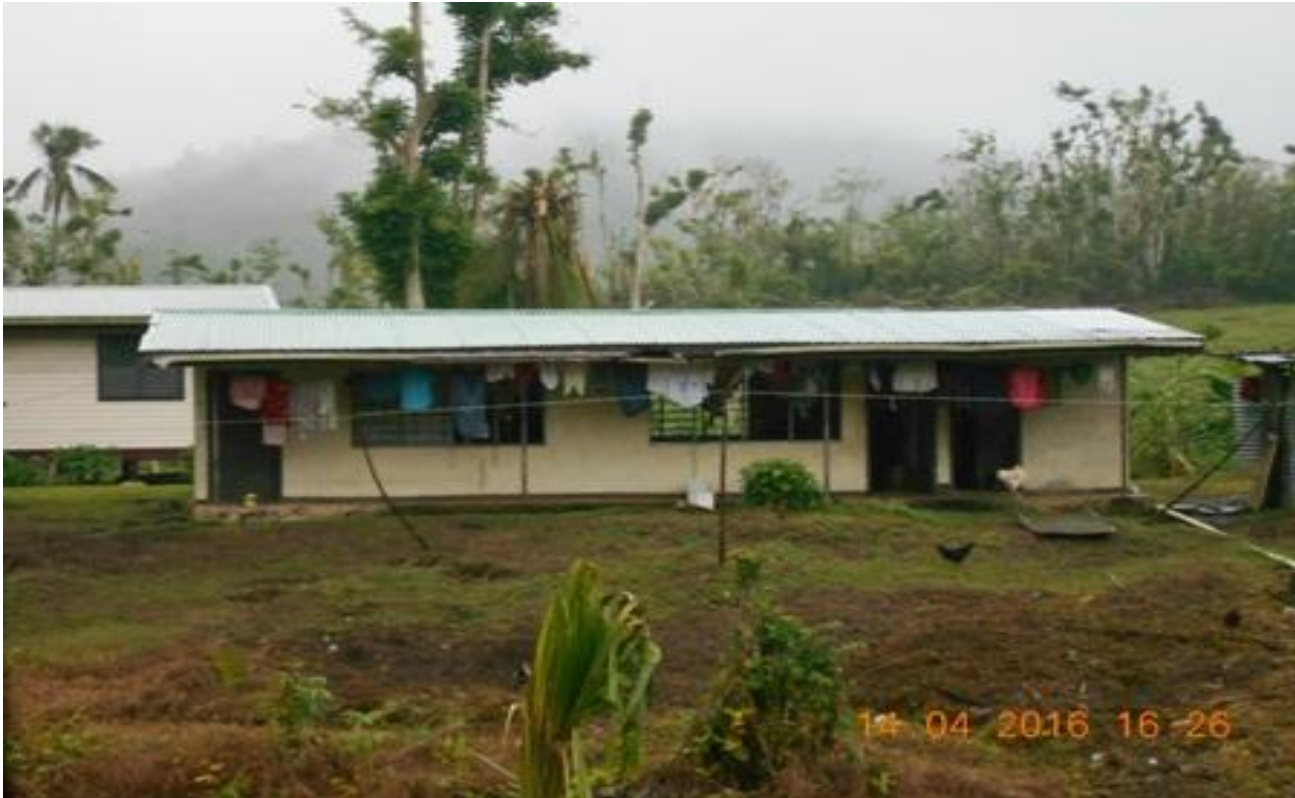
**Photo7: Damaged Gutters of Quarters**

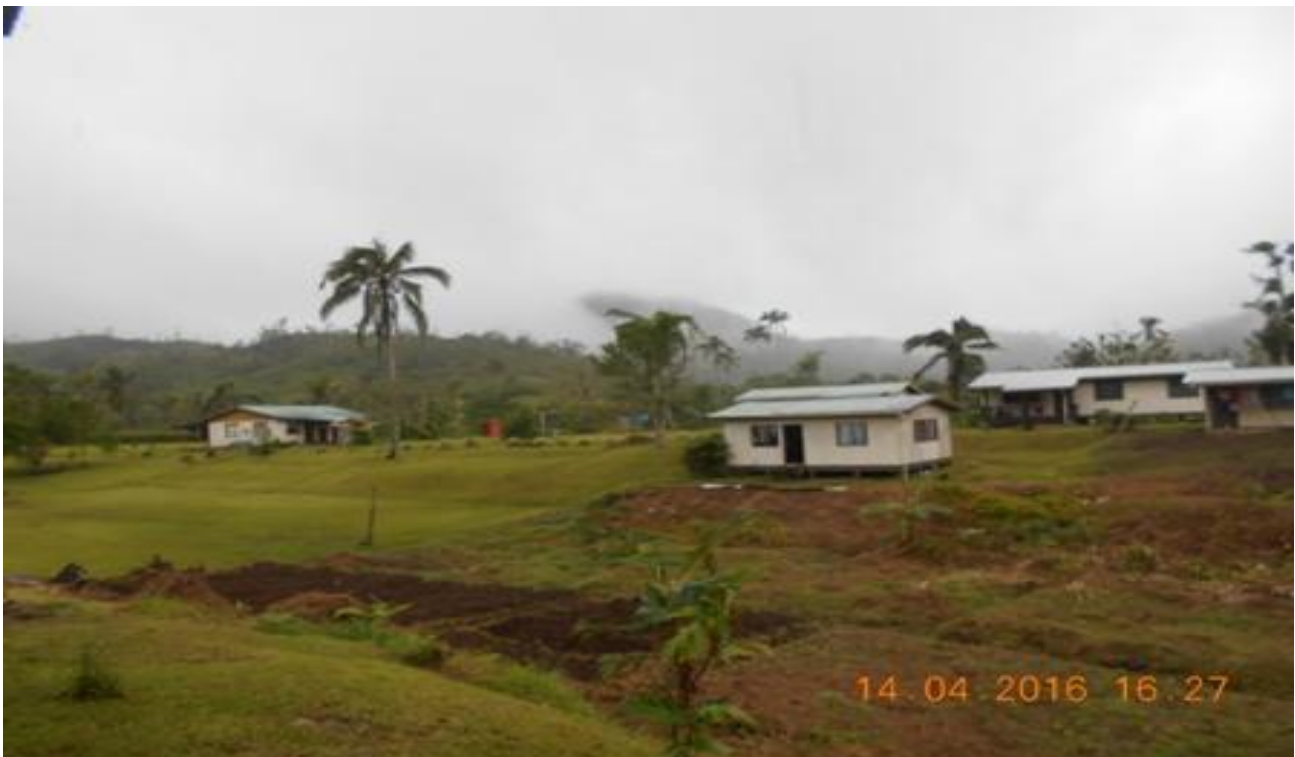
**Photo8: Damaged kitchen of Quarter 1**

<b>Possible Long Term Solution</b>	Quarters 1 from timber to Concrete- \$106,680.00 Quarters 2 from timber to Concrete- \$63,500.00 Quarters 3 from timber to Concrete- \$\$63,500.00 Head Teachers Quarters- \$152,400.00
