CYCLONE WINSTON PRELIMINARY ASSESSMENT SCHOOLS, HEALTH FACILITIES & PUBLIC BUILDINGS *for* **FIJI INSTITUTION OF ENGINEERS & DEPARTMENT OF NATIONAL PLANNING (MINISTRY OF FINANCE)**

NAME OF FACILITY:	Lautoka Arya Samaj Primary School
TYPE:	Primary School
LOCATION:	Vomo St., Lautoka
DATE OF ASSESSMENT:	28 March 2016
DATE OF REPORT:	04 April 2016
RMCE REPORT NO:	TCW/08
GOVERNMENT FACILITY NO:	067

REPORT Cyclone damages repairs completed
Page No. :
Building No. : Classroom Block A, Covered Walkway, Toilet Block
Building Approx Age: ?
No. of Storeys: 1 & 2

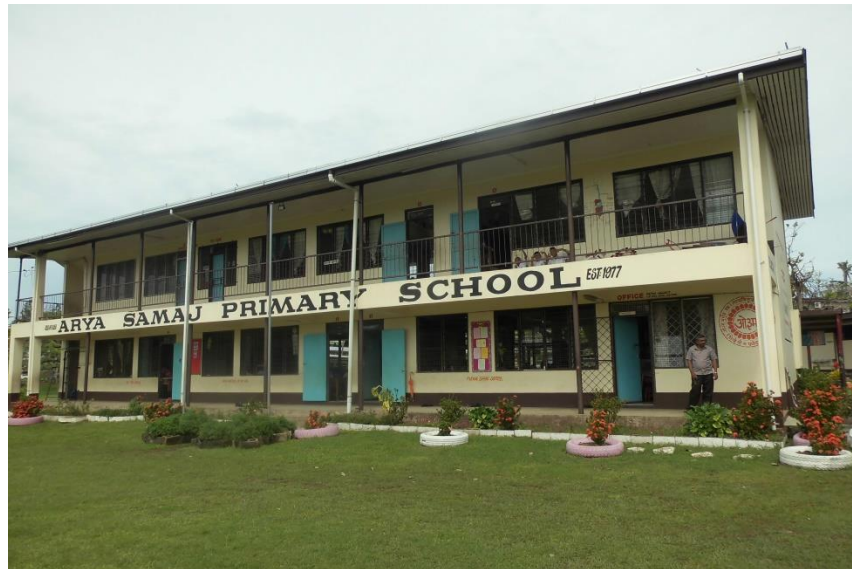
Block A (guttering repaired)

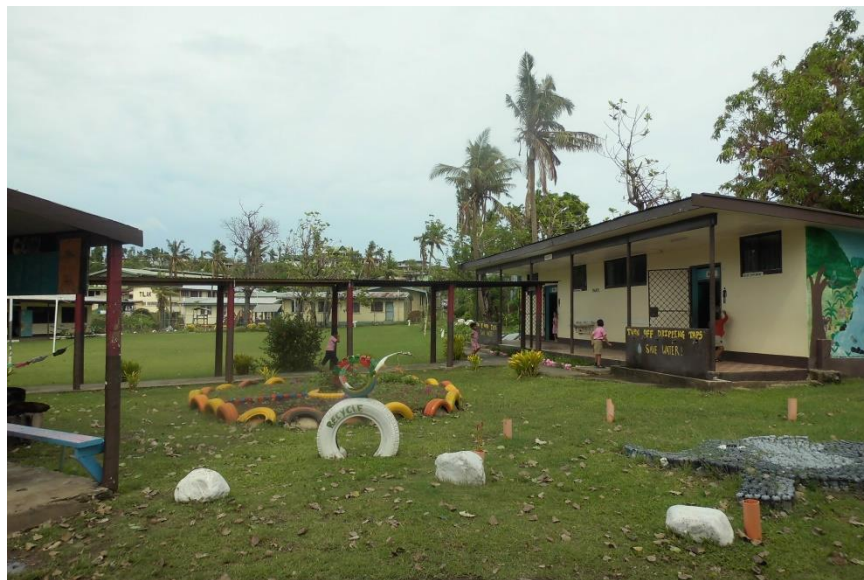
Covered walkway & Toilet Block (repaired)
