# CYCLONE WINSTON PRELIMINARY ASSESSMENT SCHOOLS, HEALTH FACILITIES & PUBLIC BUILDINGS

**THE FIJI INSTITUTION OF ENGINEERS & DEPARTMENT OF  
NATIONAL PLANNING (MINISTRY OF FINANCE)**

NAME OF FACILITY:	Moto Sanatan Sannelan School
TYPE:	Primary School
LOCATION:	Ba
DATE OF ASSESSMENT:	21 March 2016
DATE OF REPORT:	08 April 2016

JOB NO:	16015
HLKJACOB REPORT NO:	46-S
HLKJACOB FACILITY NO:	29
GOVERNMENT FACILITY NO:	47

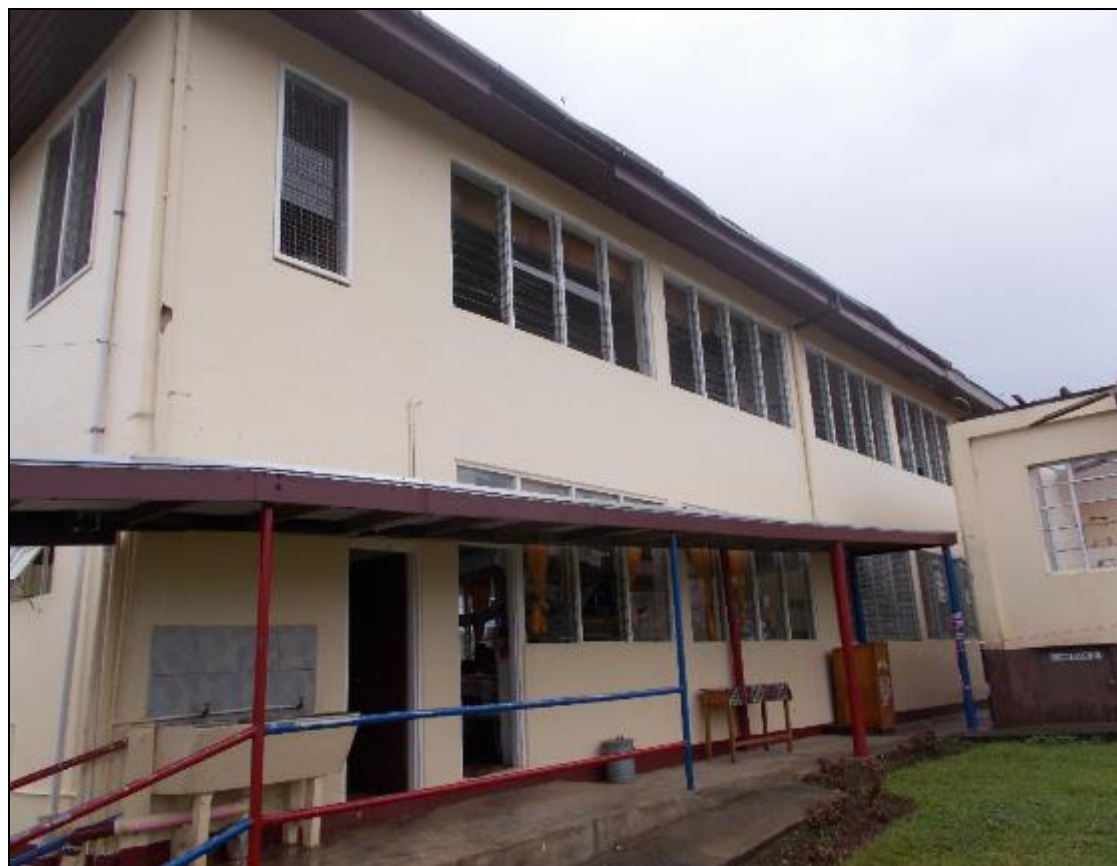
**Photo 2: Rear view of Block A- Damaged Gutter.**

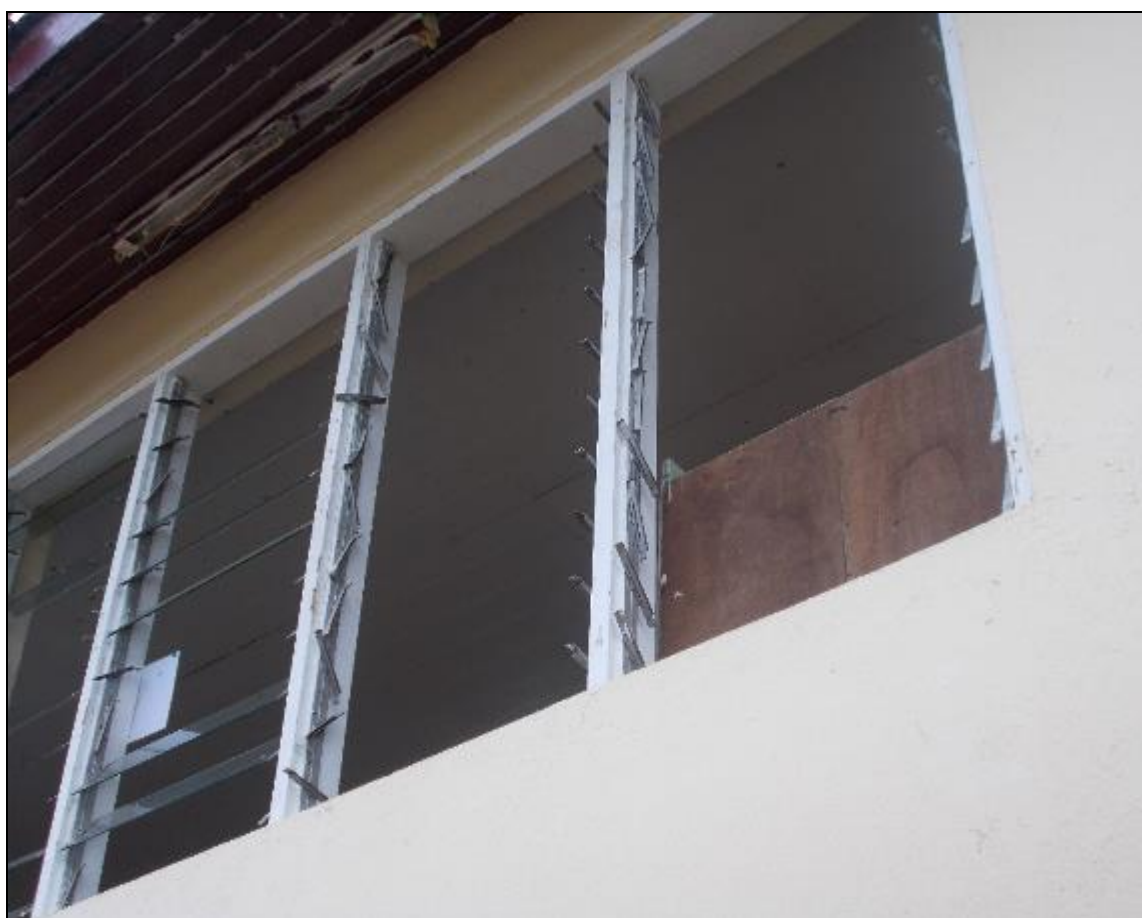
**Photo 4: View of damaged louver blades**

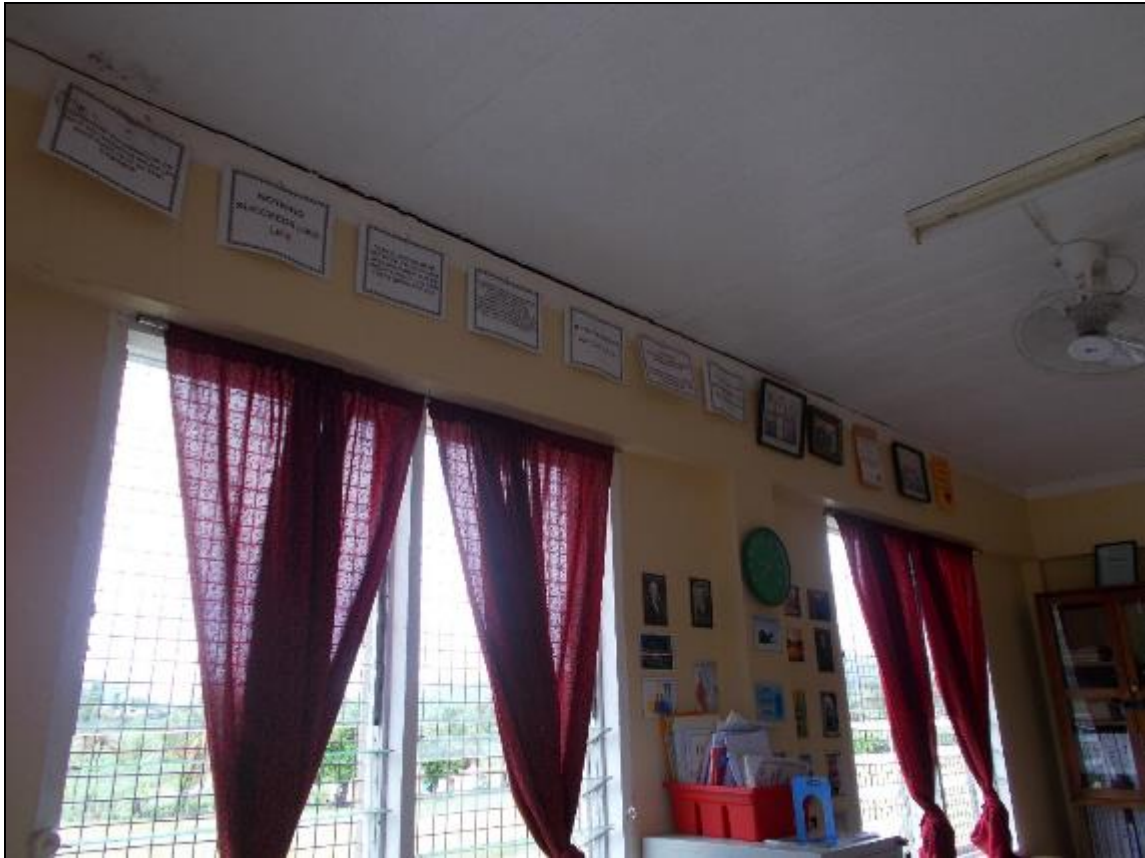
**Photo 5: View of water damaged ceiling.**

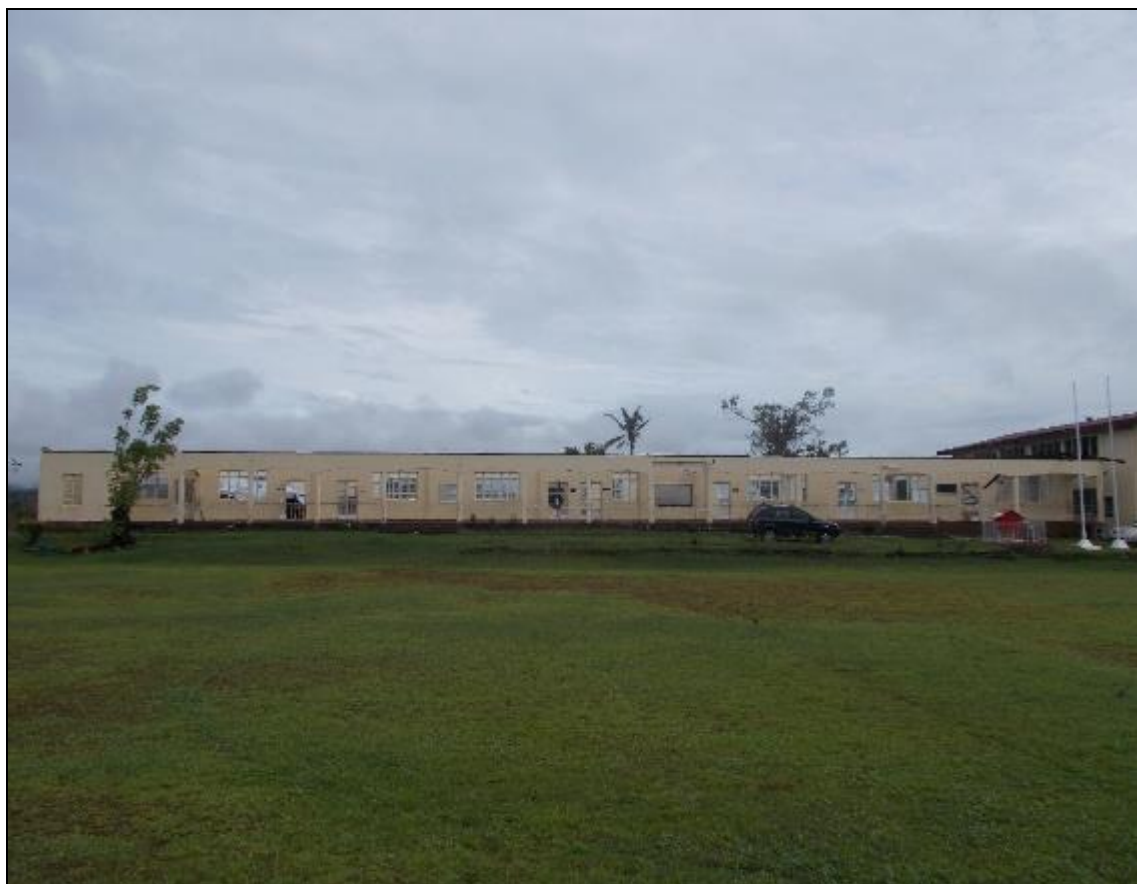
**Photo 6: Overall Side View of Block B- Blown off roof**

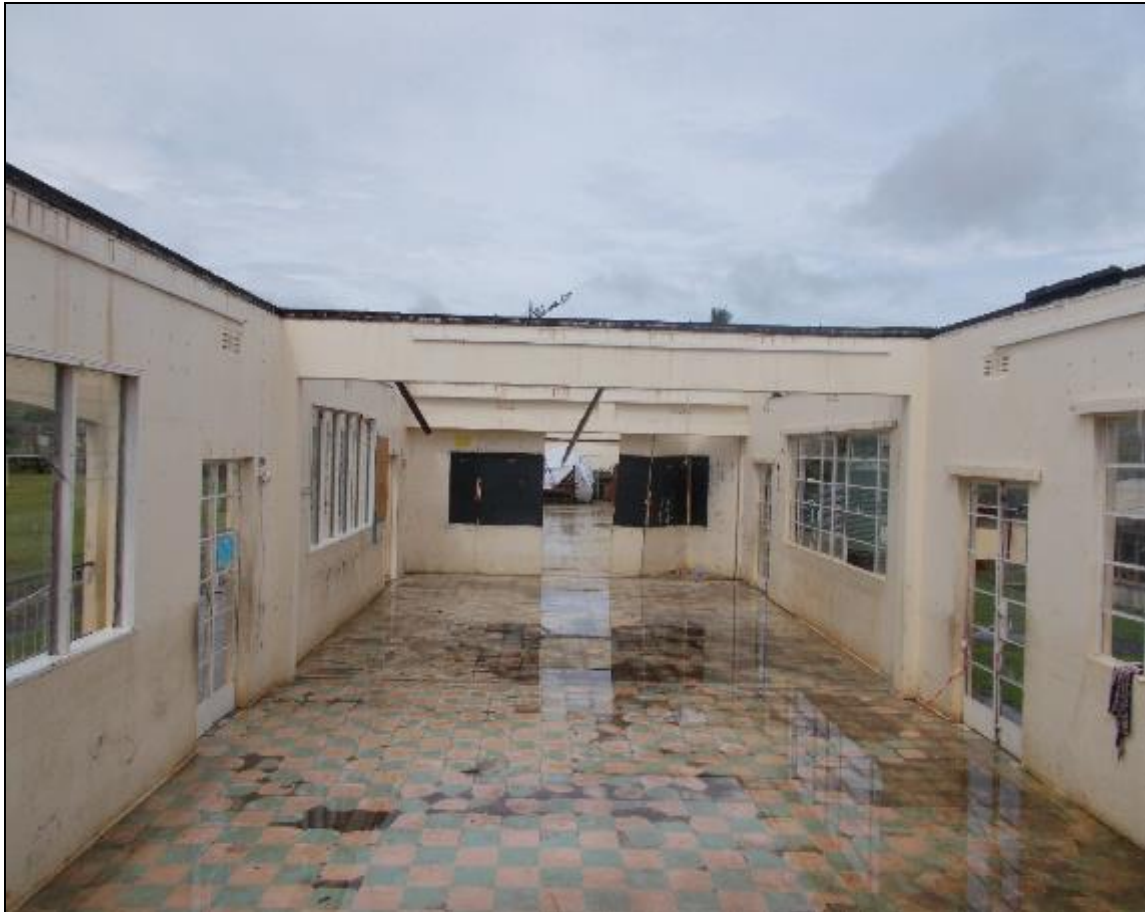
**Photo 8 :View of water logged floor and blown off roof**

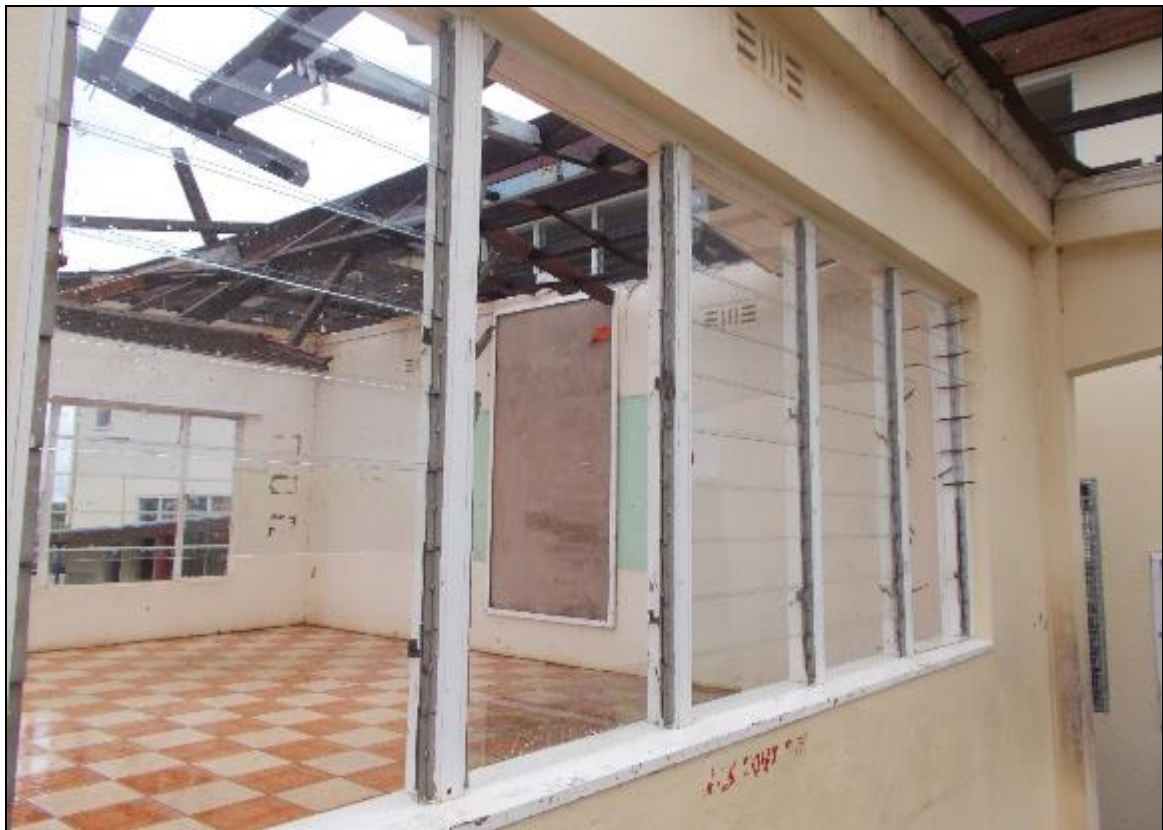
**Photo 9: Damaged louver blades/ roof frame.**

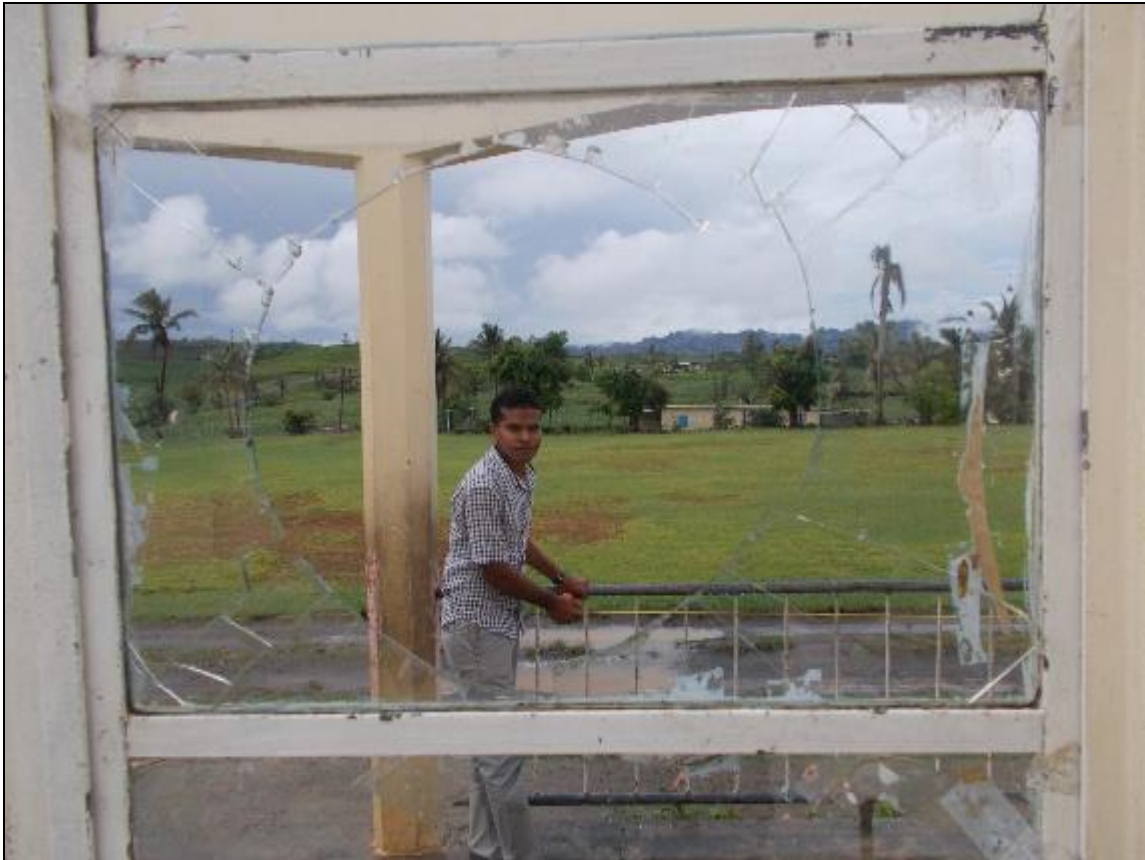
**Photo 10: Damaged glazing on casement window.**

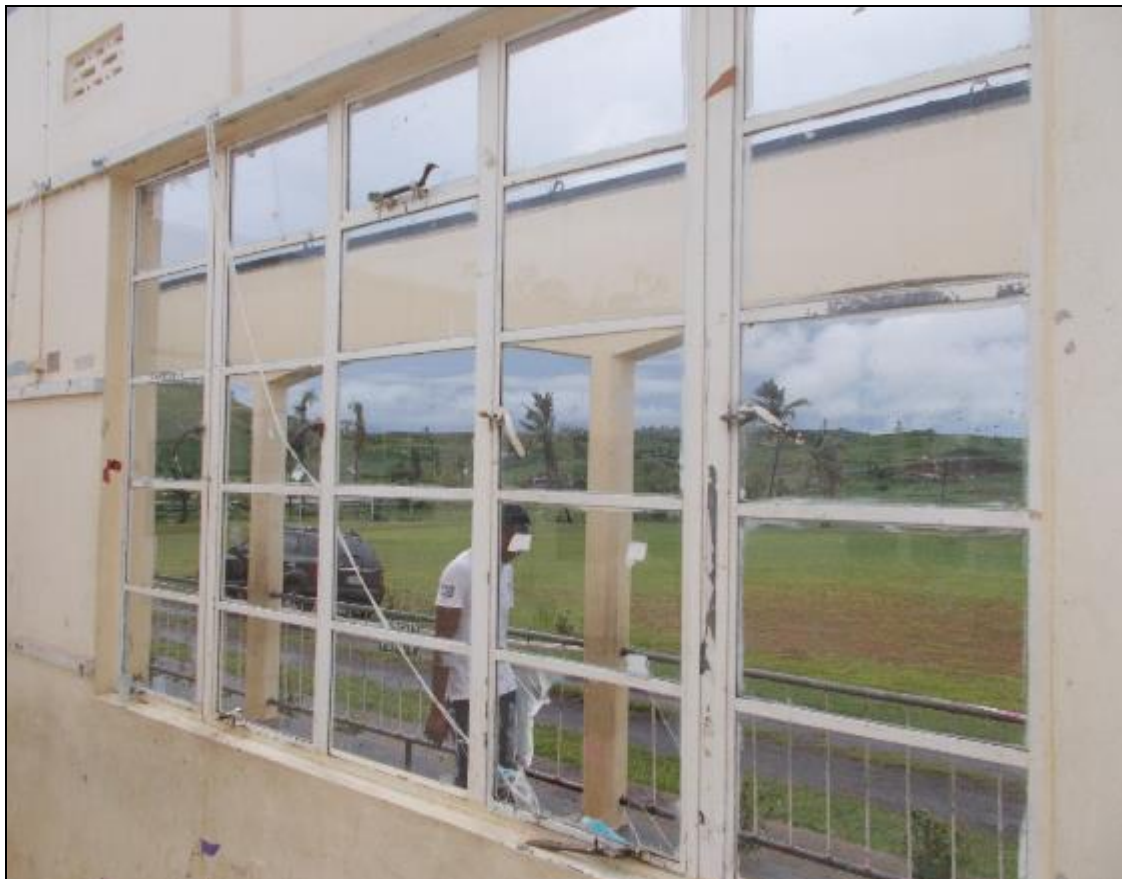
**Photo 11: View of damaged casement window**

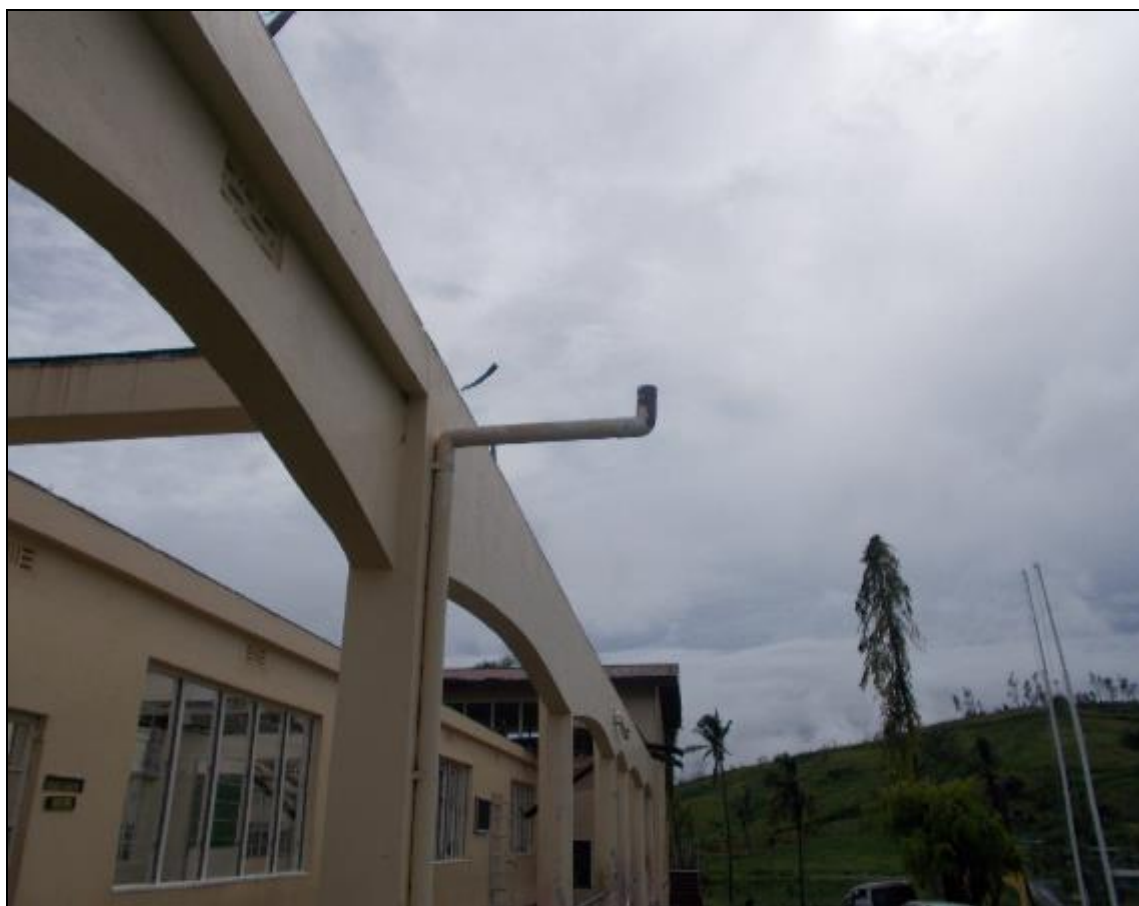
**Photo 12: Damaged down pipe, blown off fascia boards and gutters**

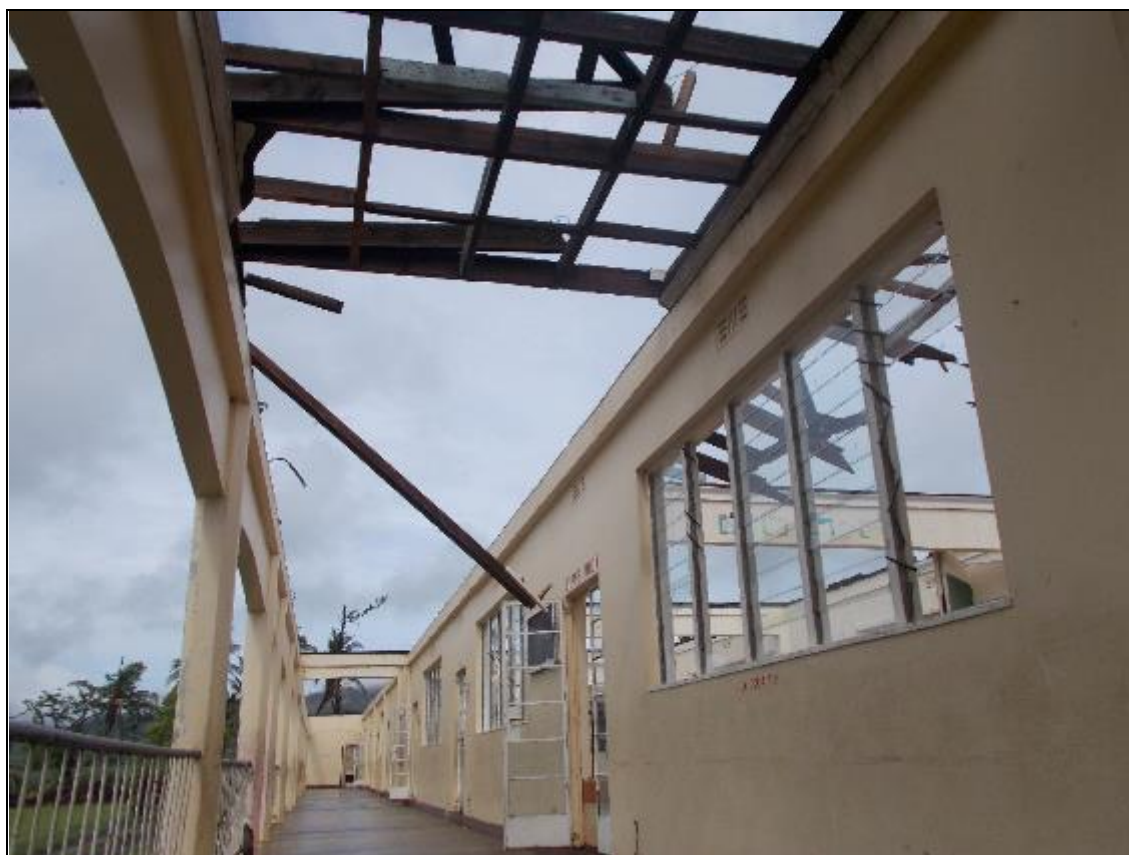
**Photo 13: View of damaged verandah area**

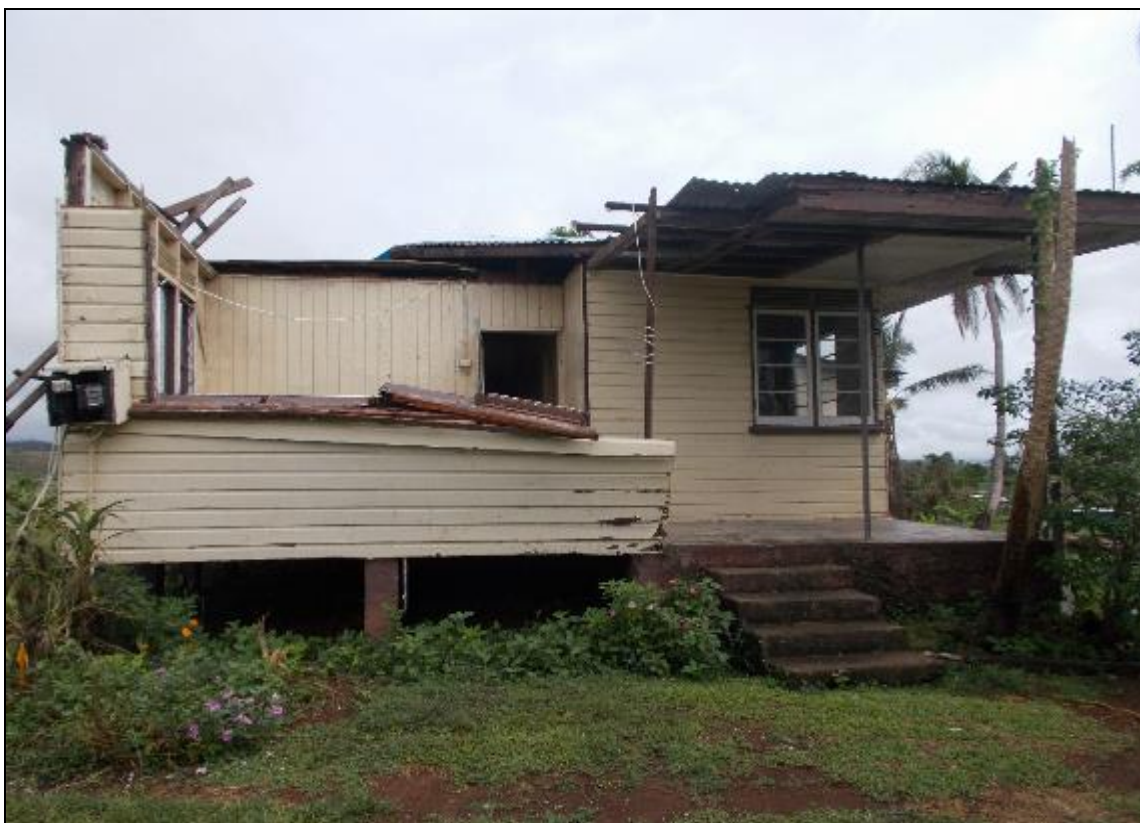
**Photo 14: Front view of damaged Staff Quarters 1- Damaged roof and walls**

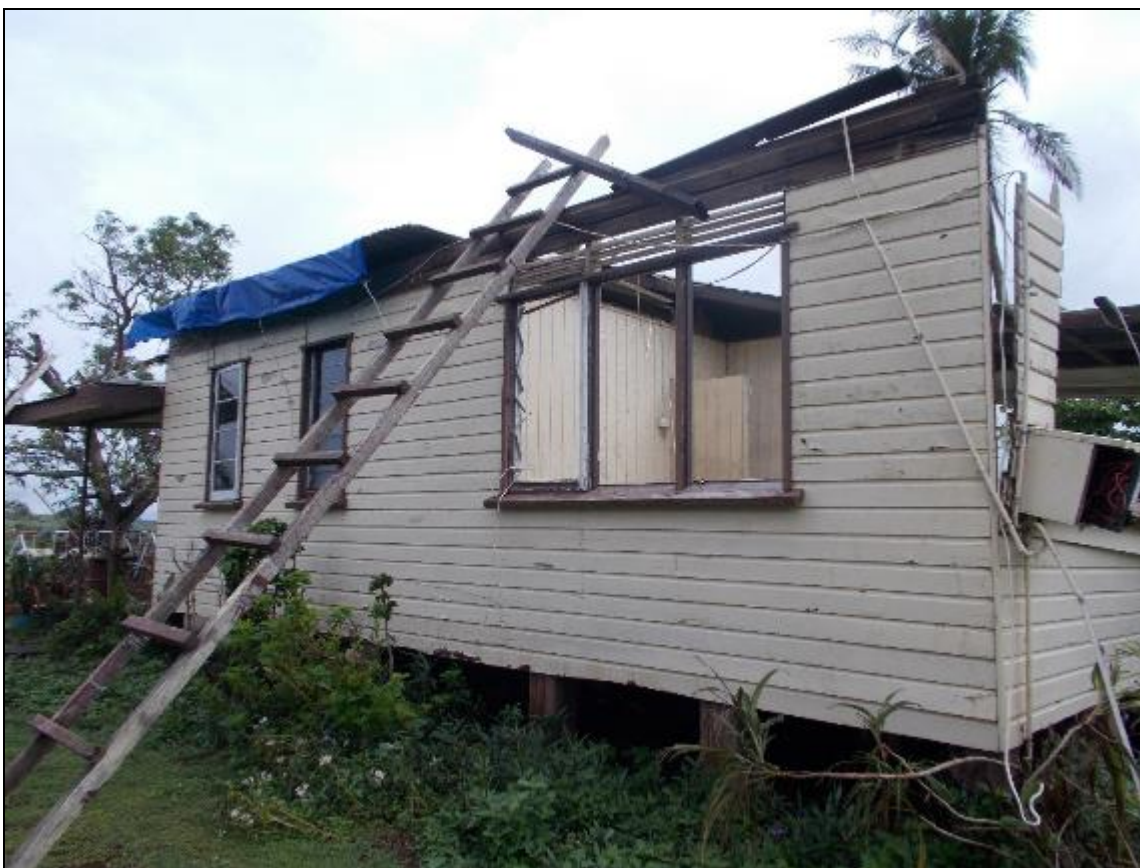
**Photo 15: Side view of damaged Staff Quarters 1- Damaged gutters,downpipes,walls,etc.**

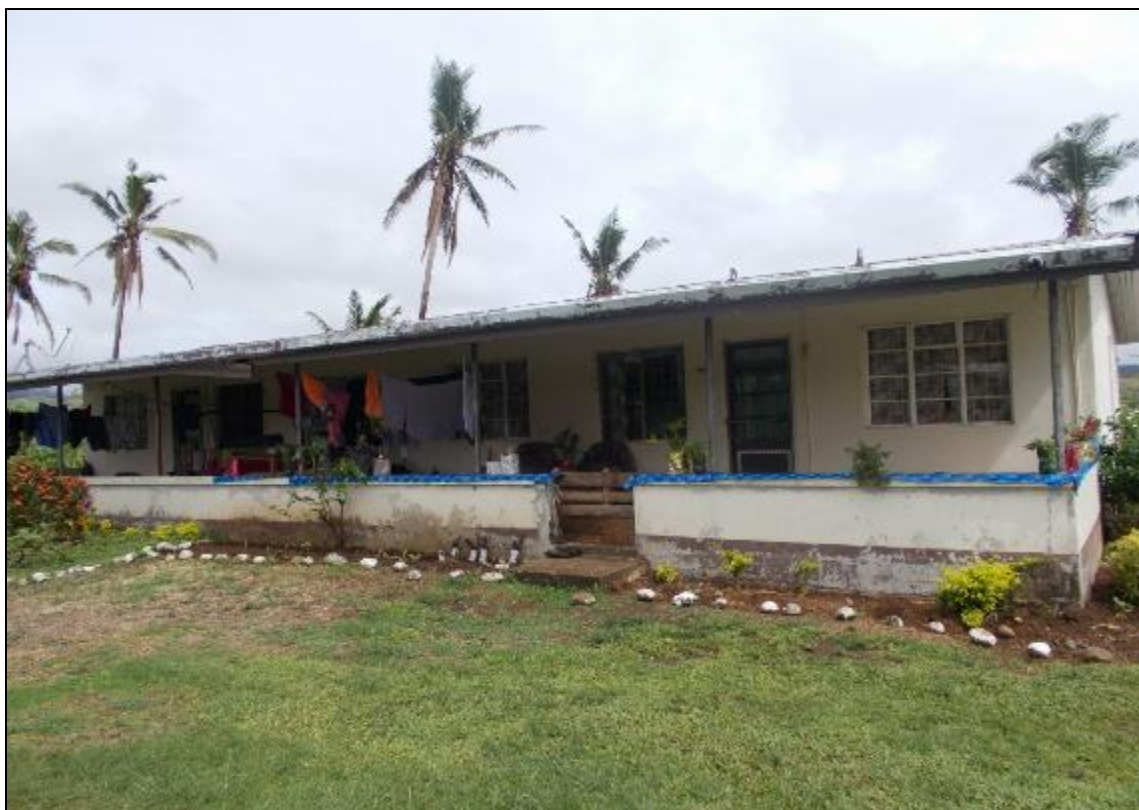
**Photo 16: Front view of damaged Staff Quarters 2- Damaged and warped gutters**

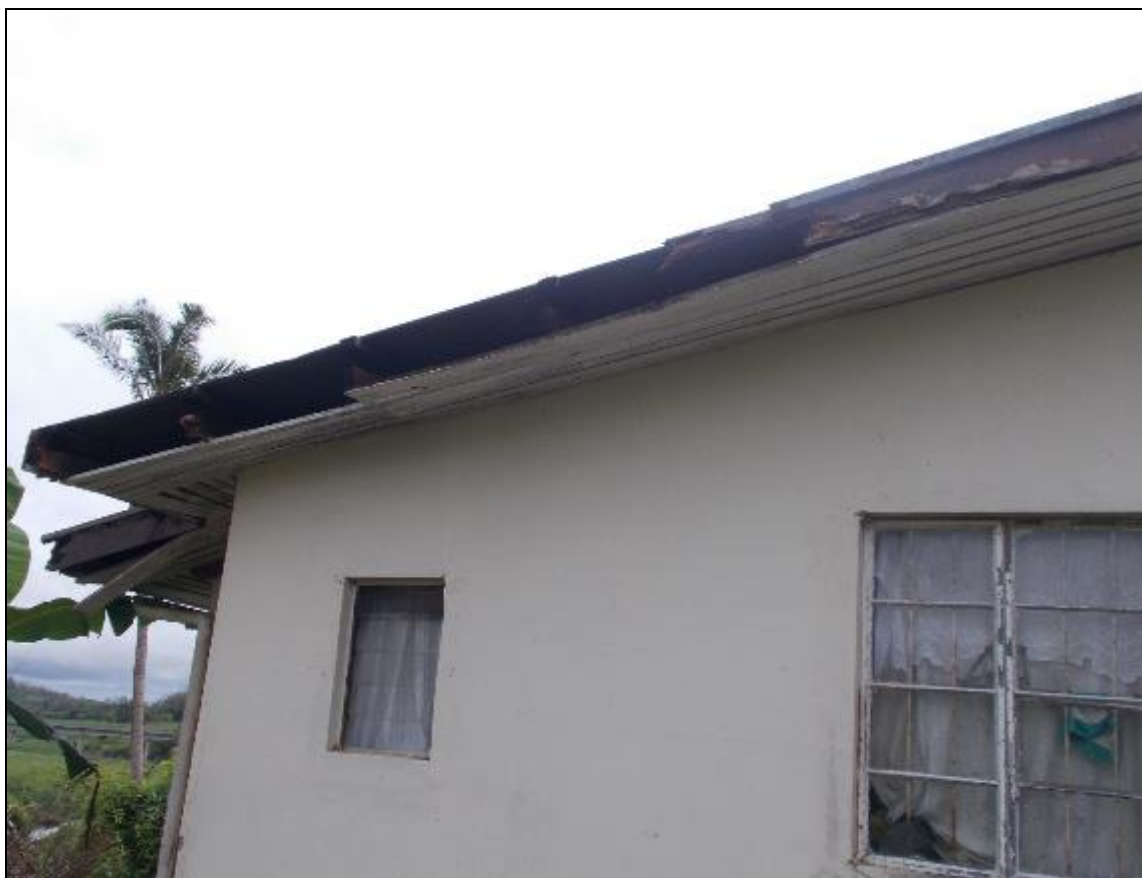
**Photo 17: Damaged Fascia Board.**

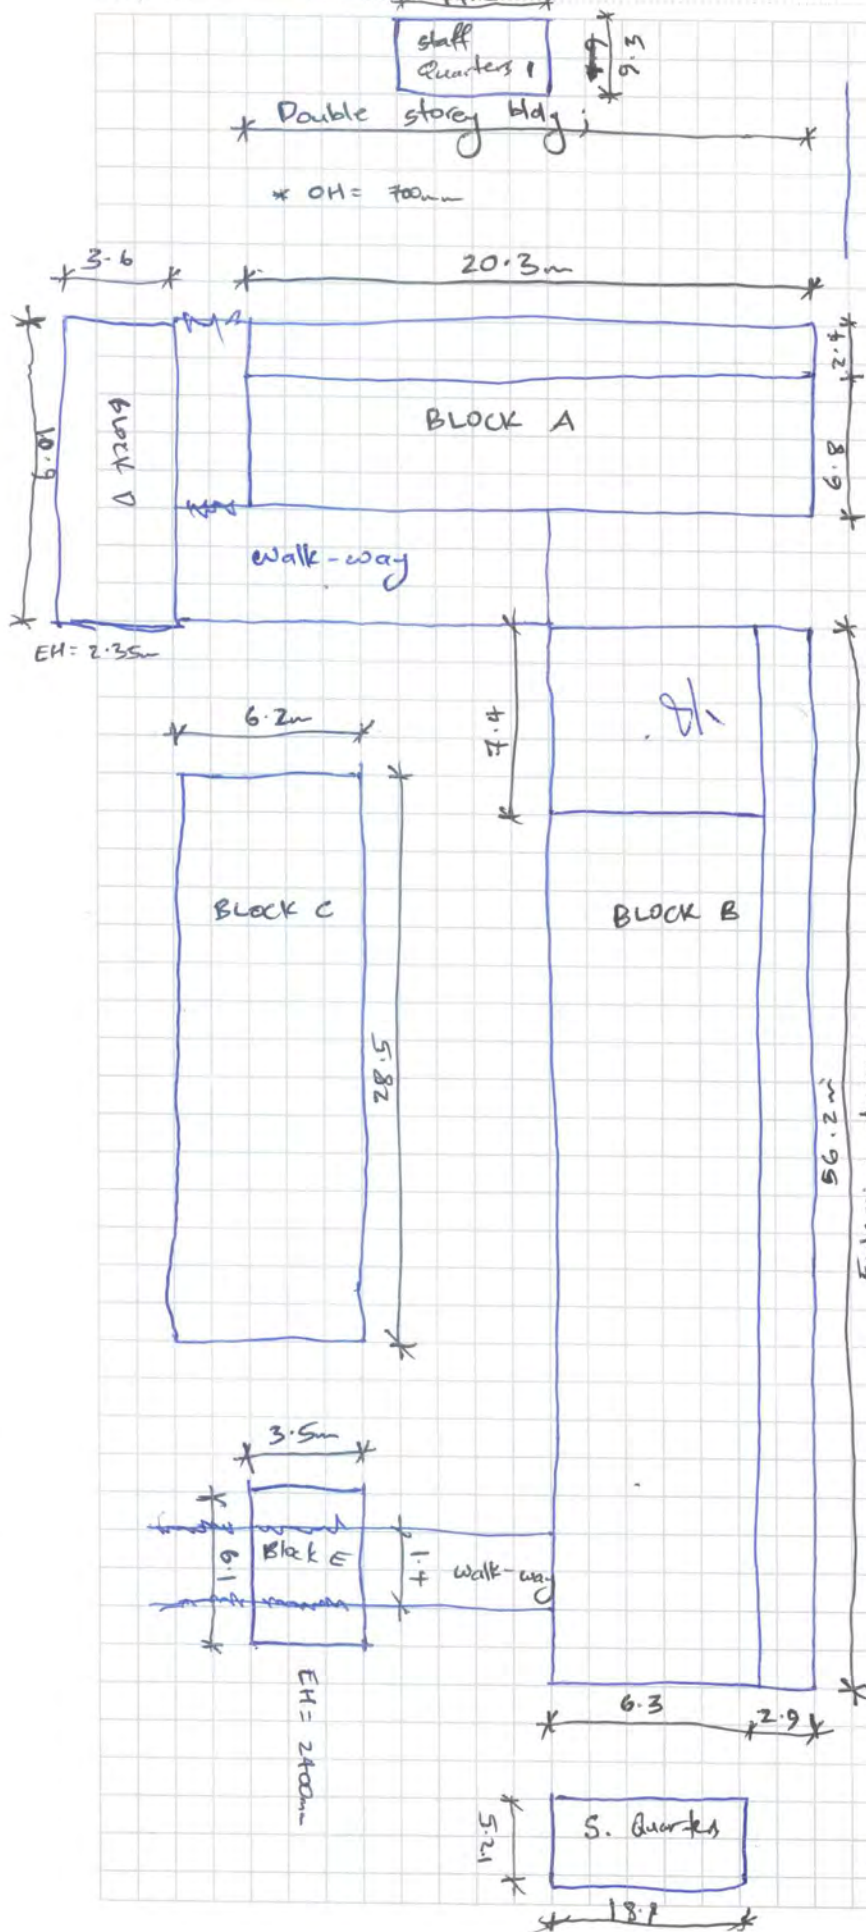
- \* EH = 6.15m from floor level
- \* Roof lifted
- \* Gutter missing

Extensive damage

- \* Damaged Gutter
- \* " " Fascia board
