CYCLONE WINSTON PRELIMINARY ASSESSMENT SCHOOLS, HEALTH FACILITIES & PUBLIC BUILDINGS

| NAME OF FACILITY: | Ba Muslim Primary School |
| DATE OF ASSESSMENT: | 21 March 2016 |

RAPID ASSESSMENT TEMPLATE: CYCLONE WINSTON DAMAGED BUILDINGS
SCHOOLS, PUBLIC BUILDINGS & HEALTH FACILITIES

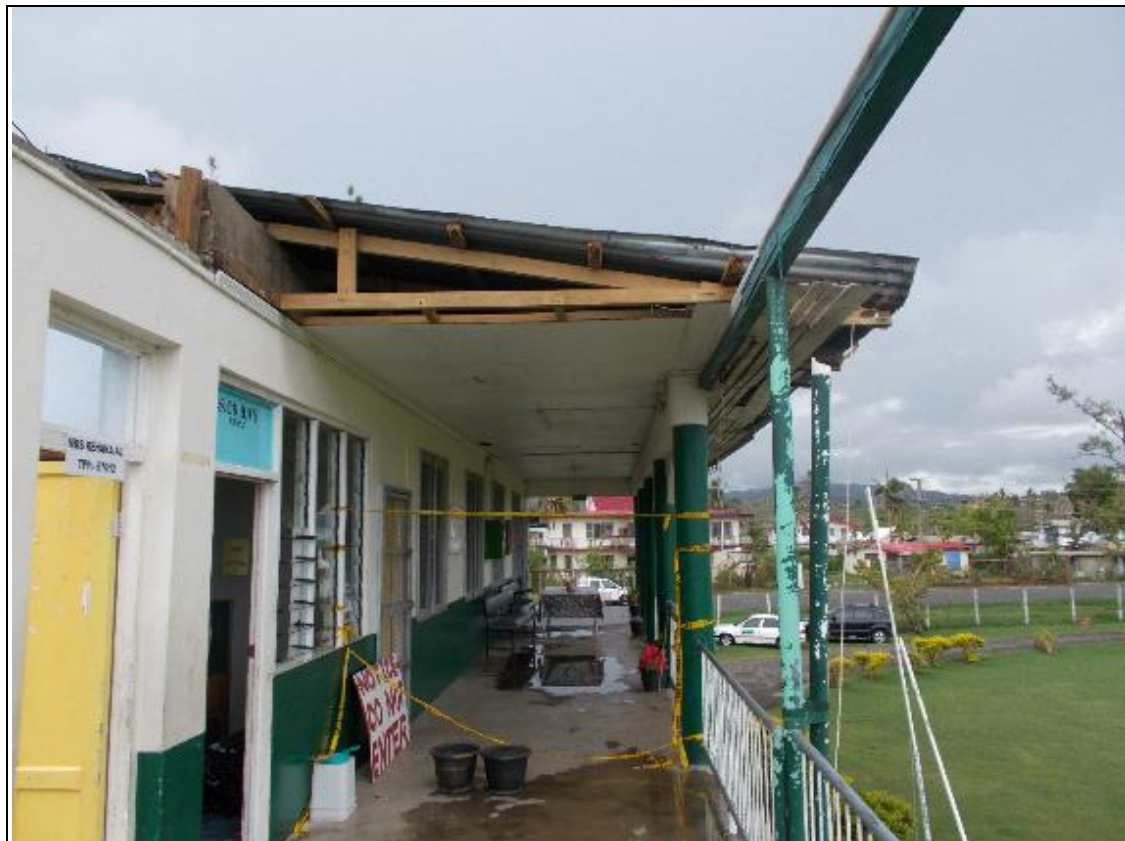
Photo 3: View of Balance of roof

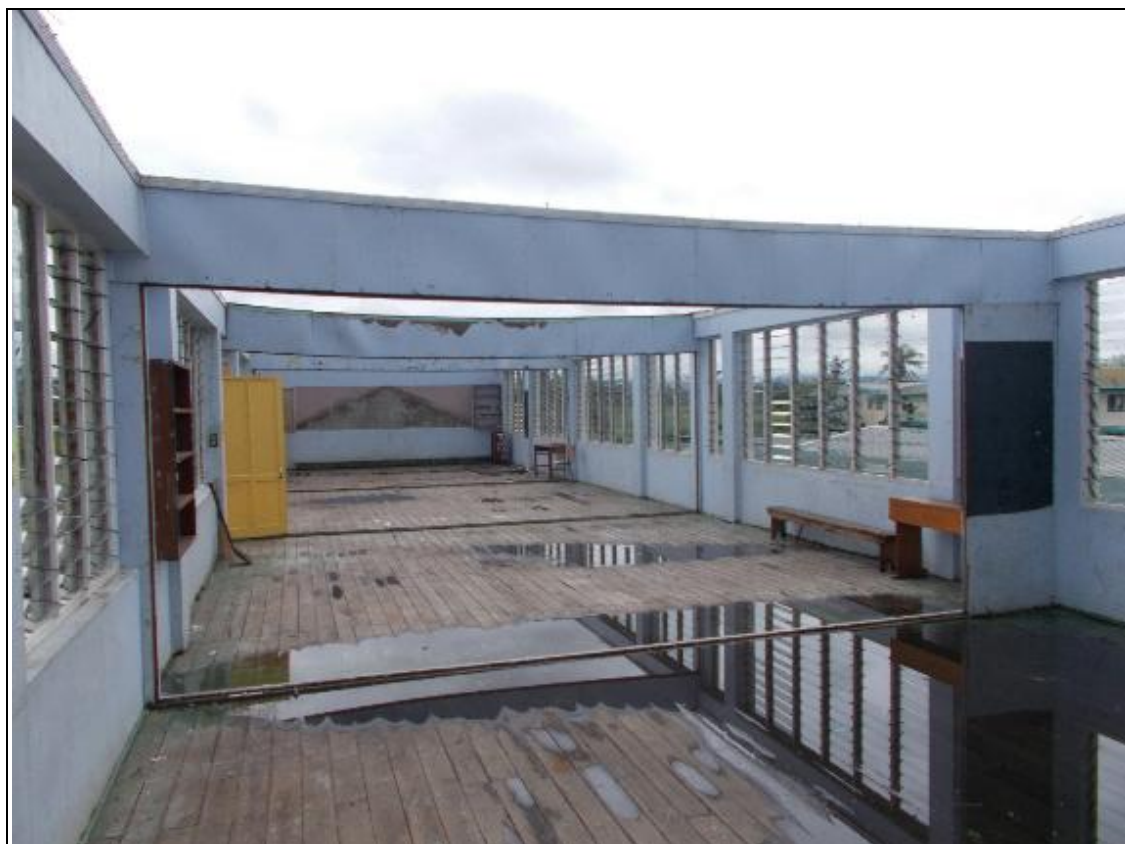
Photo 4: Completely blown off roof and water ponding on timber floor.

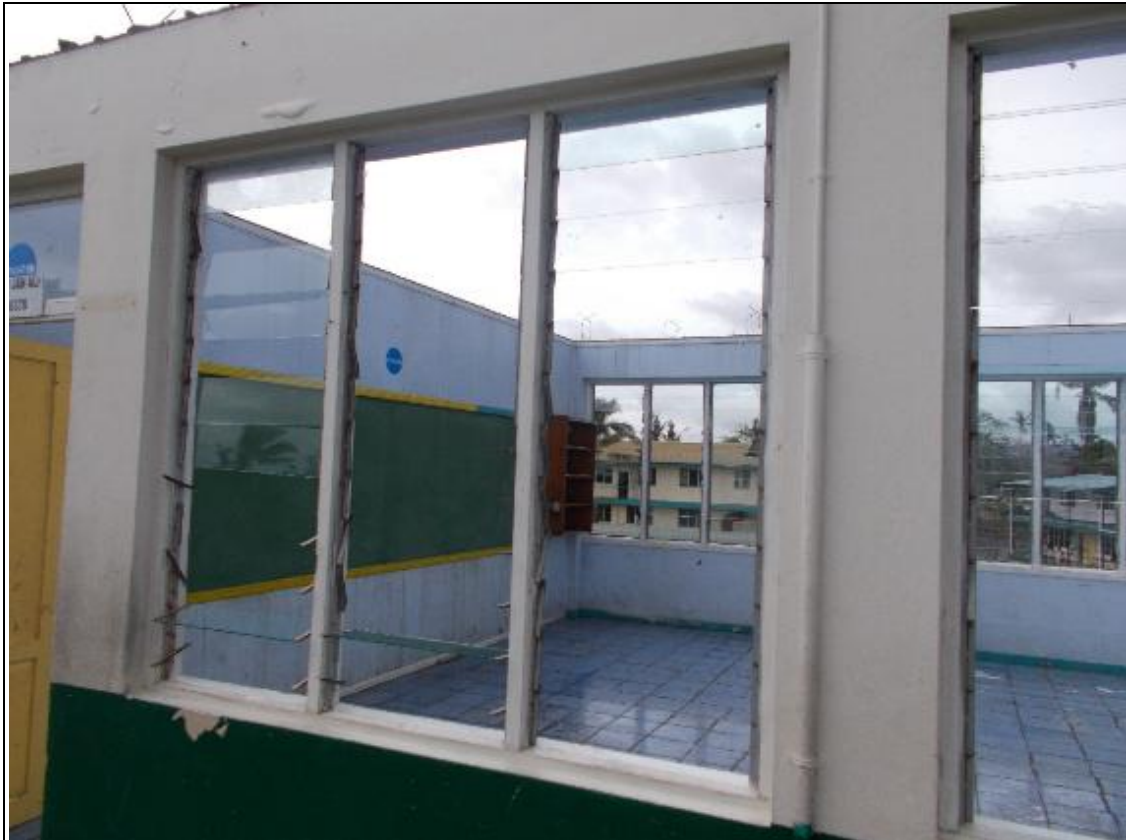
Photo 5: Broken louvers on windows

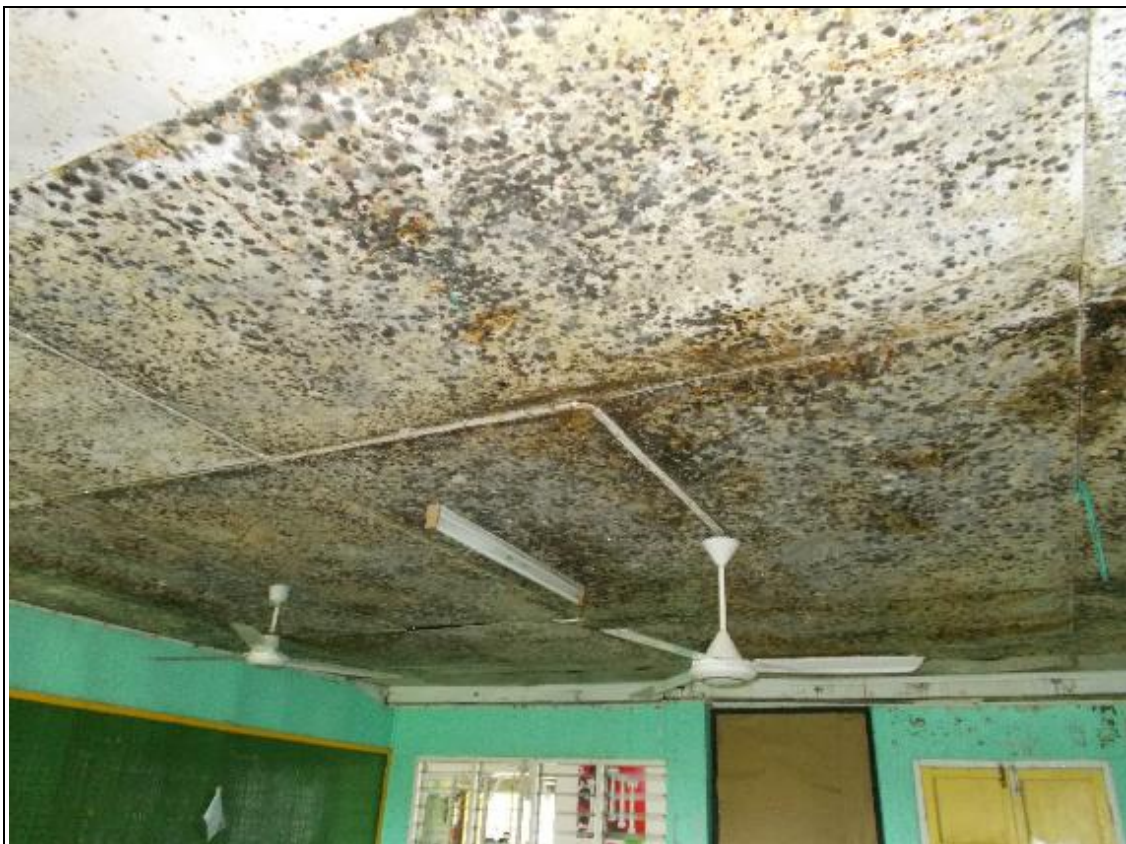
Photo 6: Water damaged ceiling under timber floor.
