CYCLONE WINSTON PRELIMINARY ASSESSMENT SCHOOLS, HEALTH FACILITIES & PUBLIC BUILDINGS

NAME OF FACILITY:	Ba Sangam Primary School
TYPE:	Primary School & Kindergarten
LOCATION:	Ba
DATE OF ASSESSMENT:	22 March 2016
DATE OF REPORT:	06 April 2016
JOB NO:	16015
HLKJACOB REPORT NO:	19-S
HLKJACOB FACILITY NO:	12
GOVERNMENT FACILITY NO:	025

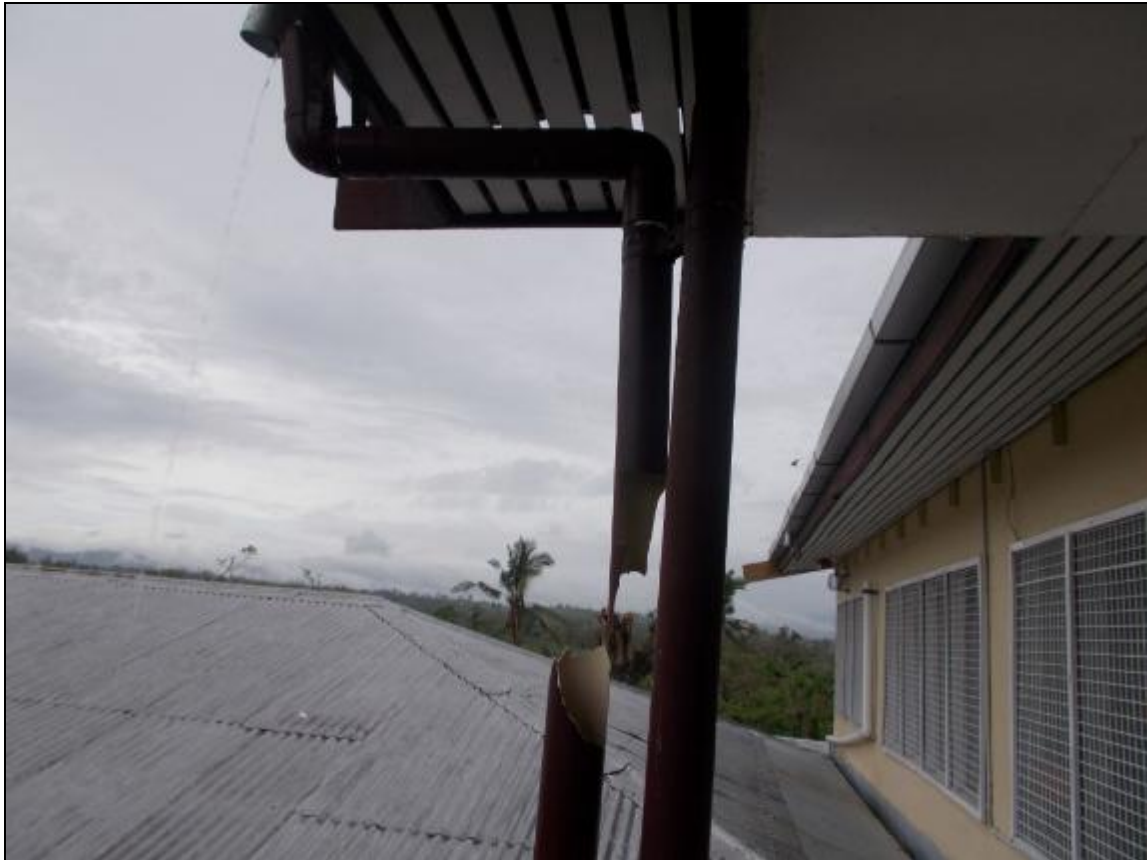
Photo 3: Roof view/Damaged downpipe

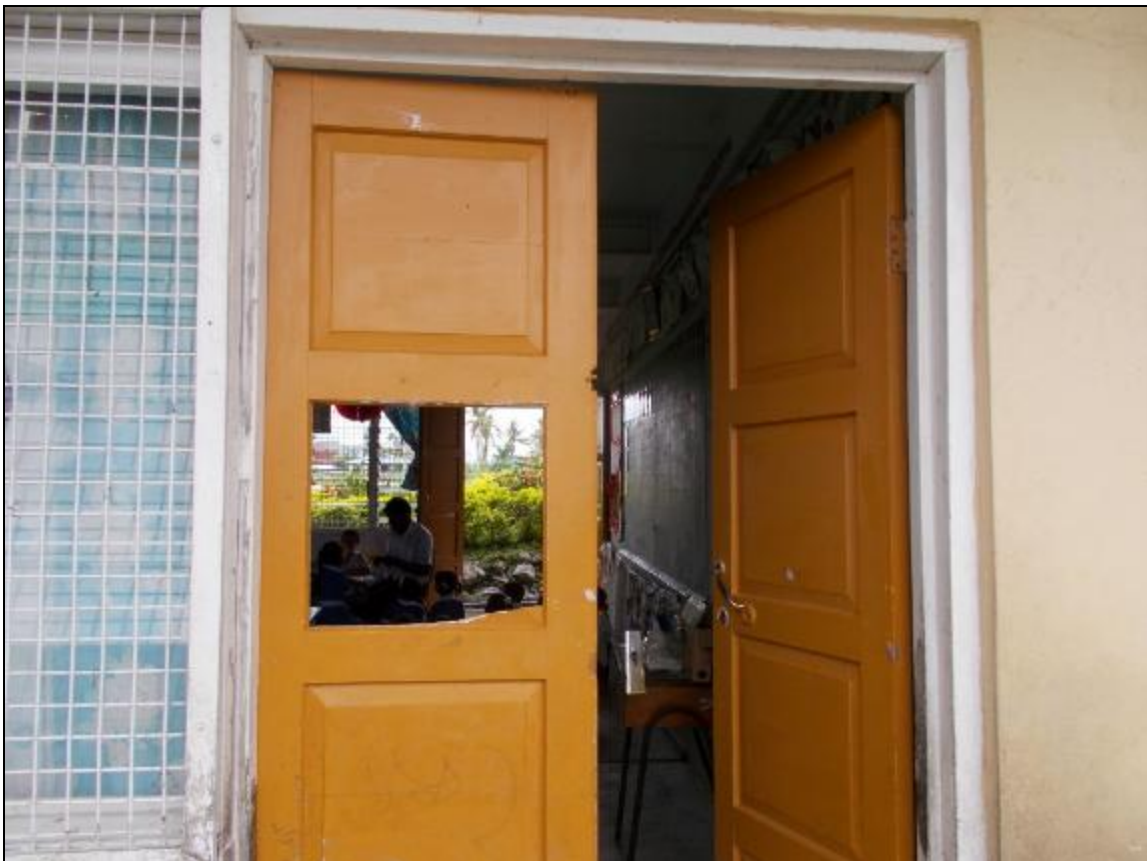
Photo 4: Showing Damaged door leaf

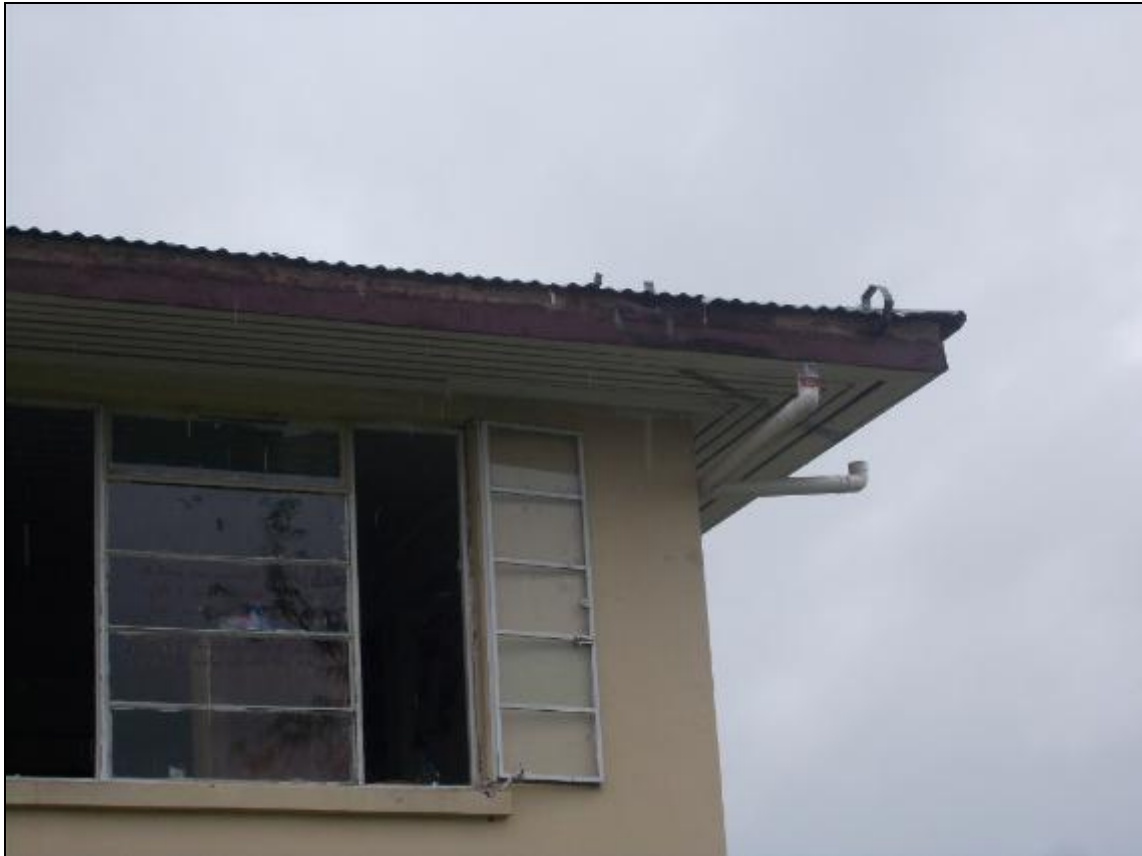
Photo 5: Showing TypicalAwning Windows / Damaged Gutters

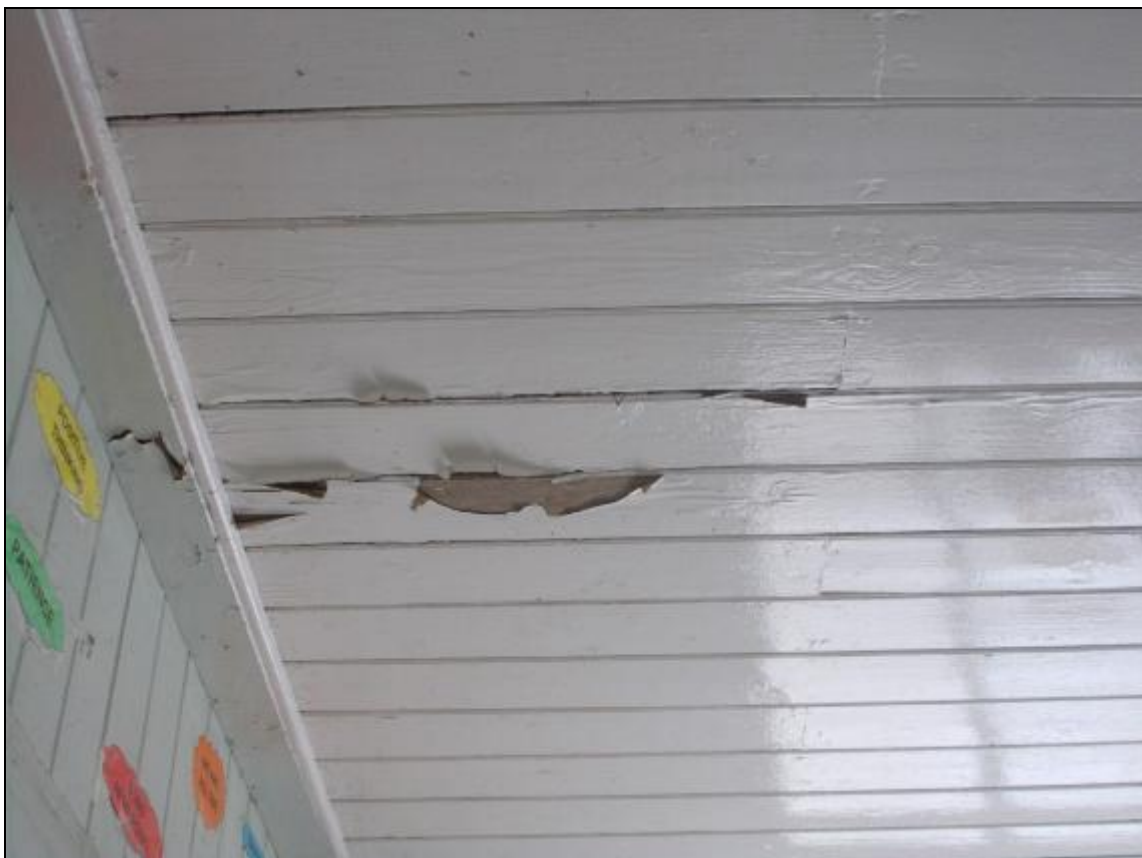
Photo 6: Showing typical water damaged ceiling

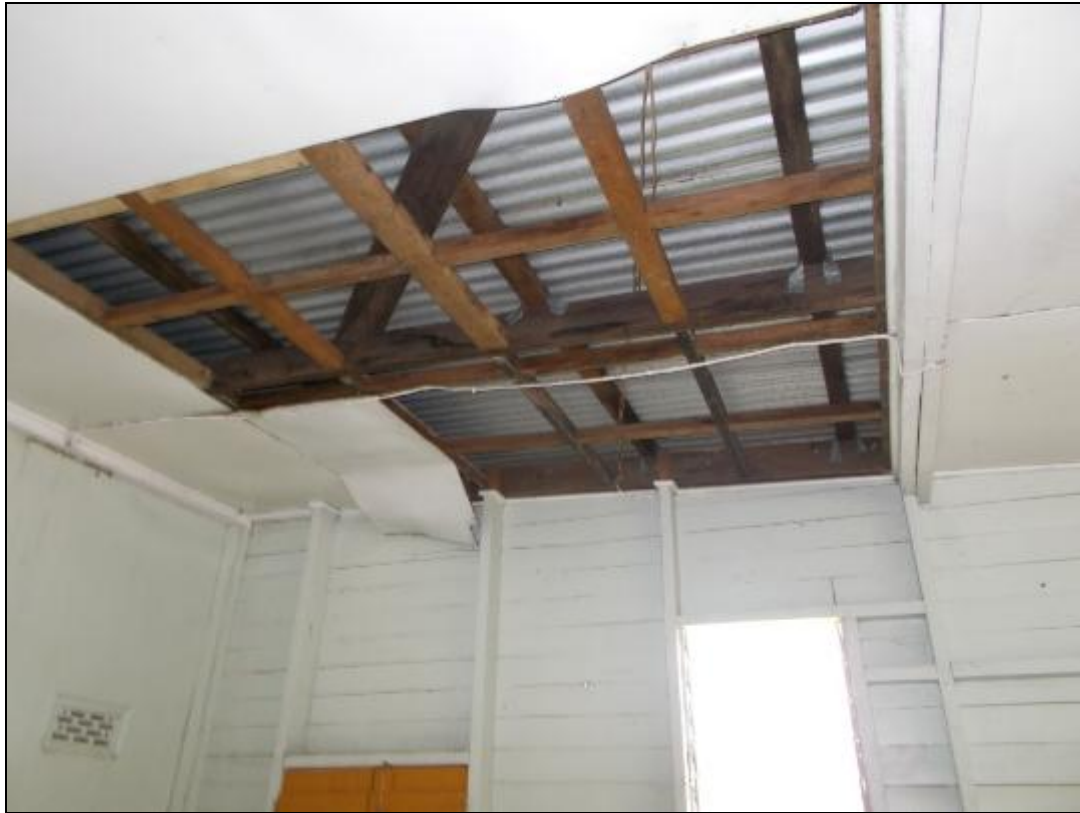
Photo 9: Showing Hall ceiling boards blown off

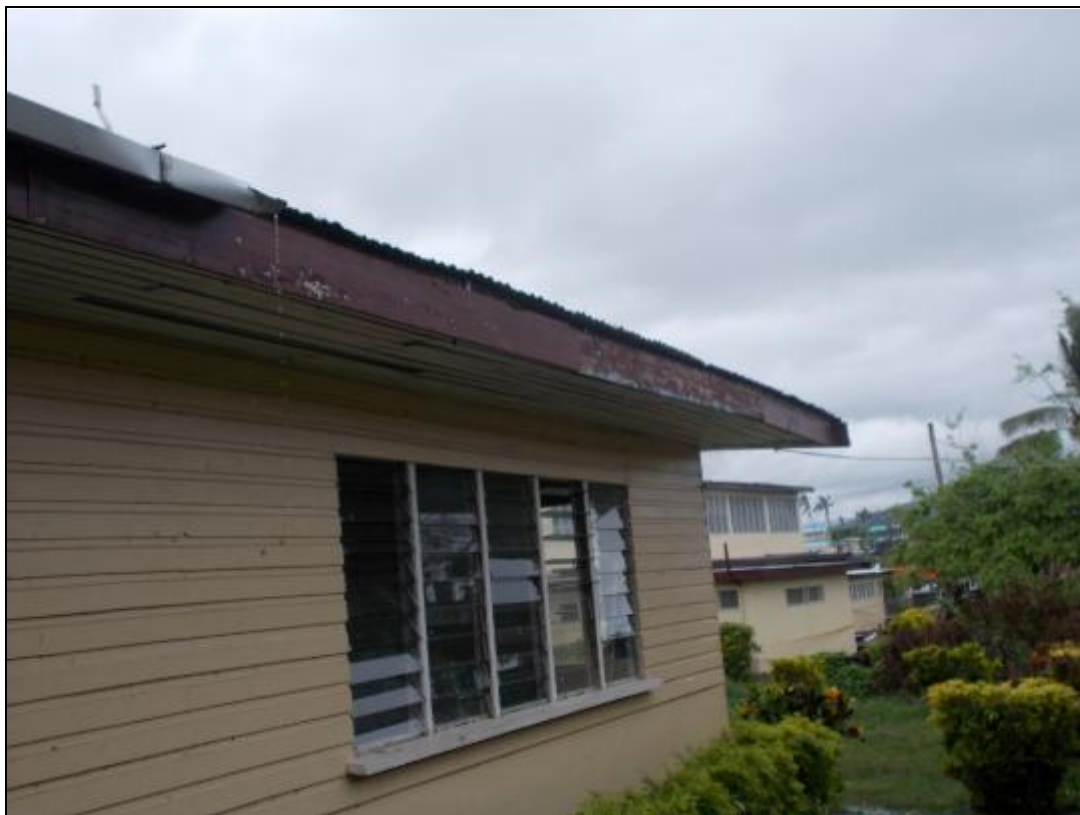
Photo 10: Showing typical Windows /Blown off gutters

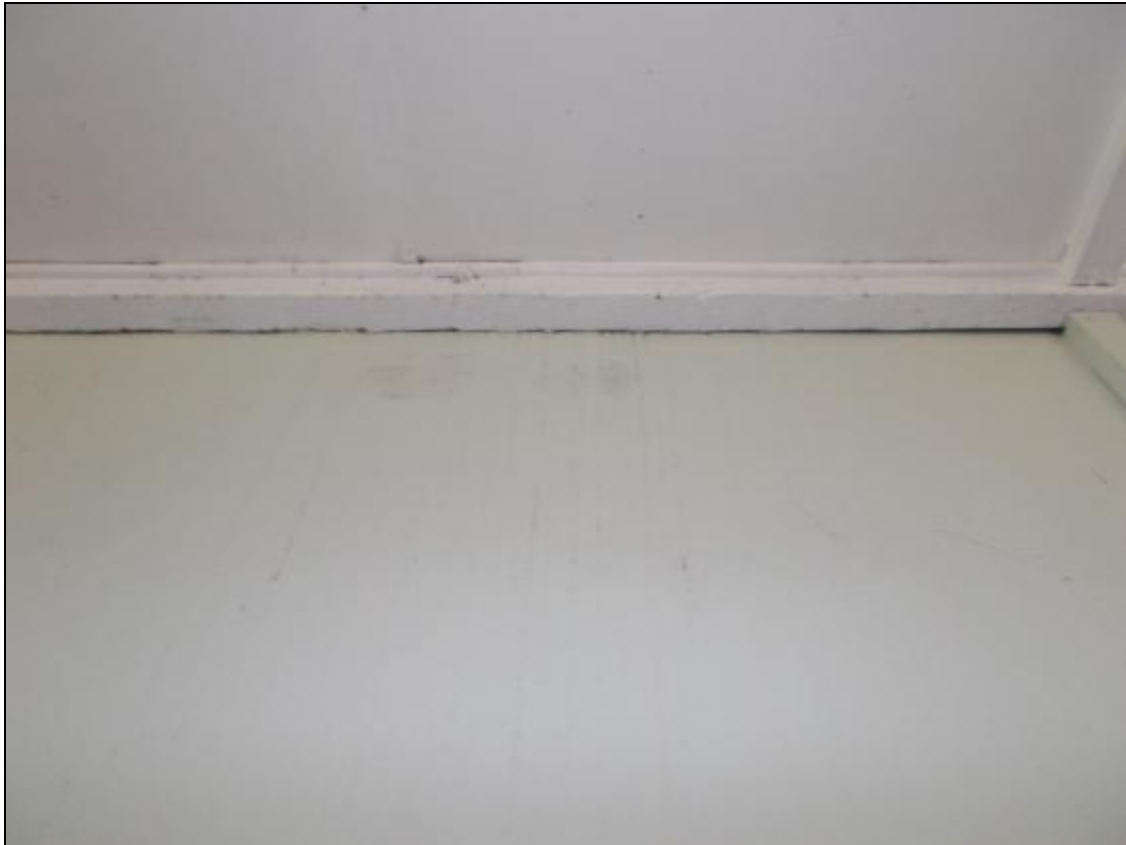
Photo 11: Showing water leak stains

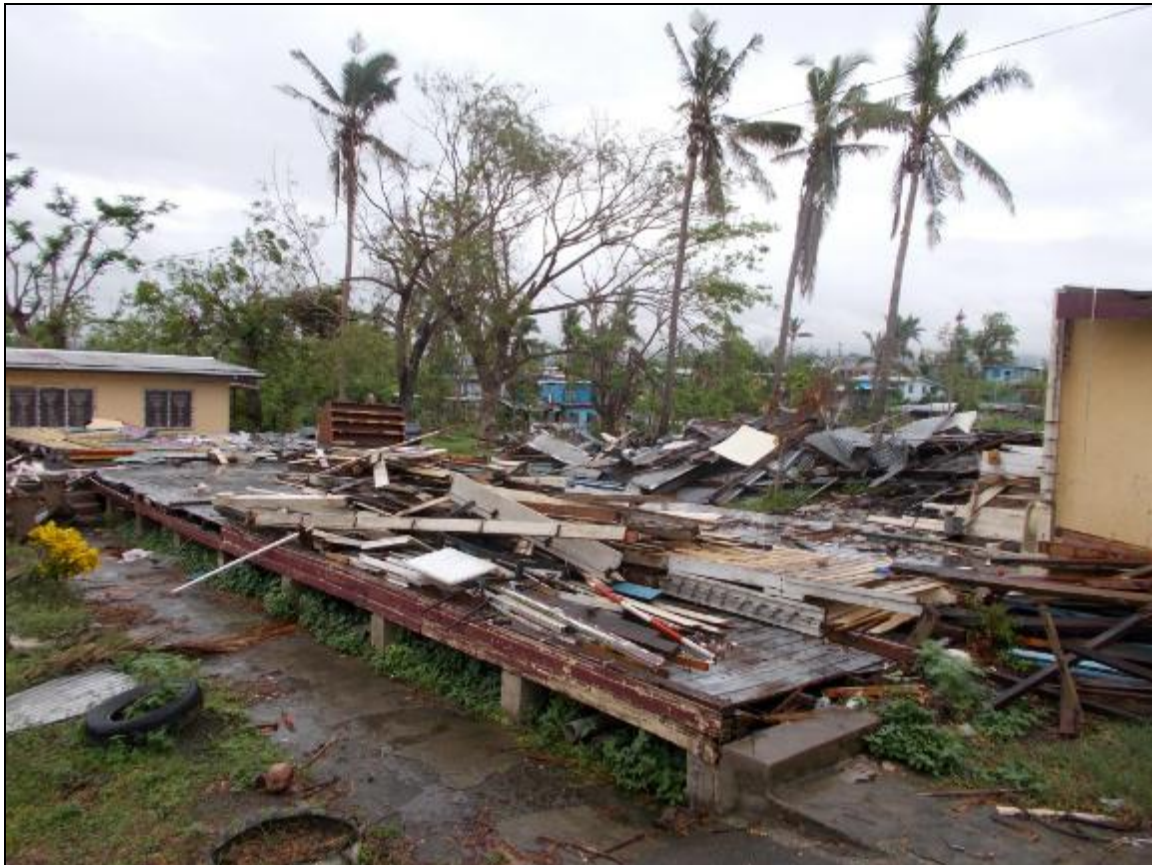
Photo 12: Total destruction of Building 3-Kindergarten

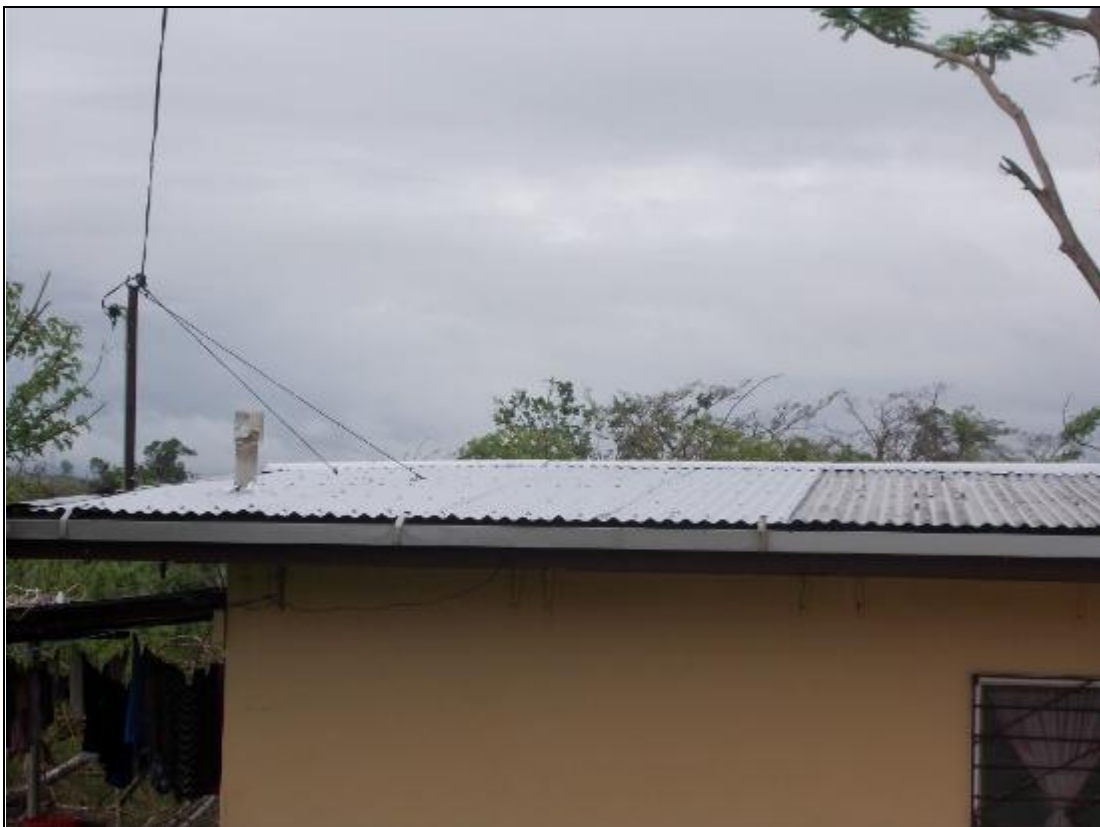
Photo 14: Showing newly replaced roof cladding

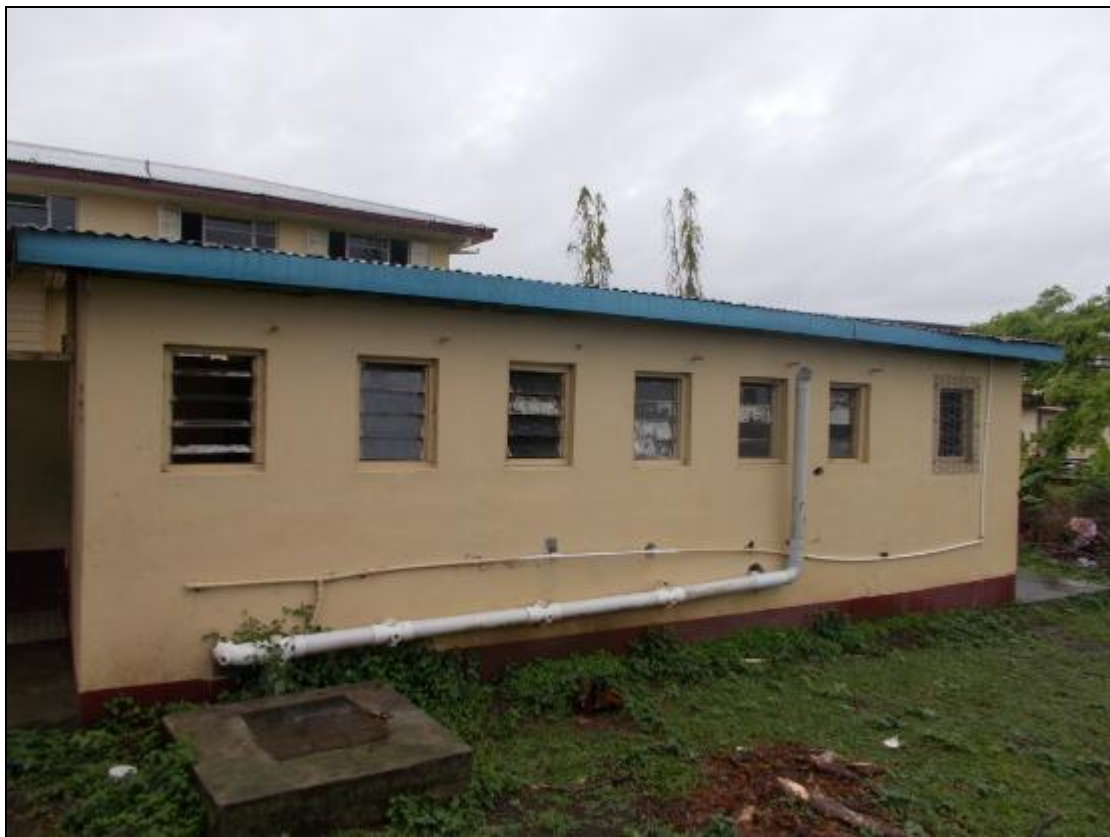
Photo 15: Typical Minor damages to Toilet Plumbing
