CYCLONE WINSTON PRELIMINARY ASSESSMENT SCHOOLS, HEALTH FACILITIES & PUBLIC BUILDINGS

NAME OF FACILITY:	Tagore Memorial School
TYPE:	Primary School
LOCATION:	Varadoli, Ba
DATE OF ASSESSMENT:	22 March 2016
DATE OF REPORT:	06 April 2016
JOB NO:	16015
HLKJACOB REPORT NO:	25-S
HLKJACOB FACILITY NO:	49
GOVERNMENT FACILITY NO:	151

**RAPID ASSESSMENT TEMPLATE: CYCLONE WINSTON DAMAGED BUILDINGS
SCHOOLS, PUBLIC BUILDINGS & HEALTH FACILITIES**

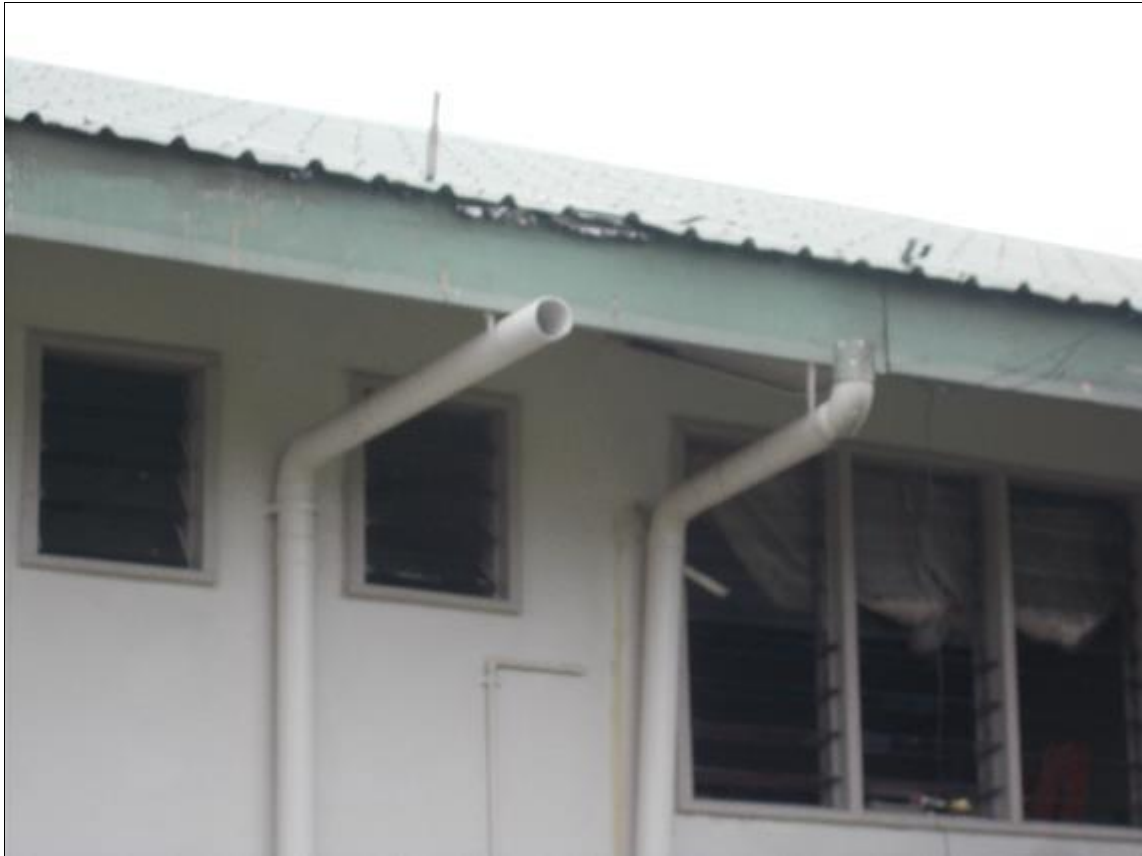
Photo 5: View of unshuttered windows/damaged plumbing

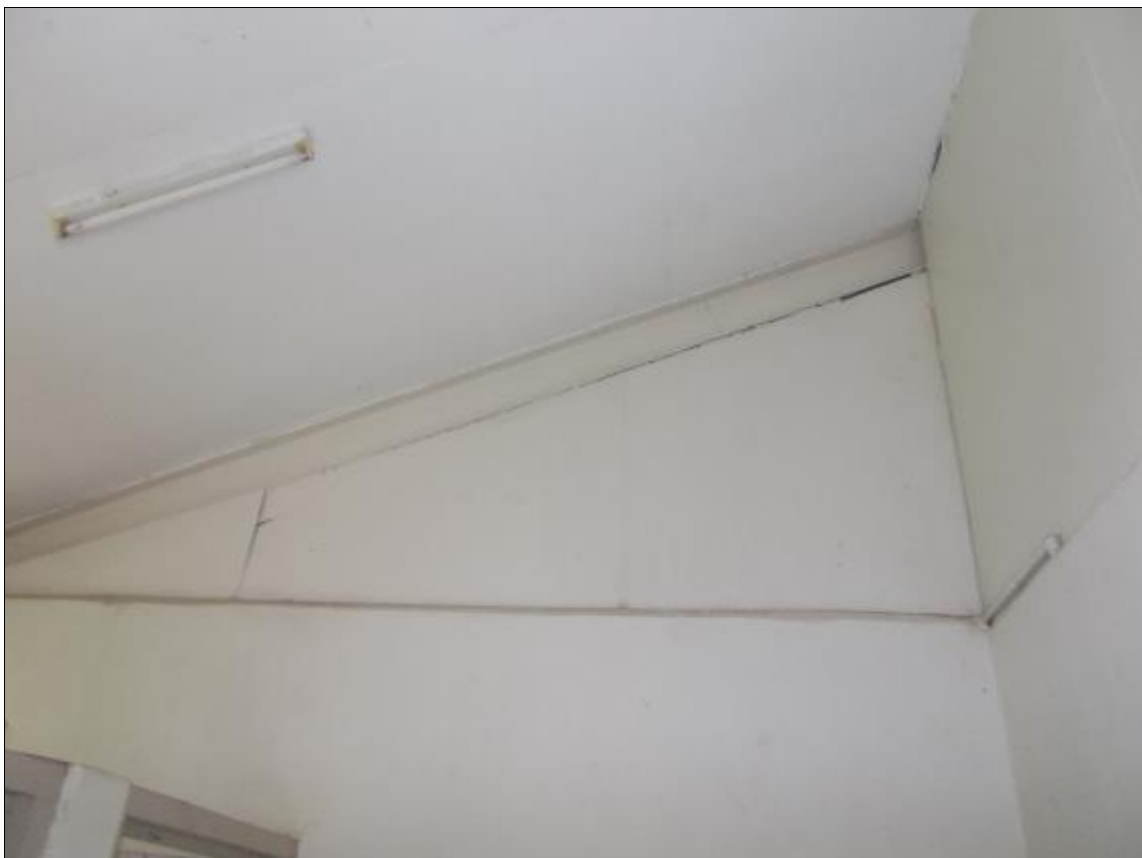
Photo 6: View of Interior Ceiling – Water Damage

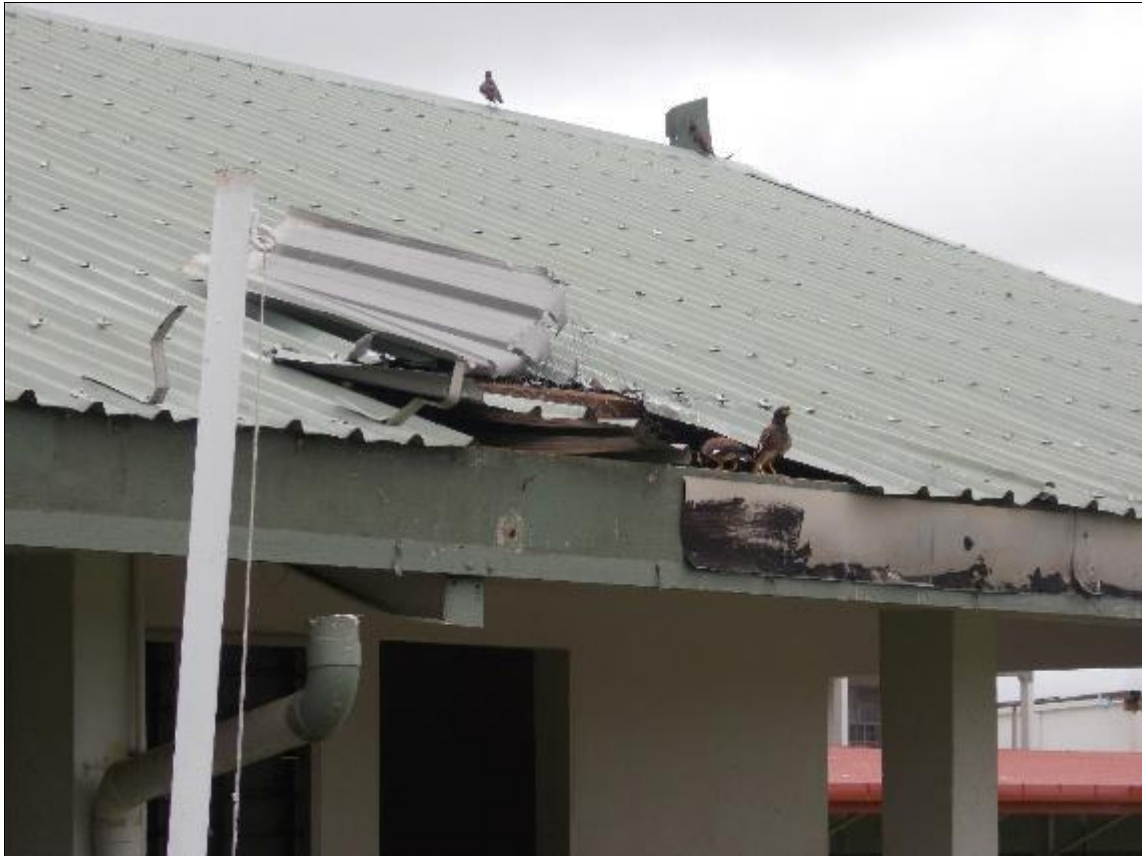
Purlins	150 x 50mm timber purlins bolted to MS cleat with 2 - M12 bolts	1	Good	2	Average	3	Poor	No visible damage - Limited visibility	0	N/A
Roof Cladding	Trimdek metal profile cladding screwed at every crest	1	Good	2	Average	3	Poor	Minor cladding damage observed on ends and mid.	2	7
Terraces/Verandah	Typically concrete floor with RC/steel frame supporting roof structure	1	Good	2	Average	3	Poor	No visible damage	0	N/A
Gutters	Standard steel box gutters with proprietary strappings	1	Good	2	Average	3	Poor	Front gutters generally blown away.	3	7,8
Downpipes	100mm PVC downpipes with galvanized straps fixed to columns/walls.	1	Good	2	Average	3	Poor	75% of downpipes damaged	2	5,7,8
Fascia Boards/Flashings	240x40 mm timber fascia boards.	1	Good	2	Average	3	Poor	Approx. 15m of fascia boards damaged. Flashing damages observed.	3	4
Electrical	Typically standard switches, fans, GPO's and fluorescent tube lights and bulbs	1	Good	2	Average	3	Poor	No visible damage	0	N/A

Photo 7: View of Roof – Damage to Cladding/Gutters and Flashings.

Mechanical	N/A	1	Good	2	Average	3	Poor	N/A	N/A	N/A
Possible Intermediate Solutions	New gutter and downpipes and fascia boards for damaged areas with gutter strapping to all areas for adequate hold down. Also shutters to be provided. Roof flashing/fascia boards, down pipes to be repaired. New claddings to be provided selectively.									
Possible Long Term Solutions	Detailed investigations for roof framing recommended along to retrofit to a post disaster building. Much dependent upon detailed investigations by an Engineer.

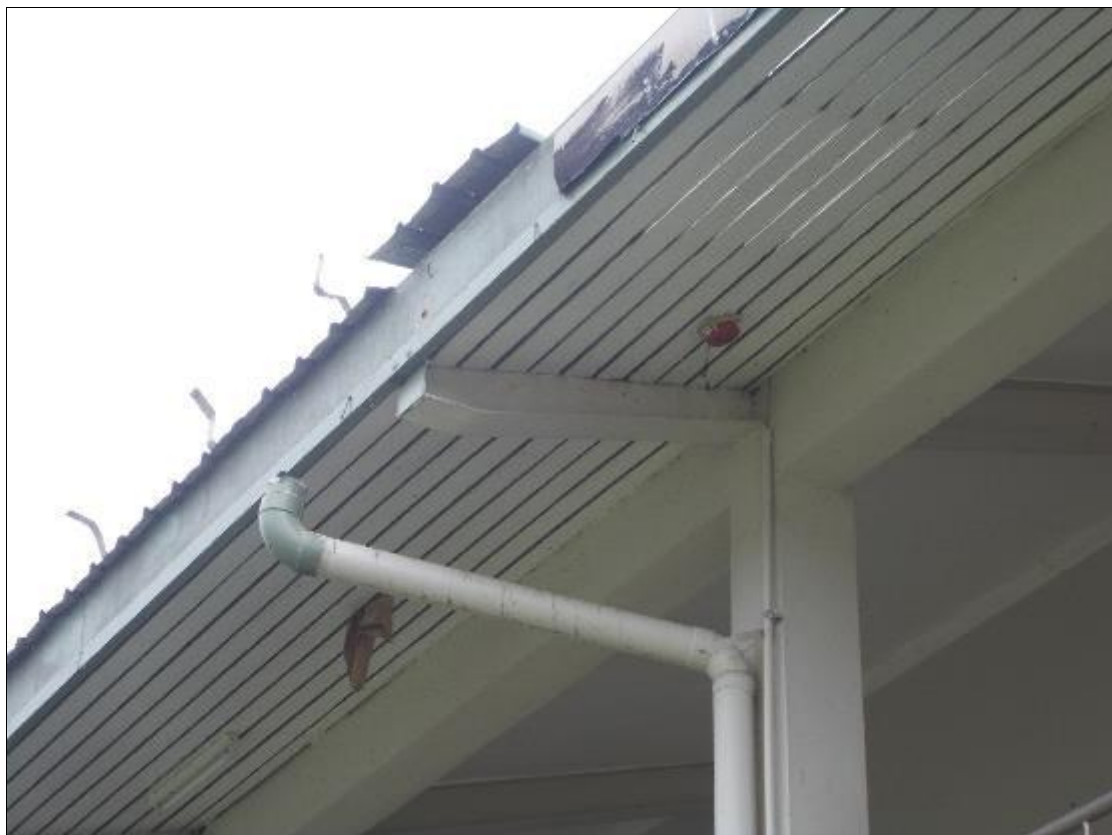
Photo 8: Blown out gutters

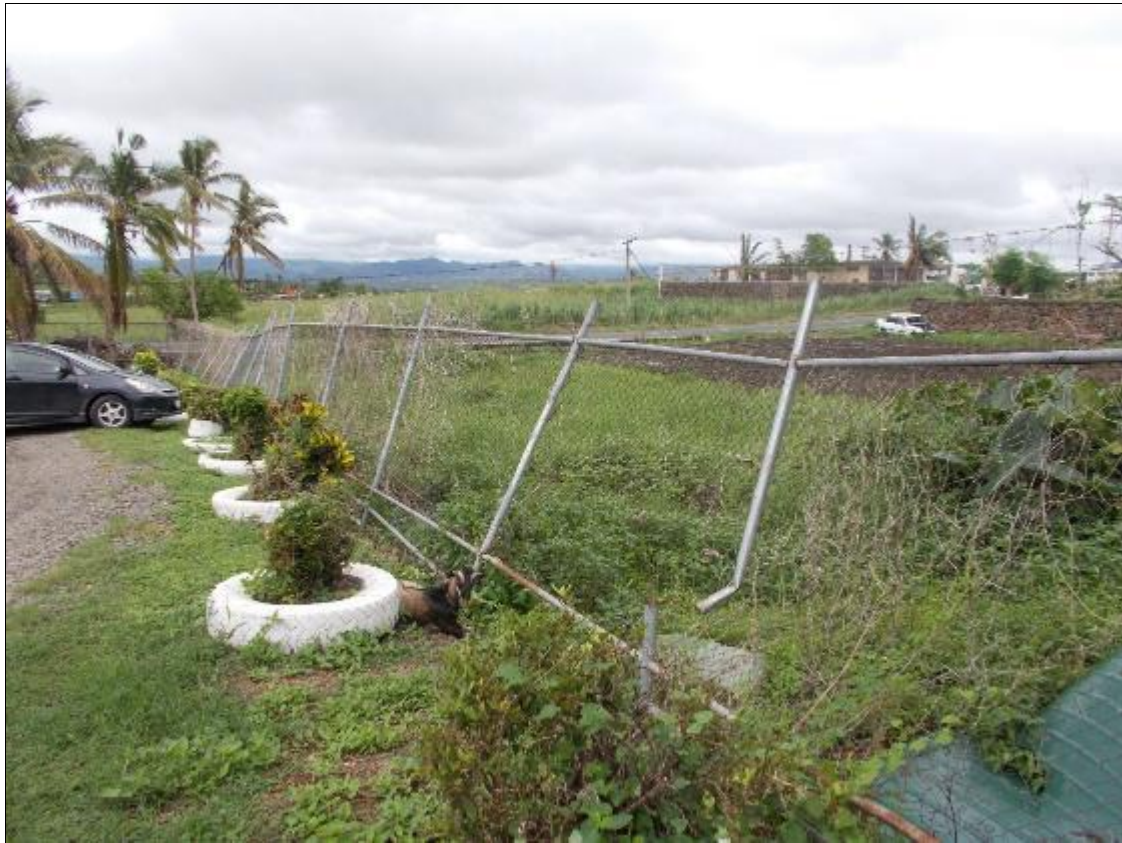
50m chain link fence damaged. Estimate = \$ 5,000 for fence fixing.

Photo 10: Showing Typical Chain-link Fence – Damaged Areas due to Fallen Tress & Debris

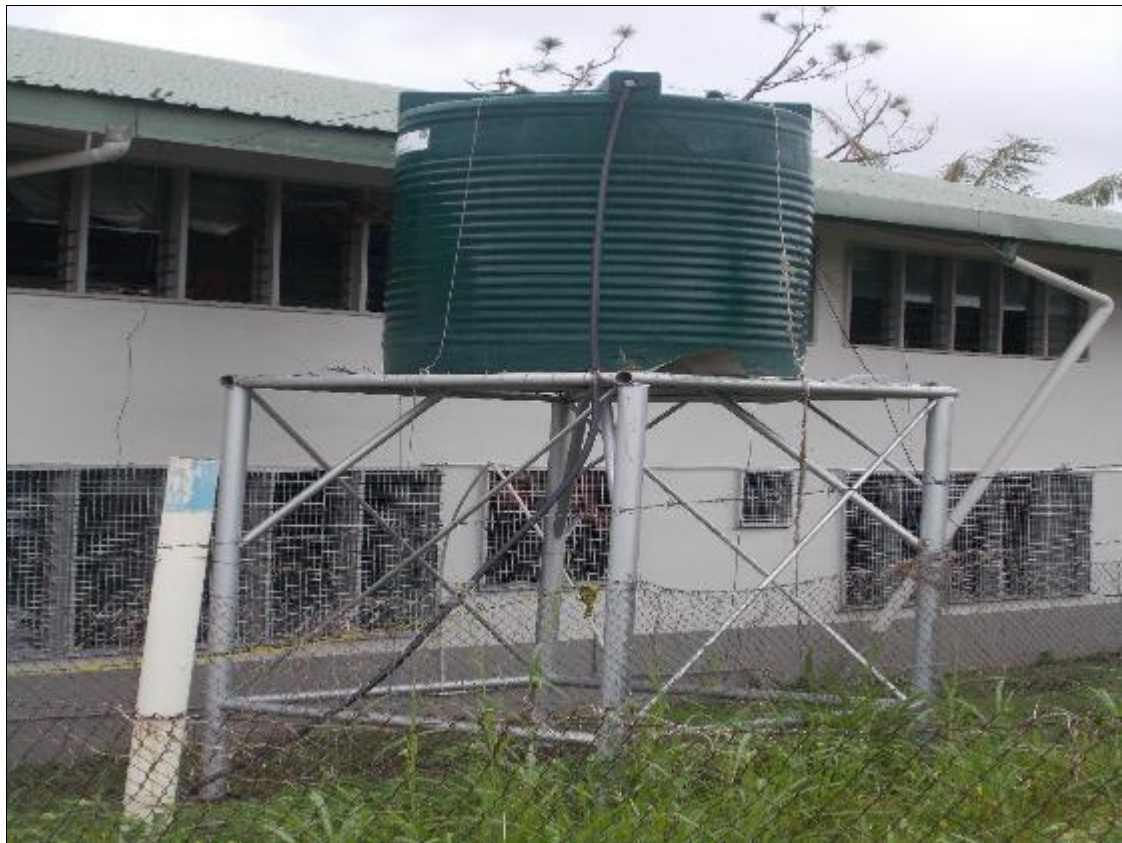
A 5000 L water tank/wash-tub area plumbing was damaged during the cyclone. Exposed plumbing had also been damaged. Estimated damages of approx. \$2,000.00.

Photo 11: Rotomold Tank on Platform – Damage to plumbing
