**CYCLONE WINSTON PRELIMINARY ASSESSMENT
SCHOOLS, HEALTH FACILITIES AND PUBLIC BUILDINGS
FOR
FIJI INSTITUTION OF ENGINEERS &
DEPARTMENT OF NATIONAL PLANNING
(MINISTRY OF FINANCE)**

NAME OF FACILITY: Ra High School
TYPE: College
LOCATION: Rakiraki
DATE OF ASSESSMENT: 22 March 2016

JOB NO: 16-117
GOVERNMENT FACILITY NUMBER: GFN-019

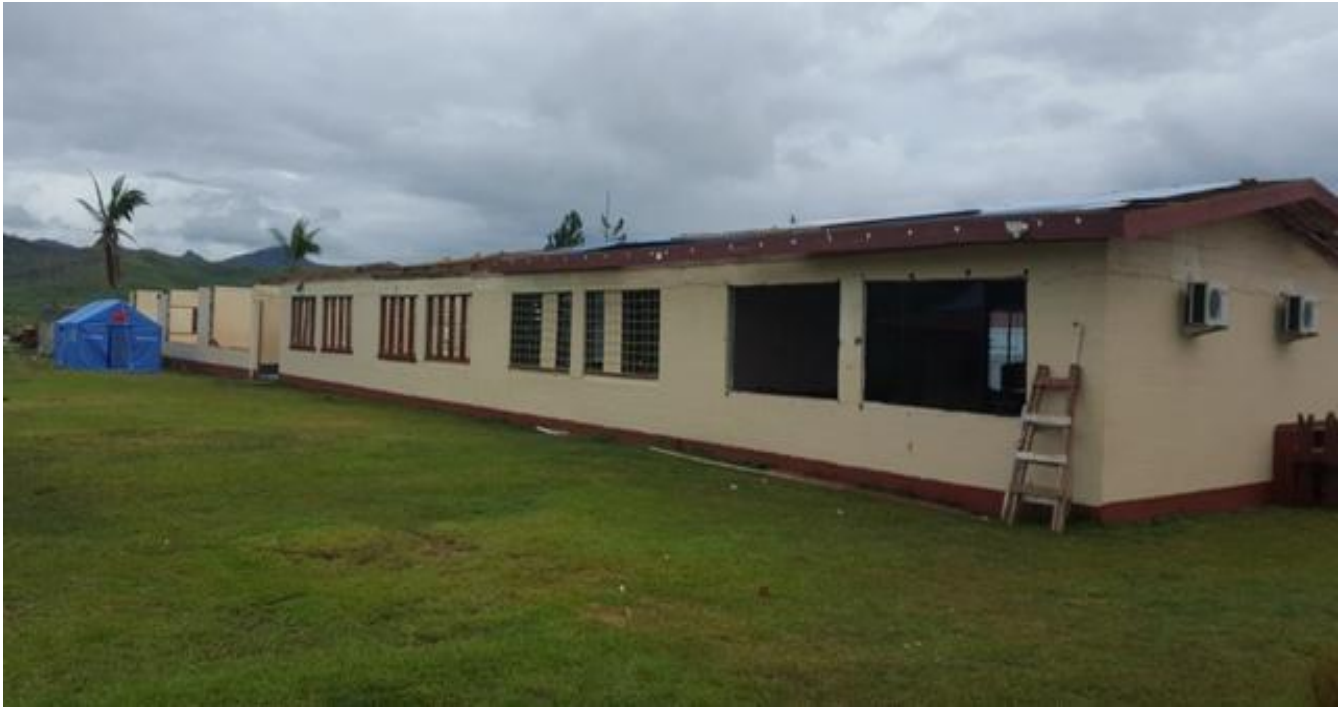
Hydraulics	None	1 Good	2 Average	3 Poor	N/A	N/A	N/A
Windows/Doors	louver windows on standard carriers typically for all windows and timber doors.	1 Good	2 Average	3 Poor	3 buildings are 100% damaged	4	1,4
Shutters	50 x 50mm mesh observed for a few windows - no shutters also observed to a few windows	1 Good	2 Average	3 Poor	windows with shutters has no damage	0	3
Ceilings	Ply board ceiling typically throughout-50% is blown out of main classroom and the rest of the ceiling is water damaged.	1 Good	2 Average	3 Poor	4 buildings are 100% damaged other buildings have water damage	4	N/A
Terraces/Verandah	concrete floor with 50mm diameter steel post.	1 Good	2 Average	3 Poor	3 buildings with 100% verandah damage. Others have roof blown out.	3	2
Tiles/Floor Covering	Concrete plaster and with ceramic tiles	1 Good	2 Average	3 Poor	Cracks observed	2	N/A
Gutters	Standard PVC gutters with proprietary PVC straps fixed to the outside of the gutter with 90% blown out	1 Good	2 Average	3 Poor	100% damage	4	1,4,5

Downpipes	100mm PVC downpipes with PVC straps fixed to the wall with 90% blown out.	1 Good	2 Average	3 Poor	100% damage	4	1,4,5
Fascia Boards	250x30mm timber fascia board.	1 Good	2 Average	3 Poor	70% damage	3	1,4
Furniture/Desks etc.		1 Good	2 Average	3 Poor			
Possible Intermediate Solution	Re-construct the fallen wall and the roof of the school blocks in accordance to the NBCF with new roof trusses, purlins, fascia, gutters, downpipes. Risks involved- potential roof failure to the other sides in future events.						
Possible Long Term Solution	N/A

Photo 1: View of the School

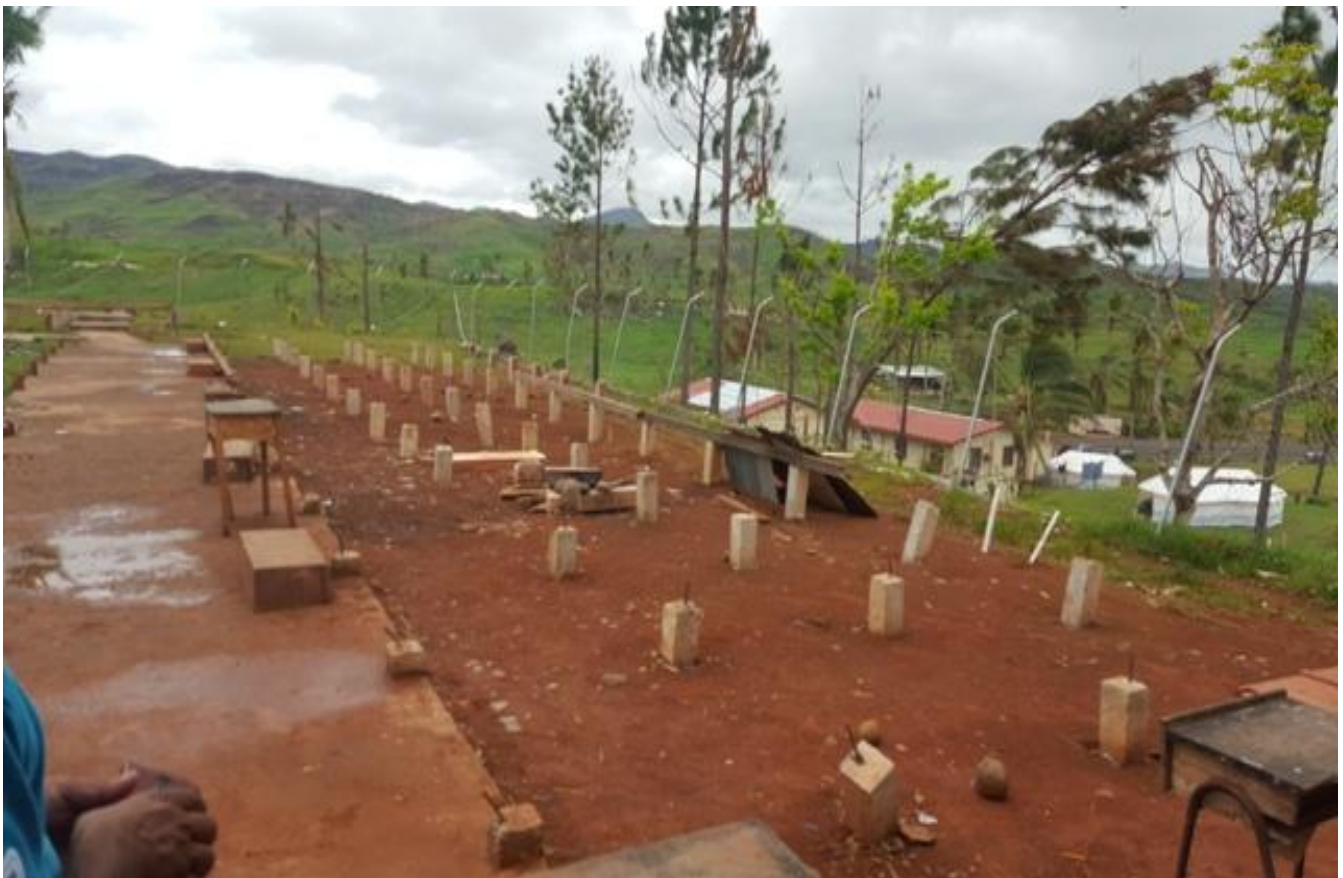
Photo 2: View 100% damaged Building

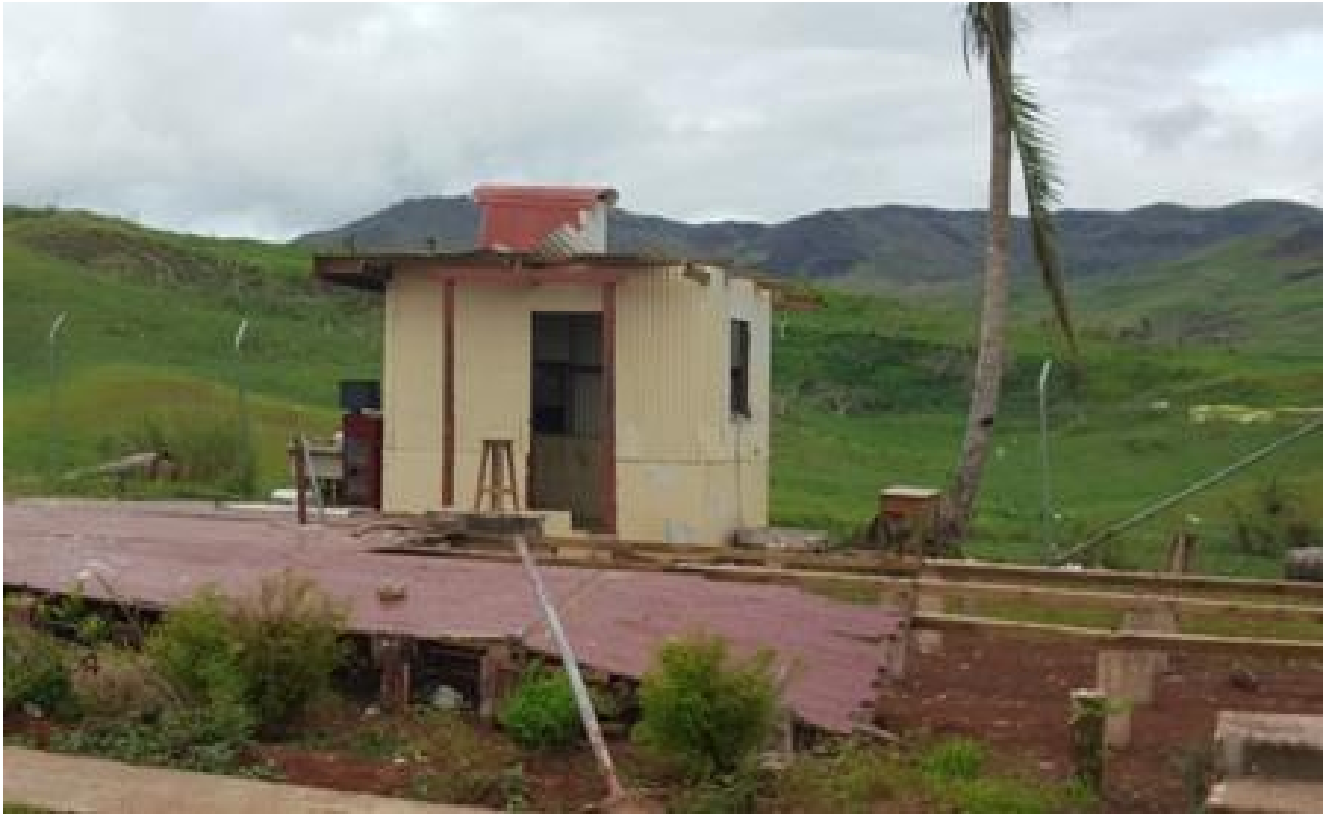
Photo 3: View of 100% Damaged Building

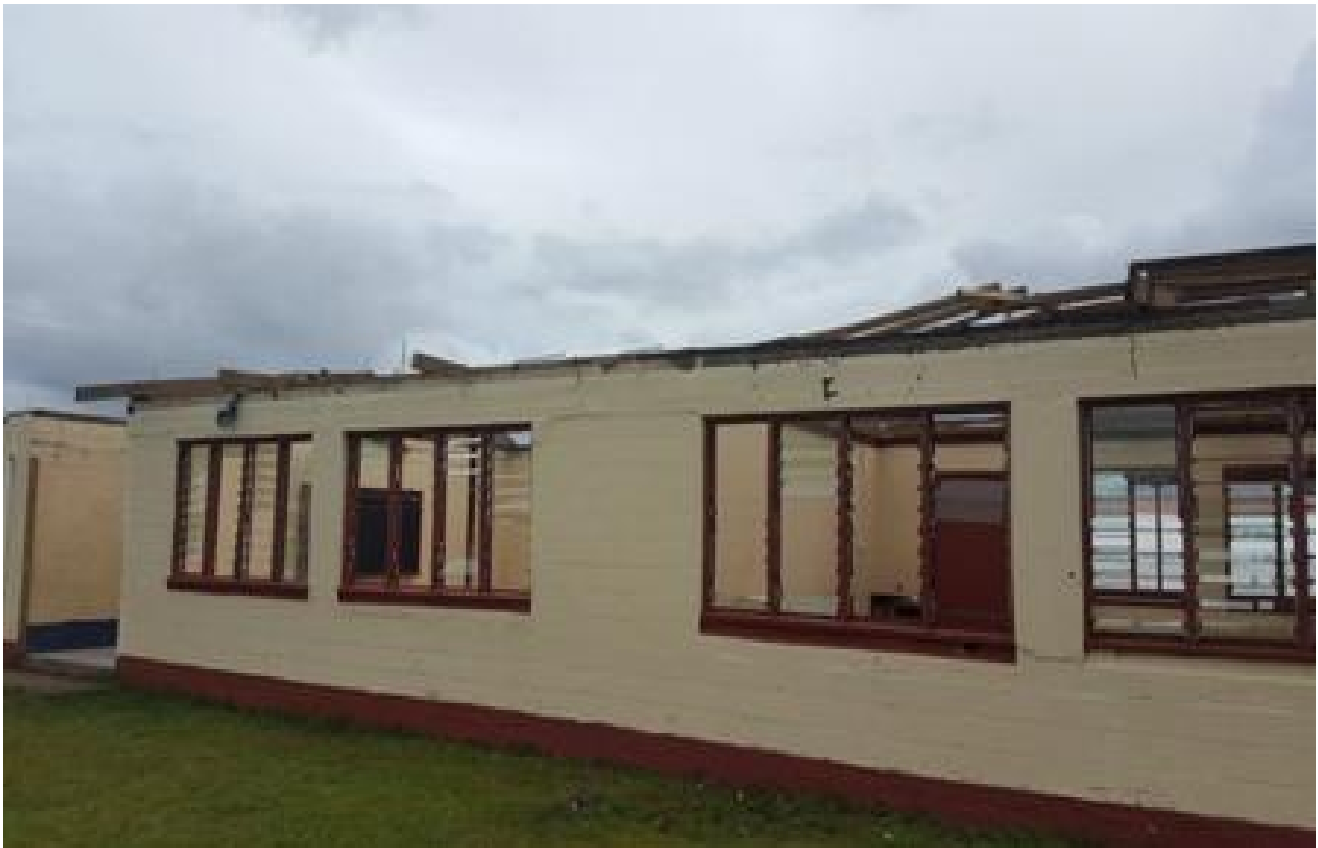
Photo 4:View of the Repairs being done at Block B

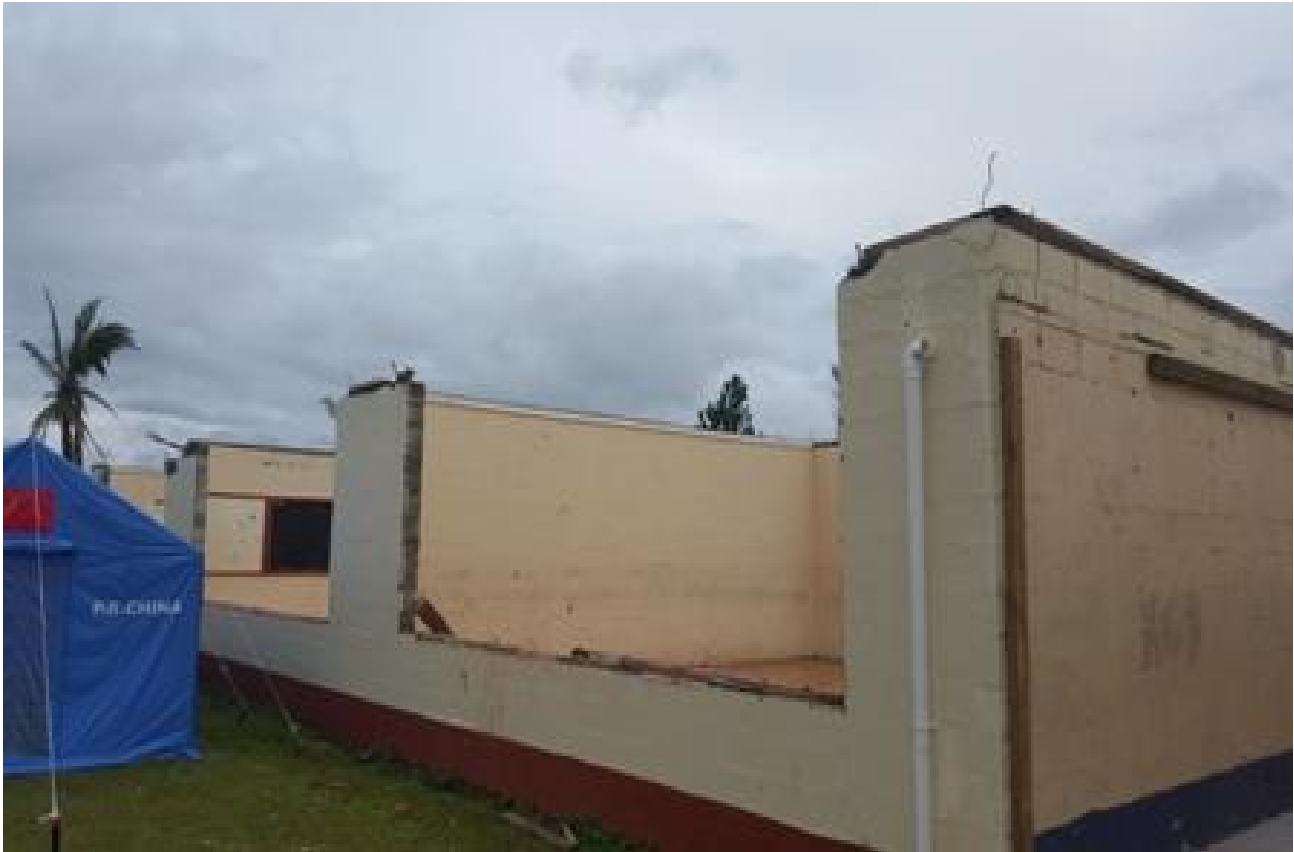
Photo 5: Fallen Wall of the School Block

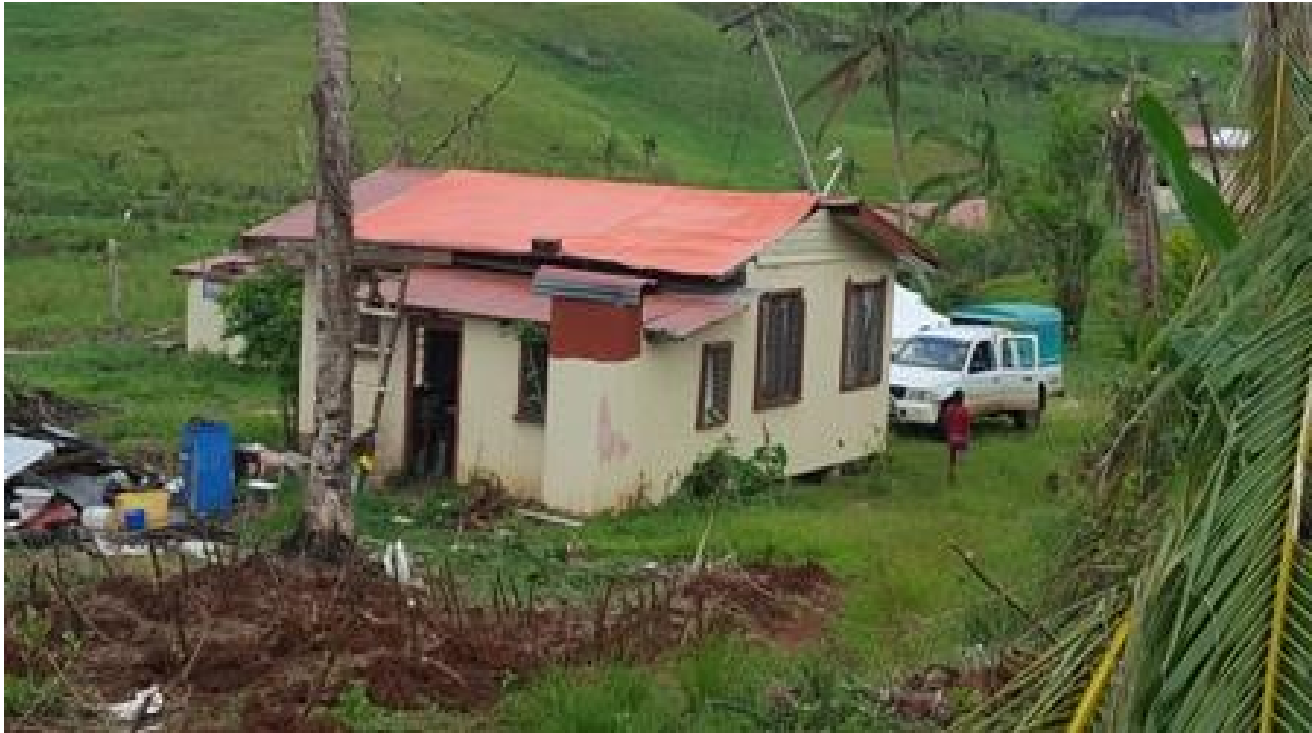
Type of Construction	Description	Build Quality	Damage	Extent of Damage Rating	Photo No.
Floor	combination of timber floor and concrete floor.	1 Good 2 Average 3 Poor	6 quarters 100% damaged and the remaining has temporary covers	4	6
Foundations	Not visible.	1 Good 2 Average 3 Poor	6 quarters 100% damaged and the remaining has temporary covers	4	N/A
Walls	combination of timber cladding, corrugated cladding and 150mm blockwall	1 Good 2 Average 3 Poor	6 quarters 100% damaged and the remaining has temporary covers	4	6
Rafters	100x50 timber rafter	1 Good 2 Average 3 Poor	6 quarters 100% damaged and the remaining has temporary covers	4	N/A
Purlins	75x50 timber purlins	1 Good 2 Average 3 Poor	6 quarters 100% damaged and the remaining has temporary covers	4	N/A
Roof	corrugated roof cladding	1 Good 2 Average 3 Poor	6 quarters 100% damaged and the remaining has temporary covers	4	6
Electrical	typical standard switches, GPO's and fluorescent tubelights and bulbs.	1 Good 2 Average 3 Poor	6 quarters 100% damaged and the remaining has temporary covers	4	N/A

Hydraulics	None	1 Good 2 Average 3 Poor	N/A	N/A	N/A
Windows/Doors	louver windows on standard carriers typically for all windows and timber doors.	1 Good 2 Average 3 Poor	6 quarters 100% damaged and the remaining has temporary covers	4	6
Shutters	50 x 50 mesh observed on windows - no shutters also observed to few windows	1 Good 2 Average 3 Poor	6 quarters 100% damaged and the remaining has temporary covers	4	6
Ceilings	Ply board ceiling typically throughout- 4 quarters is blown out and the remaining of the ceiling is water damaged-painted	1 Good 2 Average 3 Poor	6 quarters 100% damaged and the remaining has temporary covers	4	N/A
Terraces/Verandah	Concrete floor with 50mm steel post	1 Good 2 Average 3 Poor	6 quarters 100% damaged and the remaining has temporary covers	4	N/A
Tiles/Floor Covering	concrete plaster	1 Good 2 Average 3 Poor	6 quarters 100% damaged and the remaining has temporary covers	4	7

Gutters	Standard PVC gutters with proprietary PVC straps fixed to the outside of the gutter.	1 Good 2 Average 3 Poor	6 quarters 100% damaged and the remaining has temporary covers	4	6
Downpipes	Downpipes blown out.	1 Good 2 Average 3 Poor	6 quarters 100% damaged and the remaining has temporary covers	4	6
Fascia Boards	250x30mm timber fascia board.	1 Good 2 Average 3 Poor	6 quarters 100% damaged and the remaining has temporary covers	4	6
Furniture/Desks etc.		1 Good 2 Average 3 Poor			
Possible Intermediate Solution	re-construct the 6 blown out quarters and re-construct the roof of the damaged buildings in accordance to the NBCF with new roof trusses, walls, foundations, purlins, gutters downpipes, fascia. Damaged buildings to have new flashings, fascia, gutterings, downpipes with retrofits.				
Possible Long Term Solution	Detailed investigation for roof framing recommended along with checks on wall capacity for uplift/lateral loads for more tolerance towards Cat.4. Much dependent upon detailed investigation by an Engineer. Considering the building age and with the 6 of the timber structure blown out possibly demolish and re-build all the quarters to comply with NBCF. Estimated cost currently around \$200,000.00 for all new quarters with

Photo 6: View of the Teachers Quarters with Damaged Roof

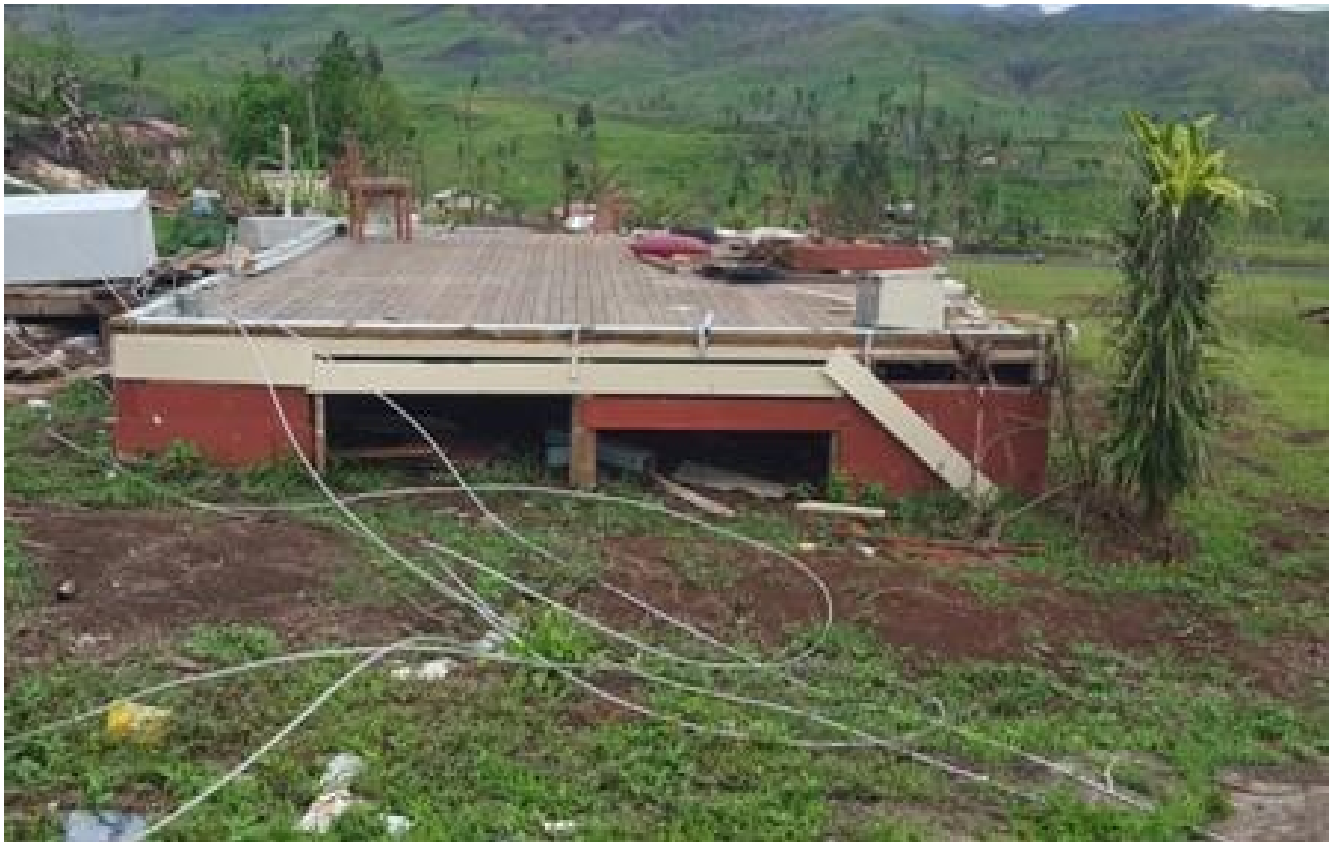
Photo 7: View of the 100% Damaged Teachers Quarters

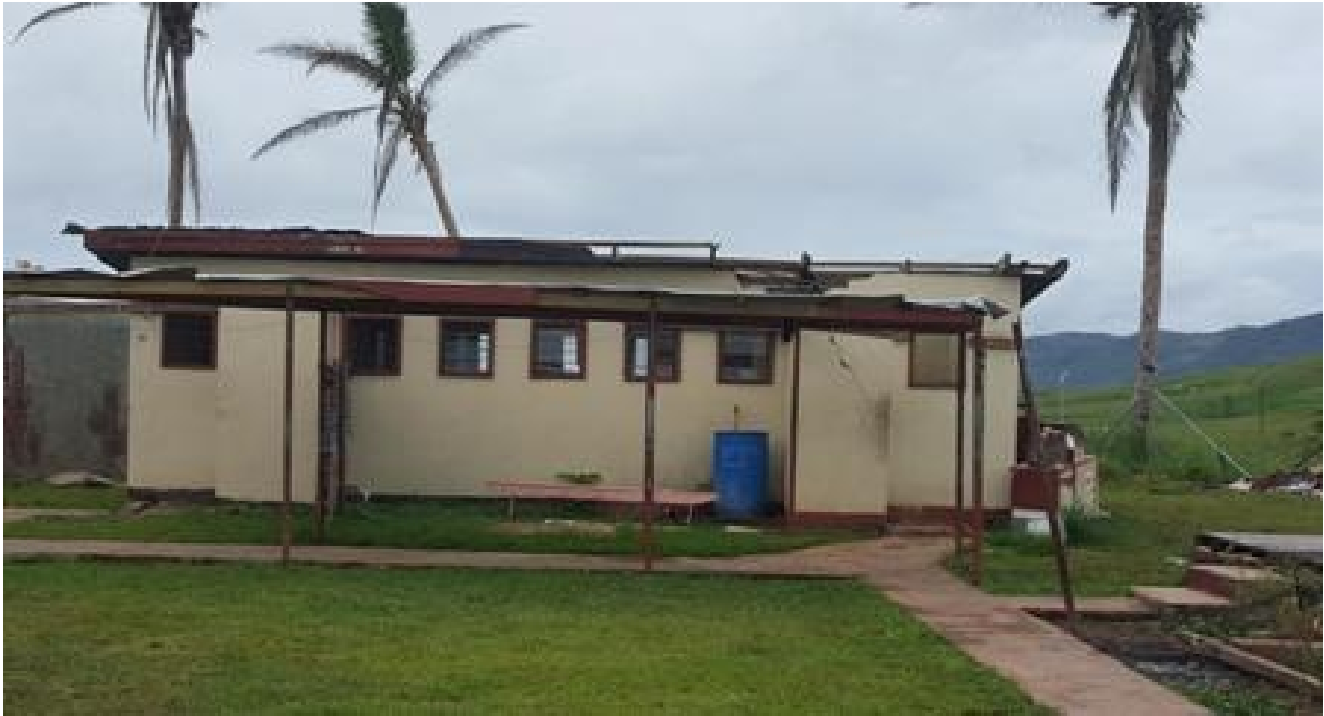
Terraces/Verandah	N/A	1 Good 2 Average 3 Poor	N/A	0	N/A
Tiles/Floor Covering	Ceramic tile and concrete plaster on walkway	1 Good 2 Average 3 Poor	No visible damage	0	N/A
Gutters	Completely blown out	1 Good 2 Average 3 Poor	100% damaged	4	8
Downpipes	Completely blown out	1 Good 2 Average 3 Poor	100% damaged	4	8
Fascia Boards	250 x 30mm timber fascia	1 Good 2 Average 3 Poor	No damage	4	8
Furniture/Desks etc.		1 Good 2 Average 3 Poor			
Possible Intermediate Solution	Re-construct the whole roof of the toilet blocks and plaster the cracks in accordance to the NBCF with new roof trusses, purlins, gutters, downpipes, fascia, flashings and shutters.				
Possible Long Term Solution	N/A

Photo 8: View of the Toilet Blocks

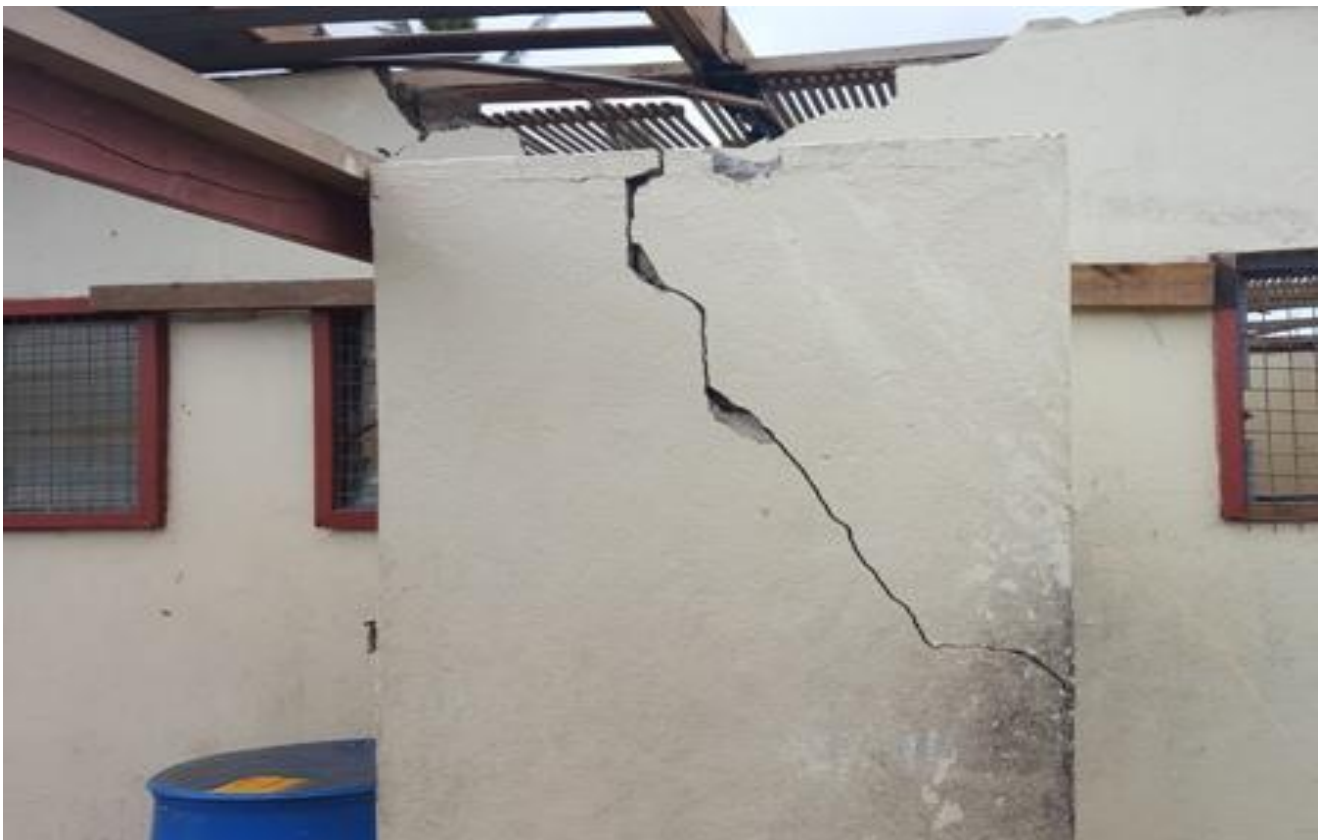
Type of Construction	Description	Build Quality	Damage	Extent of Damage Rating	Photo No.
Floor	reinforced concrete slab on ground.	1 Good 2 Average 3 Poor	No visible damage	0	N/A
Foundations	Not visible	1 Good 2 Average 3 Poor	Not Visible - concealed	0	N/A
Walls	150mm blockwall	1 Good 2 Average 3 Poor	Signs of crack	3	8
Rafters	Not visible	1 Good 2 Average 3 Poor	Not Visible	1	8,9
Purlins	Not visible	1 Good 2 Average 3 Poor	Not Visible	1	8,9
Roof	Corrugated roof cladding	1 Good 2 Average 3 Poor	50% roof blown out	3	8
Electrical	typical standard switches, GPO's and fluorescent tubelights and bulbs.	1 Good 2 Average 3 Poor	N/A	0	N/A
Hydraulics	N/A	1 Good 2 Average 3 Poor	N/A	N/A	
Windows/Doors	louver windows on standard carriers typically for all windows and timber doors.	1 Good 2 Average 3 Poor	Water damaged	1	8,9
Shutters	N/A	1 Good 2 Average 3 Poor	No shutters	0	8,9
Ceilings	Ply board ceiling typically throughout- water damaged and painted	1 Good 2 Average 3 Poor	Water damaged	1	9

Photo 9: View of the Crack in Toilet Block

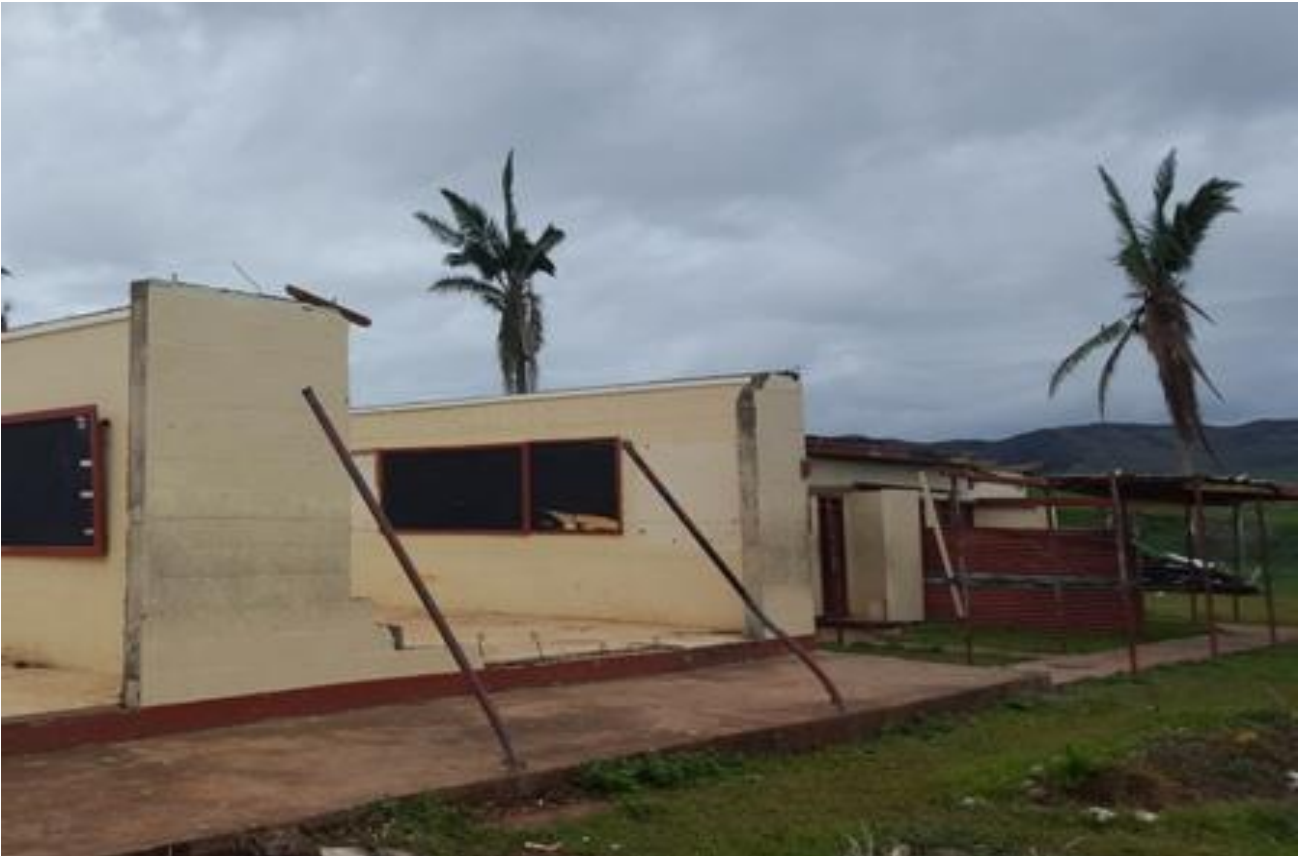
Walkway leading to the toilet block for the classrooms is 100% damaged.
 Walkway leading to the classrooms from the entrance is tilted to 1 side and whole roof is blown out.

Photo 10: View of the Walkway from the Classroom to the Toilet Block

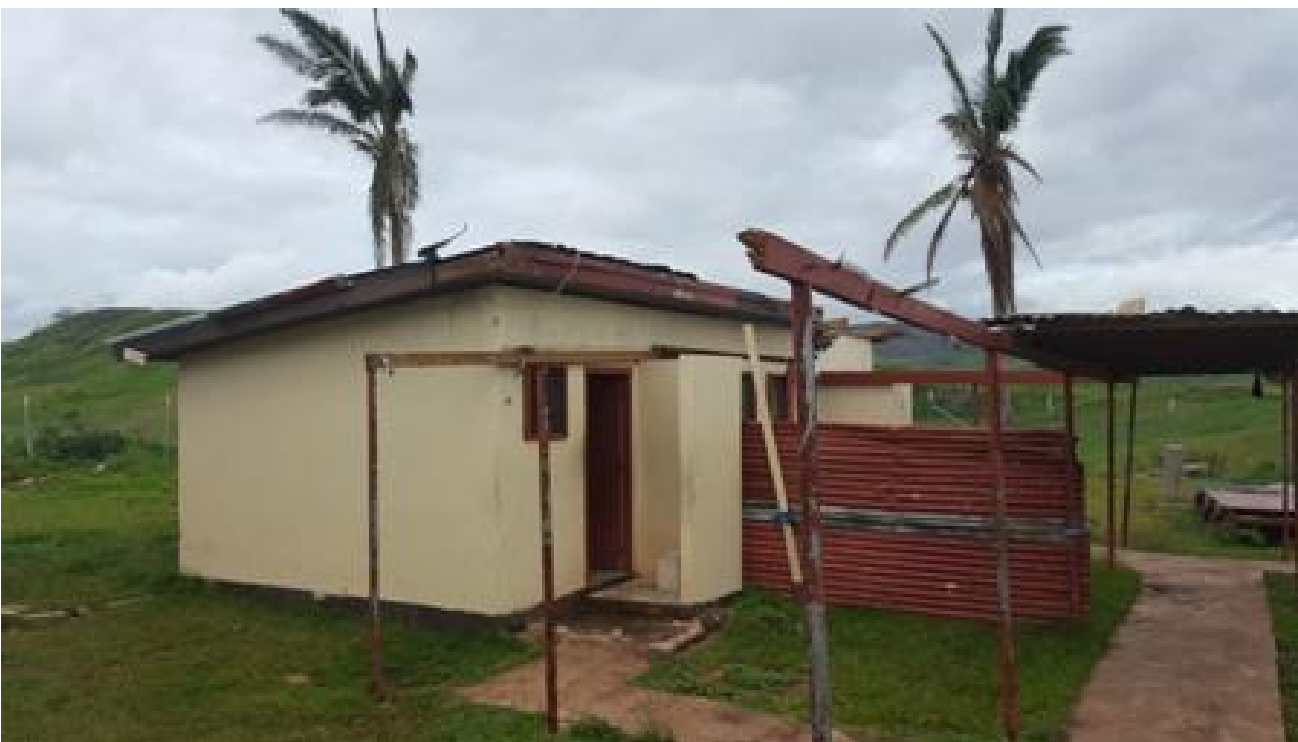
Photo 11: View of the Toilet Block Walkway
