**CYCLONE WINSTON PRELIMINARY ASSESSMENT
SCHOOLS, HEALTH FACILITIES AND PUBLIC BUILDINGS
FOR
FIJI INSTITUTION OF ENGINEERS &
DEPARTMENT OF NATIONAL PLANNING
(MINISTRY OF FINANCE)**

NAME OF FACILITY: Doboilevu Muslim Primary School
TYPE: Primary School
LOCATION: Rakiraki
DATE OF ASSESSMENT: 21 March 2016

JOB NO: 16-108
GOVERNMENT FACILITY NUMBER: GFN-106

**RAPID ASSESSMENT TEMPLATE: CYCLONE WINSTON DAMAGED BUILDINGS
SCHOOLS, PUBLIC BUILDINGS & HEALTH FACILITIES**

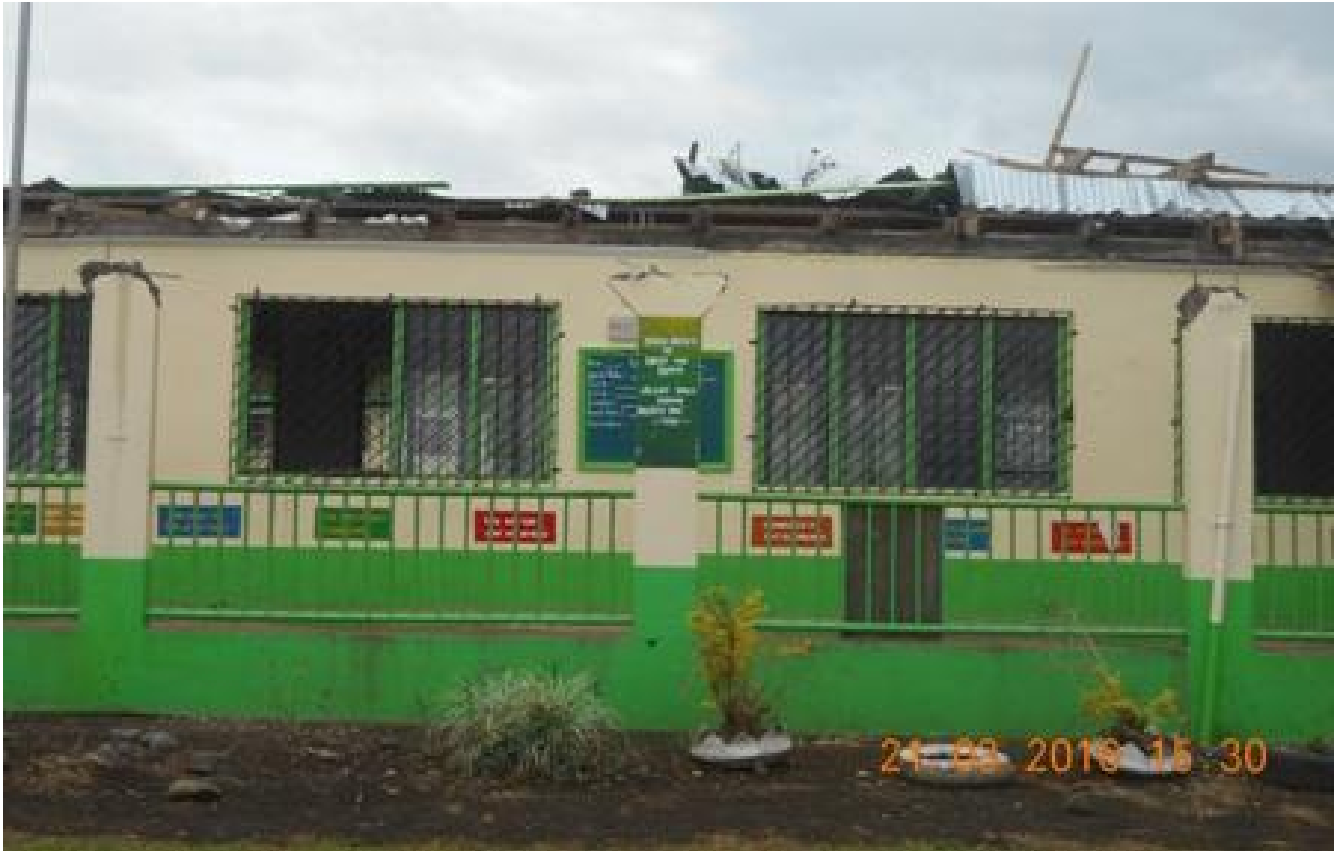
Shutters	steel bars were observed on all glass openings.	1 Good 2 Average 3 Poor	No damage	0	N/A
Ceilings	Ply board ceiling typically throughout-partial collapse of ceiling due to water damage-painted	1 Good 2 Average 3 Poor	Water damage	1	N/A
Terraces/Verandah	typically concrete floor with RC columns and beam.	1 Good 2 Average 3 Poor	80% of the verandah roof beam damaged	4	3, 4, 5
Tiles/Floor Covering	ceramic tiles for the classrooms and concrete plaster for the corridoh	1 Good 2 Average 3 Poor	No damage		N/A
Gutters	Standard PVC gutters with proprietary PVC straps fixed to the outside of the gutter.	1 Good 2 Average 3 Poor	At least 50% guttering and down-pipes damaged	2	1,2
Downpipes	100mm PVC downpipes with PVC straps fixed to the columns at 3m crs.	1 Good 2 Average 3 Poor	At least 50% guttering and down-pipes damaged		1,2
Fascia Boards	250x30mm timber fascia board.	1 Good 2 Average 3 Poor	50% damage- verandah area of the roof blown out.		N/A

Photo 3: Verendah Beam View

Furniture/Desks etc.		1 Good 2 Average 3 Poor			
Possible Intermediate Solution	Re-construct the verandah roof beam and totally new verandah roof in compliant to the NBCF with new roof trusses, purlins and new ceiling. Replace all broken glass panes and louver blades and repair with grout crack in wall. New guttering, downpipes, flashings, fascia boards.				
Possible Long Term Solution	N/A

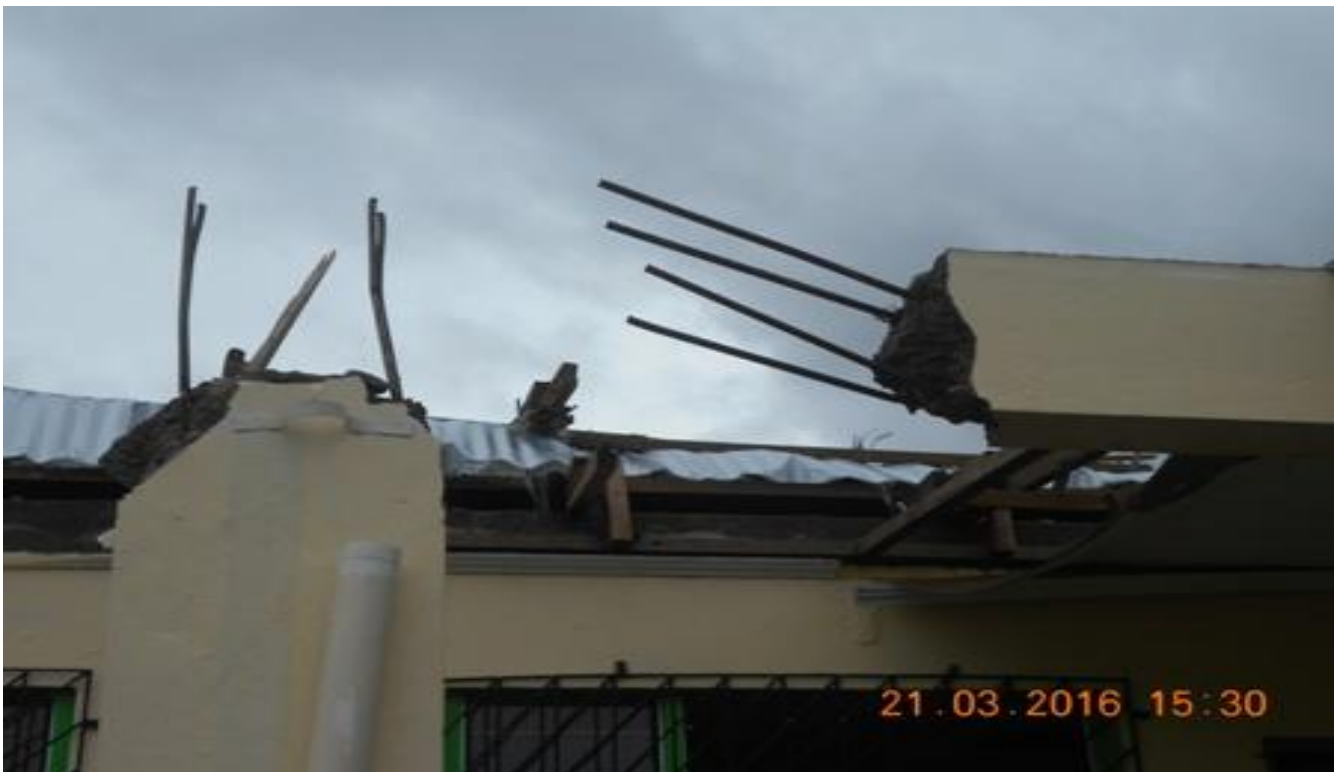
Photo 4: Beam and Column View

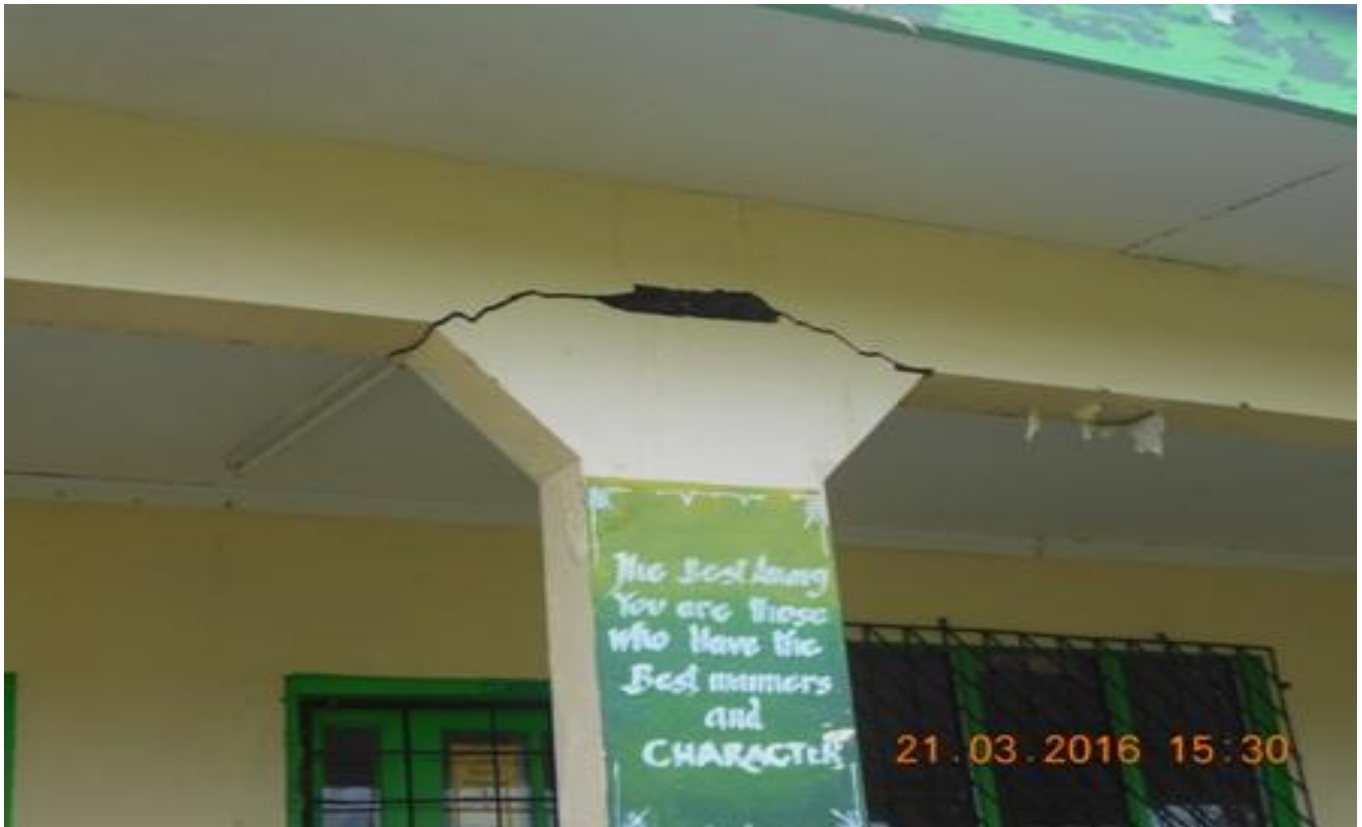
Photo 5: Column Crack View
