**CYCLONE WINSTON PRELIMINARY ASSESSMENT  
SCHOOLS, HEALTH FACILITIES AND PUBLIC BUILDINGS  
FOR  
FIJI INSTITUTION OF ENGINEERS &  
DEPARTMENT OF NATIONAL PLANNING  
(MINISTRY OF FINANCE)**

NAME OF FACILITY: Saivou District School  
TYPE: Primary School  
LOCATION: Rakiraki  
DATE OF ASSESSMENT: 22 March 2016

JOB NO: 16-116  
GOVERNMENT FACILITY NUMBER: GFN-111

**RAPID ASSESSMENT TEMPLATE: CYCLONE WINSTON DAMAGED BUILDINGS  
SCHOOLS, PUBLIC BUILDINGS & HEALTH FACILITIES**

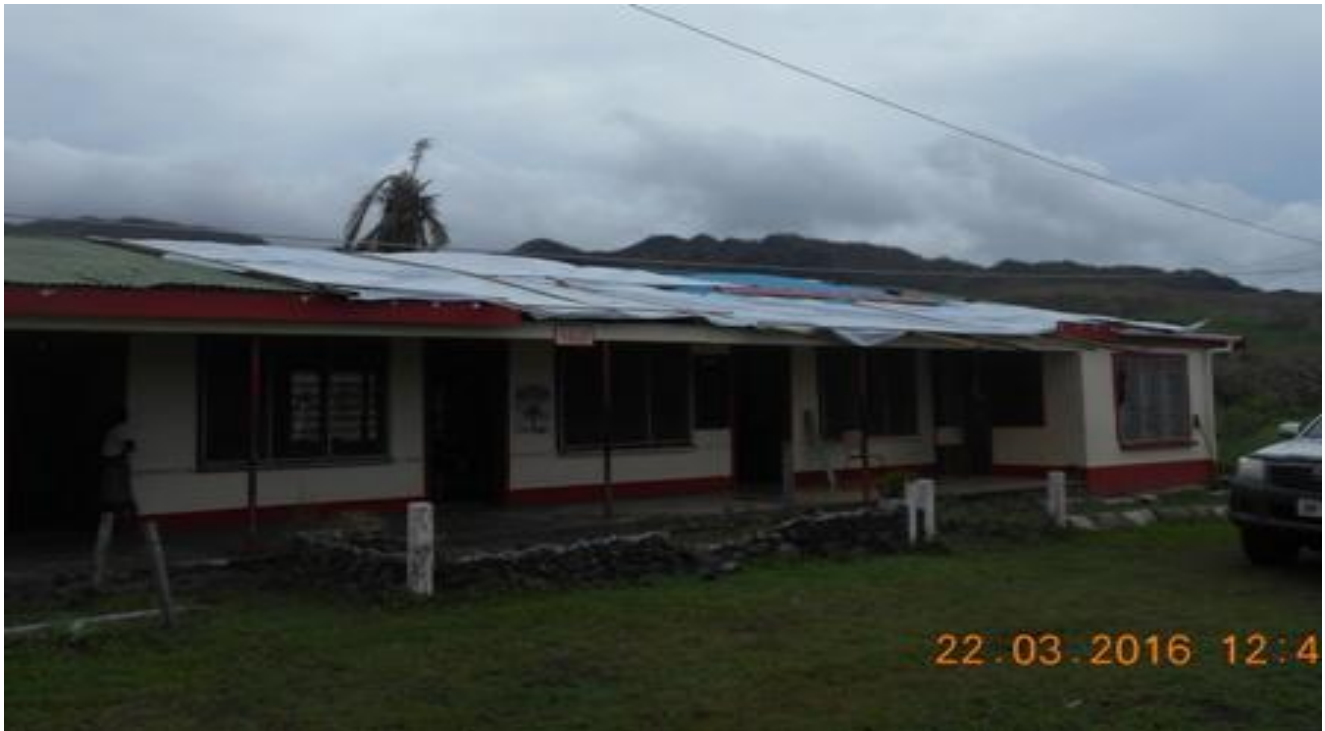
**Photo 1: View of the School Building with Damaged Roof**

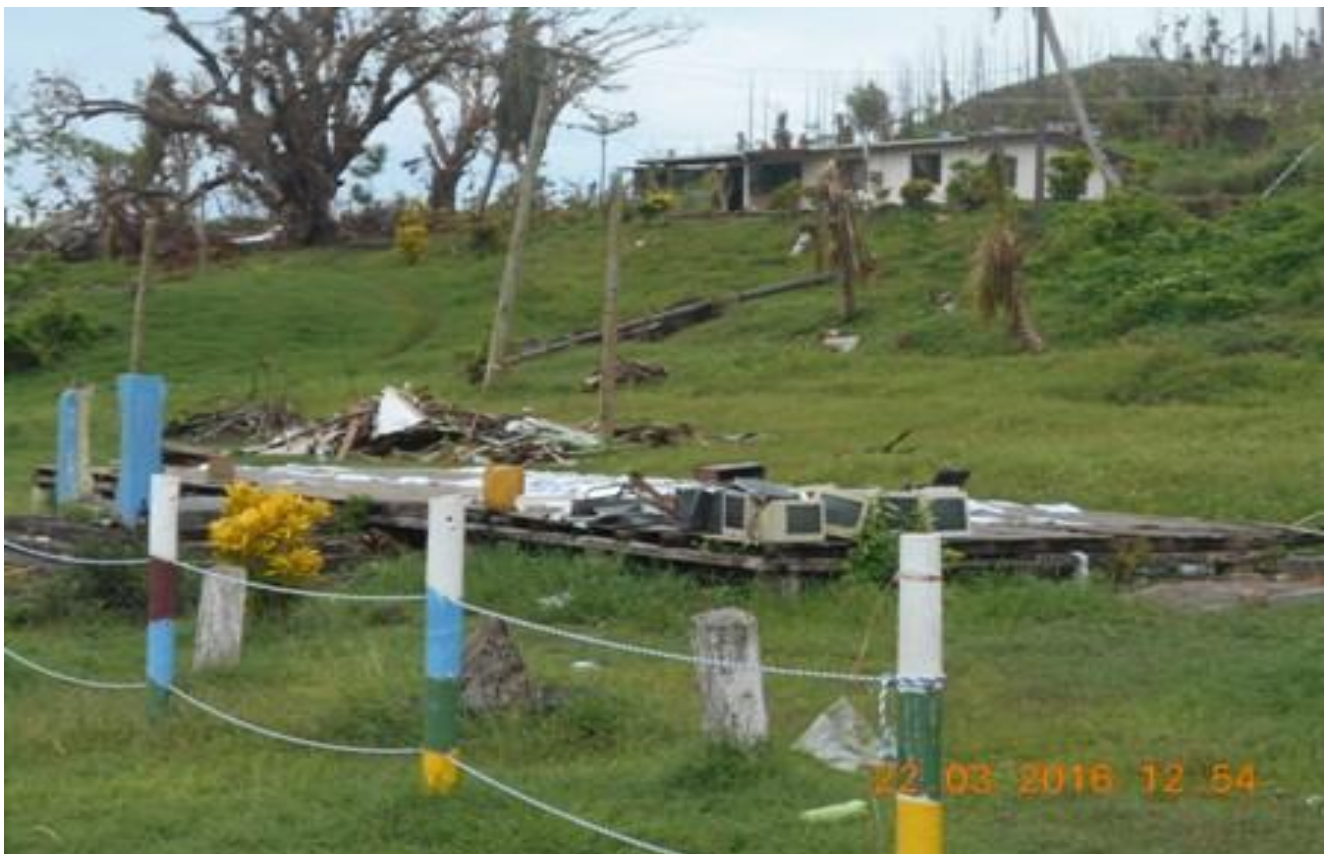
**Photo 2: View of the 100% Damaged Classroom**

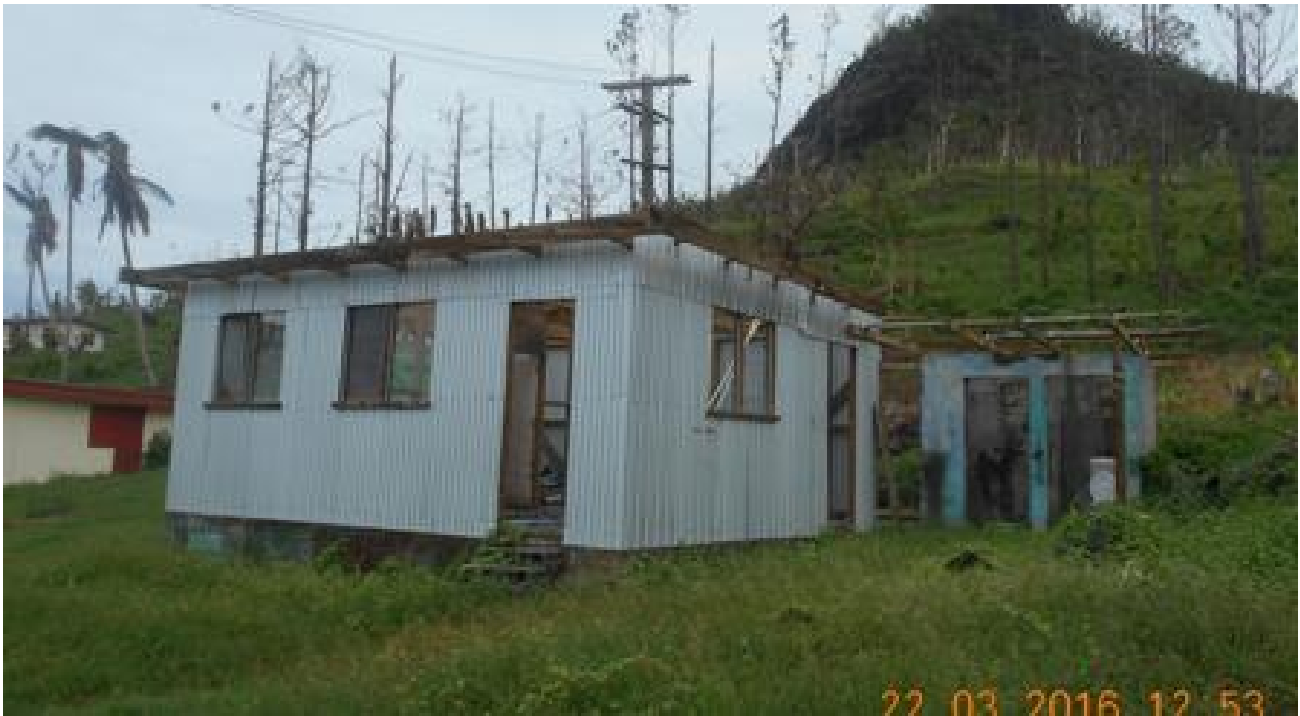
**Photo 3: View of the Damaged Teachers Quarters**

<b>Possible Long Term Solution</b>	Detailed investigation for roof framing recommended along with checks on wall capacity for uplift/lateral loads for more tolerance towards Cat.4. Much dependent upon detailed investigation by an Engineer. Considering the building age and with 100% of roof blown out, demolish and re-construct the whole quarters to comply with NBCF. Estimated cost currently around \$30,000.00 for all new quarters with retrofit.

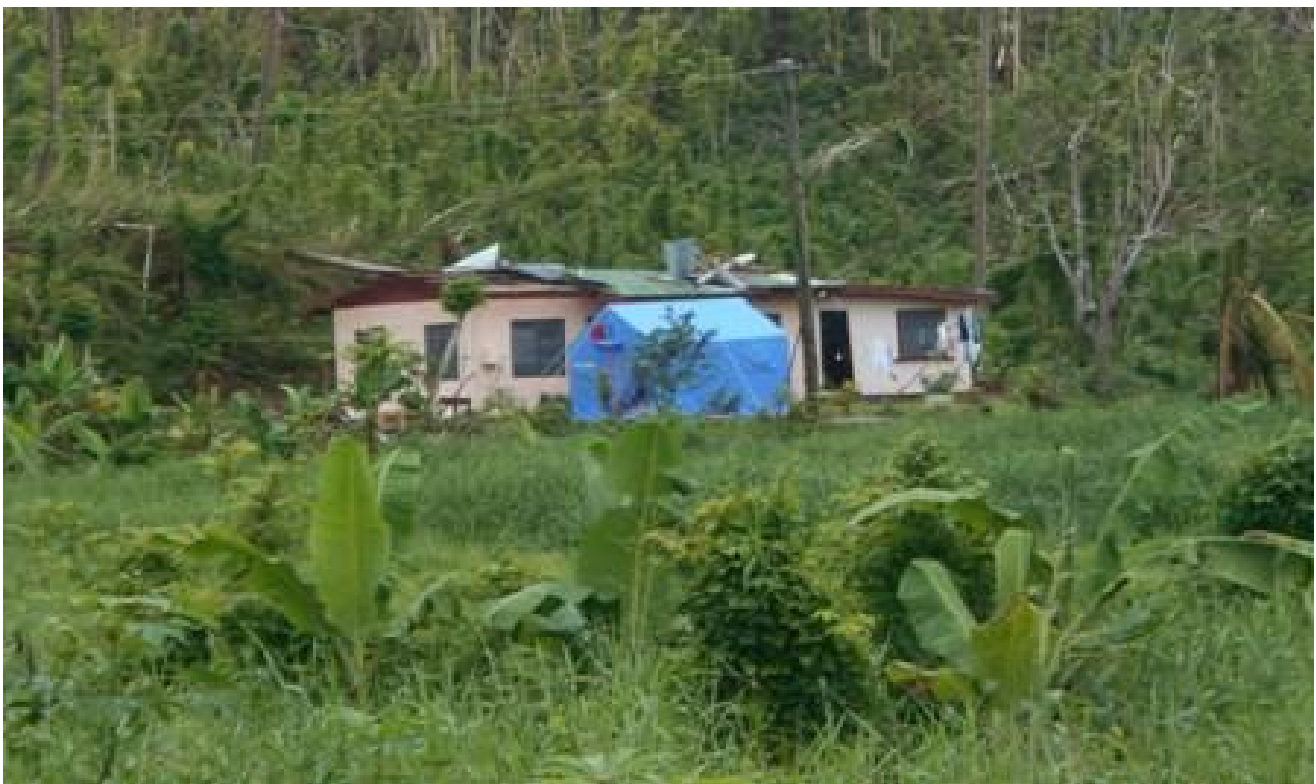
**Photo 4: View of the Damaged Teacher Quarters.**
