**CYCLONE WINSTON PRELIMINARY ASSESSMENT  
SCHOOLS, HEALTH FACILITIES AND PUBLIC BUILDINGS  
FOR  
FIJI INSTITUTION OF ENGINEERS &  
DEPARTMENT OF NATIONAL PLANNING  
(MINISTRY OF FINANCE)**

NAME OF FACILITY: Nabau District School  
TYPE: Primary School  
LOCATION: Rakiraki  
DATE OF ASSESSMENT: 21 March 2016

JOB NO: 16-109  
GOVERNMENT FACILITY NUMBER: GFN-118

# RAPID ASSESSMENT TEMPLATE: CYCLONE WINSTON DAMAGED BUILDINGS SCHOOLS, PUBLIC BUILDINGS & HEALTH FACILITIES

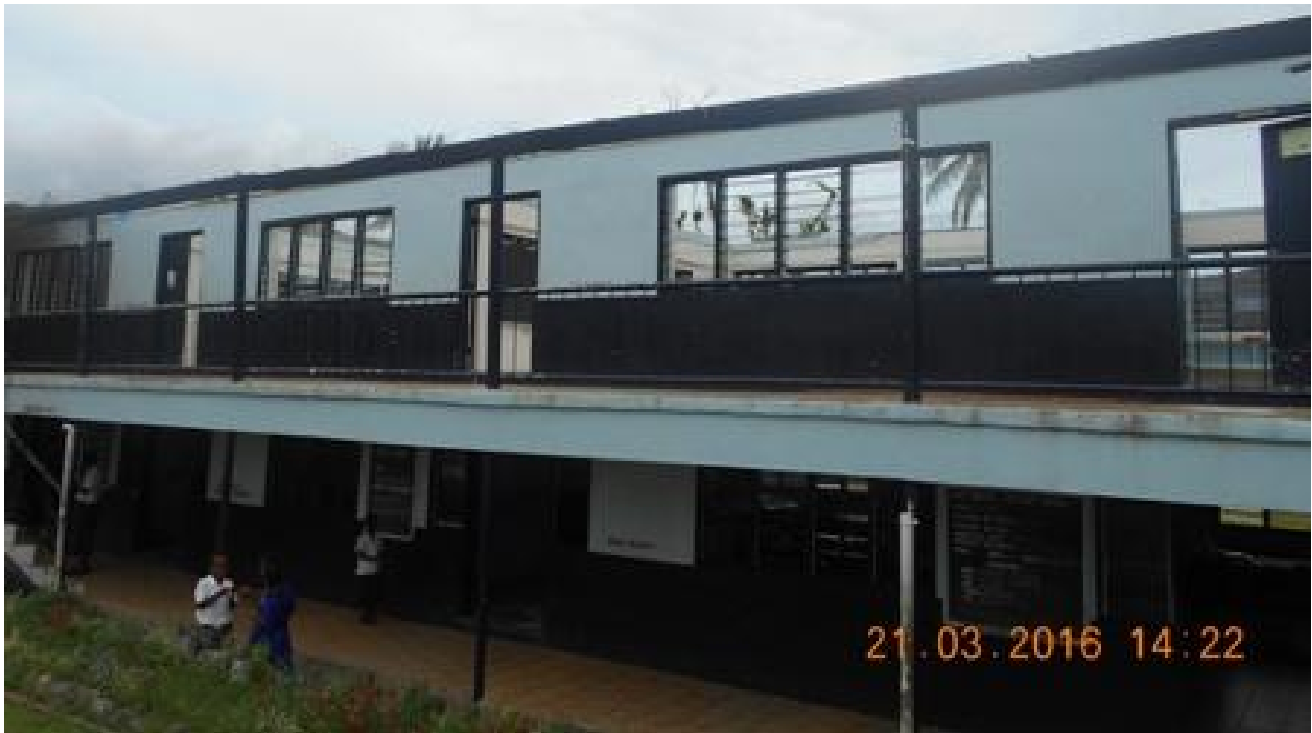
**Photo 1:View of Building Frontage**

3	Poor			
Hydraulics	None	1	Good	N/A	N/A	N/A
		2	Average			
		3	Poor			
Windows/Doors	louver windows on standard carriers typically for all windows and timber doors.	1	Good	Doors have water damage	2	1,2,3
		2	Average	Louvers shattered		
		3	Poor			
Shutters	none	1	Good	No damage	0	1,2,3
		2	Average			
		3	Poor			
Ceilings	Ply board ceiling typically throughout- 80% of the ceiling blown out and the remainin of the ceiling is water damaged-painted	1	Good	Damaged	4	3
		2	Average			
		3	Poor			
Terraces/Verandah	typically concrete floor with 50mm steel post and 200mm x 50mm timber beam on the terraces with 50mm steel post and RC beam on the verandah.	1	Good	80% of the terrace roof beam	4	4
		2	Average	damaged		
		3	Poor			
Tiles/Floor Covering	Ceramic tiles	1	Good	water damage	2	N/A
		2	Average			
		3	Poor			
Gutters	Standard PVC gutters with proprietary PVC straps fixed to the outside of the gutter.	1	Good	At least 90% guttering and down-	3	1,2

2	Average	pipes damaged		
		3	Poor			
Downpipes	100mm PVC downpipes with PVC straps fixed to the columns at 9m crs.	1	Good	At least 90% guttering and down-	3	1,2
		2	Average	pipes damaged		
		3	Poor			
Fascia Boards	250x30mm timber fascia board.	1	Good	90% damage	4	N/A
		2	Average			
		3	Poor			
Furniture/Desks etc.		1	Good			
		2	Average			
		3	Poor			
<b>Possible Intermediate Solution</b>	Remove the existing timber beam and replace it. Totally new roof construction in accordance with NBCF with new roof trusses, purlins, new guttering, downpipes, flashings, fascia boards. Replace all broken glass panes and louver blades and repair with grout crack in walls.					
<b>Possible Long Term Solution</b>	Detailed investigation for roof framing recommended along with checks on wall capacity for uplift/lateral loads for more tolerance towards Cat.4. Much dependent upon detailed investigation by an Engineer. Considering the building age and with the most roof blown out, possibly re-build the whole roof to comply with NBCF. Option also exist to retrofit cost permitting, existing wall structure by possibly introducing new columns and footings for a higher level of uplift capacity. Estimated cost currently around \$180,000.00 (new roof with retrofit) to \$300,000.00 (new construction) for long term solution.

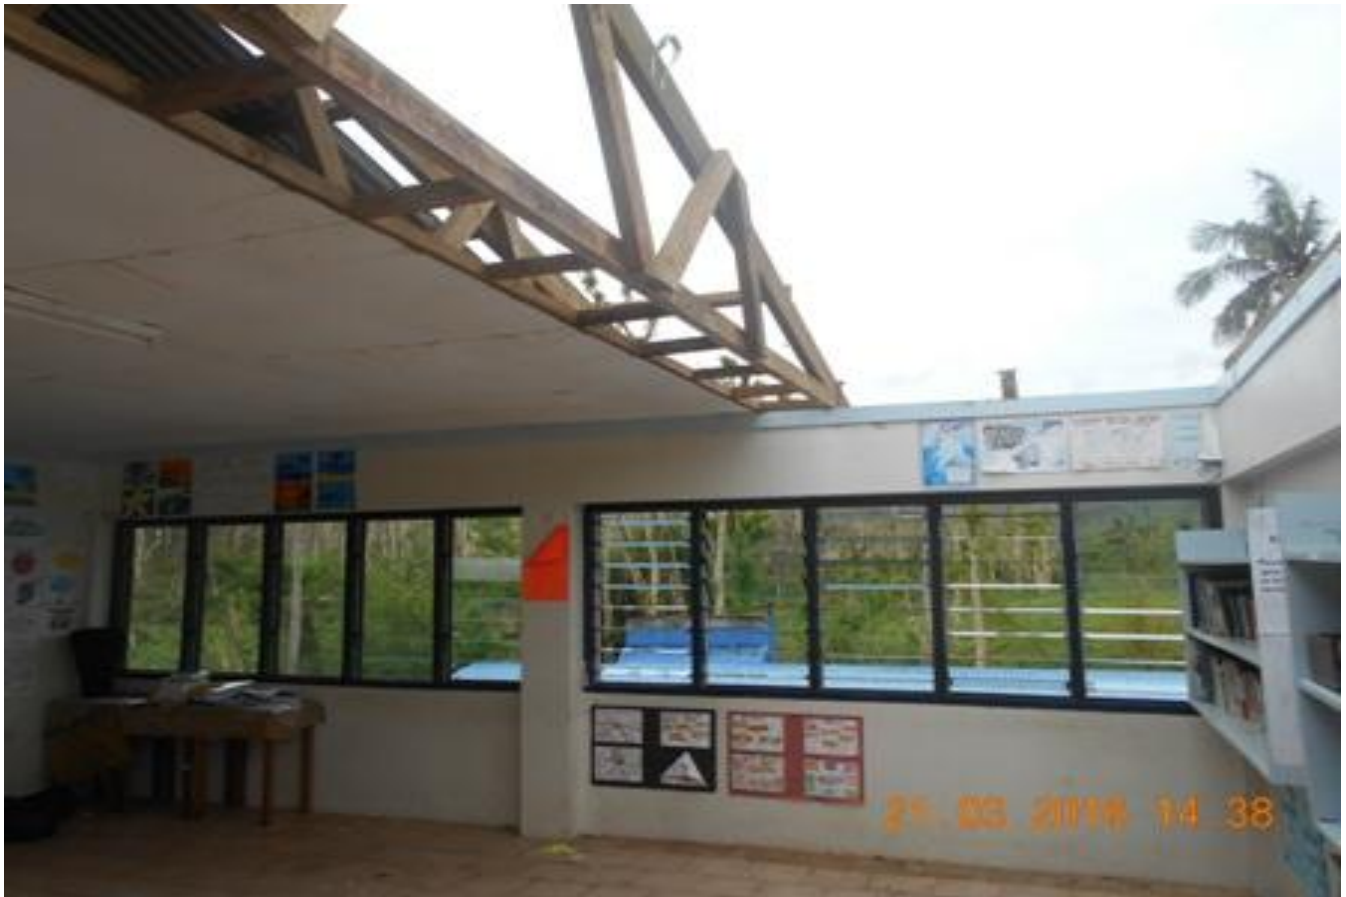
**Photo 3: Truss, “U” Bolt and Louvers View**

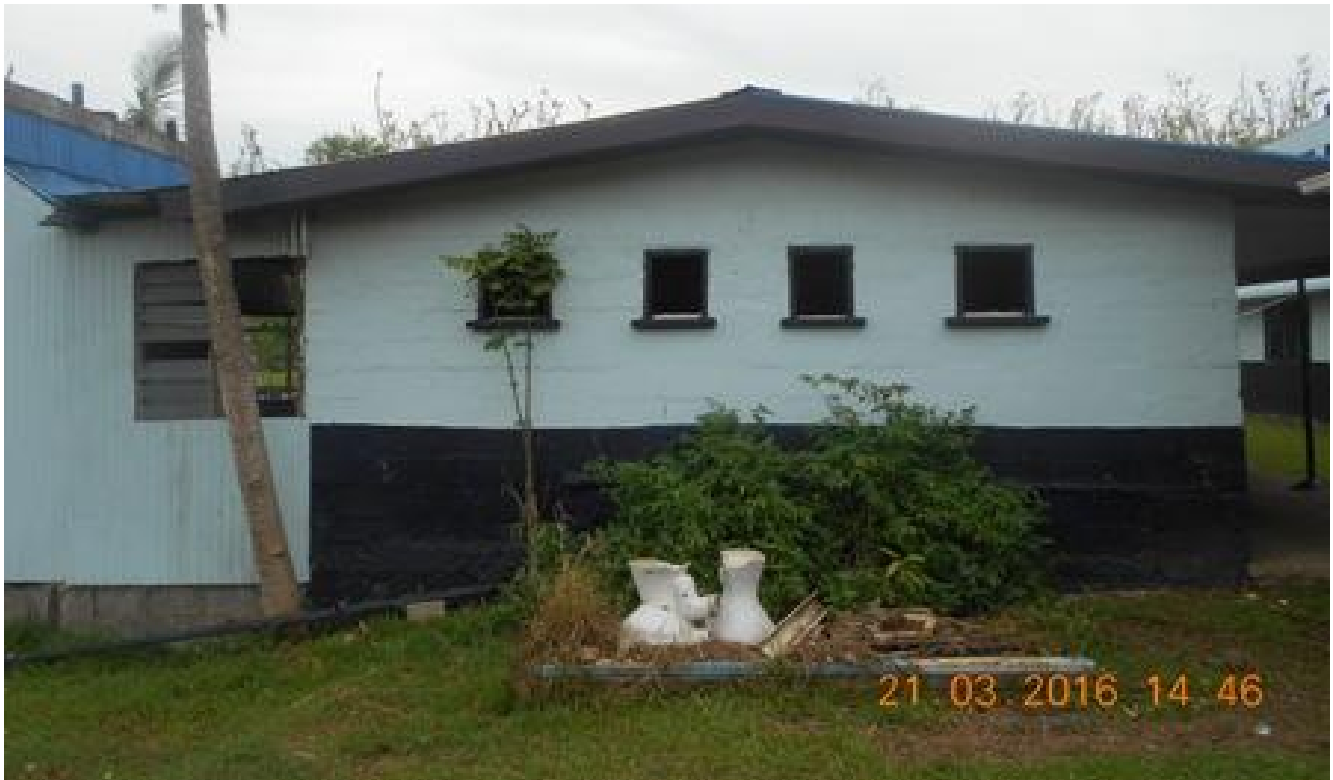
**Photo 5: Overall Dining View**

3	Poor			
Windows/Doors	louver windows on standard carriers typically for all windows and timber doors.	1 2 3	Good Average Poor	Doors have water damage Lourves shattered	3	5,6
Shutters	none	1 2 3	Good Average Poor	No damage	0	5,6
Ceilings	corrugated roof	1 2 3	Good Average Poor	No damage	0	N/A
Terraces/Verandah	50mm steel post and the entire verandah roof has blown out.	1 2 3	Good Average Poor	100% of the terrace roof blown out.	4	6
Tiles/Floor Covering	Ceramic tiles	1 2 3	Good Average Poor	water damage	2	6
Gutters	Standard PVC gutters with proprietary PVC straps fixed to the outside of the gutter.	1 2 3	Good Average Poor	At least 90% guttering and down-pipes damaged	3	6
Downpipes	100mm PVC downpipes with PVC straps fixed to the columns at 9m crs.	1 2 3	Good Average Poor	At least 90% guttering and down-pipes damaged	3	6
Fascia Boards	250x30mm timber fascia board.	1 2 3	Good Average Poor	90% damage	4	5,6

Furniture/Desks etc.		1 2 3	Good Average Poor			N/A
<b>Possible Intermediate Solution</b>	Re-construct the entire kitchen roof in accordance with NBCF with new roof trusses, purlins, new guttering, downpipes, flashings, fascia boards. Demolish the kitchen and re-construct using concrete blockwall in accordance with the NBCF.					
<b>Possible Long Term Solution</b>	Detailed investigation for roof framing recommended along with checks on wall capacity for uplift/lateral loads for more tolerance towards Cat.4. Much dependent upon detailed investigation by an Engineer. Considering the building age and with the washing area roof blown out possibly re-build the whole roof to comply with NBCF. Option also exist to retrofit cost permitting, existing wall structure for a higher level of uplift Estimated cost currently around \$80,000.00 (new roof with retrofit) to \$150,000.00 ( new construction) for long term solution

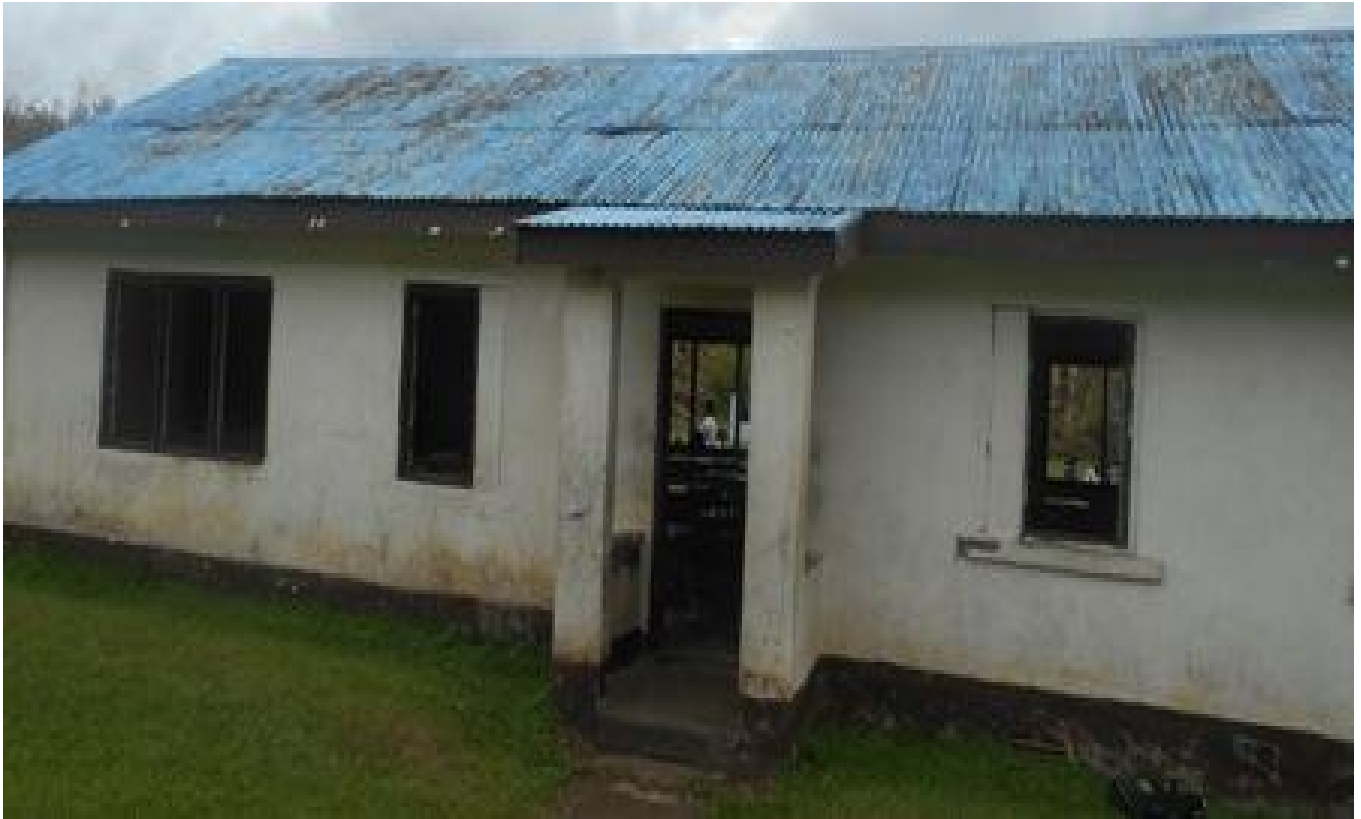
3	Poor			
Windows/Doors	standard louver carriers without any louver blades for all windows and timber doors.	1 2 3	Good Average Poor	Doors have water damage	2	7,8,9
Shutters	none	1 2 3	Good Average Poor	N/A	0	7,8,9
Ceilings	Ply board ceiling typically throughout	1 2 3	Good Average Poor	water damage	4	8
Terraces/Verandah	typically concrete floor with 50mm steel post and 200mm x 50mm timber beam on the terraces with 50mm steel post and RC beam on the verandah.	1 2 3	Good Average Poor	100% of the terrace roof damaged	4	9
Tiles/Floor Covering	concrete plaster	1 2 3	Good Average Poor	N/A	N/A	9
Gutters	Not known-totally blown out and destroyed.	1 2 3	Good Average Poor	All guttering blown out.	3	7,9
Downpipes	Not known-totally blown out and destroyed.	1 2 3	Good Average Poor	All downpipes blown out.	3	7,9
Fascia Boards	250x30mm timber fascia board.	1 2 3	Good Average Poor	100% damaged for the walkway only	4	7,9

**Photo 7: View of Damaged Roof**

Furniture/Desks etc.		1 2 3	Good Average Poor			N/A
<b>Possible Intermediate Solution</b>	Replace all the louver frames with new louver blades and re-construct the entire ablation roof and the verandah roof in accordance with NBCF with new roof trusses, purlins, new gutterings, downpipes, flashings, fascia board.					
<b>Possible Long Term Solution</b>	Detailed investigation for roof framing recommended along with checks on wall capacity for uplift/lateral loads for more tolerance towards Cat.4. Much dependent upon detailed investigation by an Engineer. Considering the building age and with the verandah area roof blown out, possibly re-build the whole roof to comply with NBCF. Option also exist to retrofit cost permitting, existing wall structure for a higher level of uplift capacity. Estimated cost currently around \$100,000.00 (new roof with retrofit) to \$200,000.00 ( new construction) for long term solution.

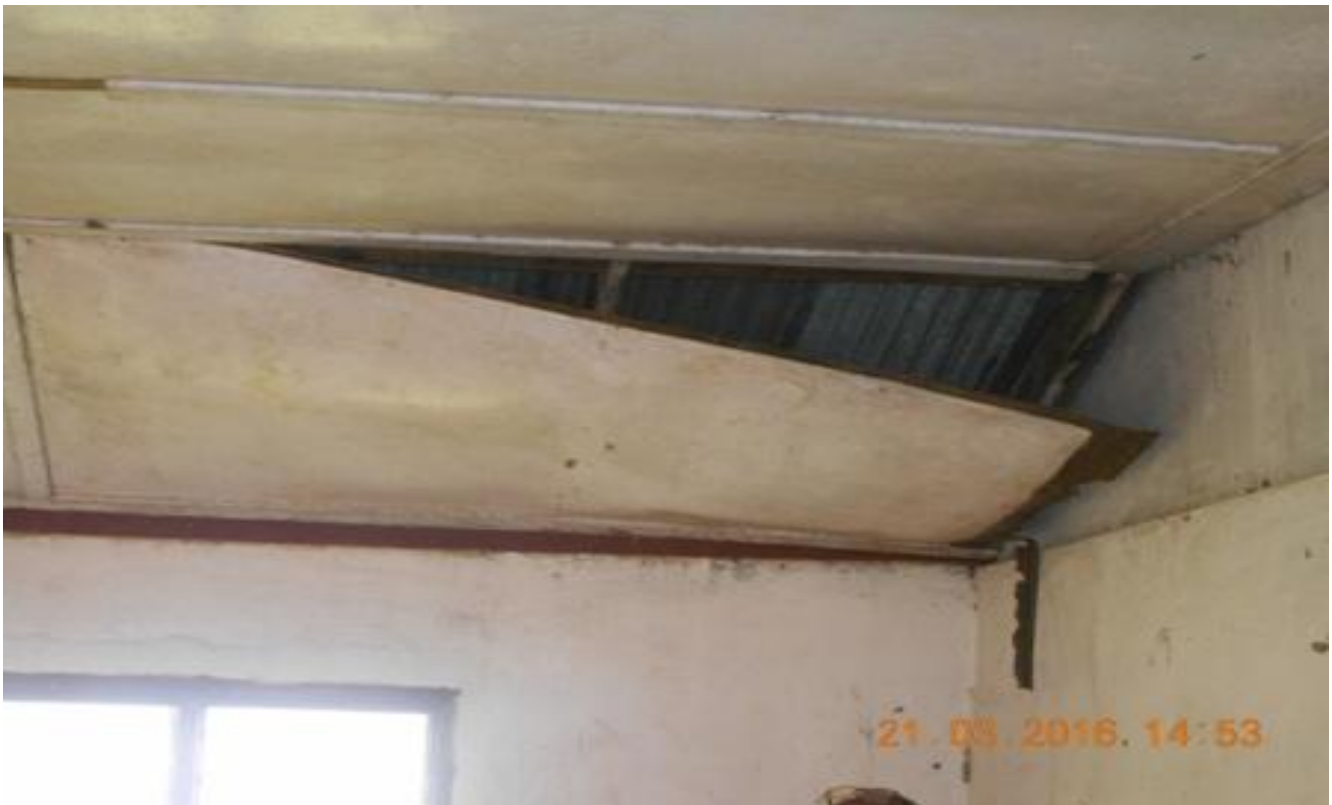
**Photo 8: View of the Water Damaged Ceiling**

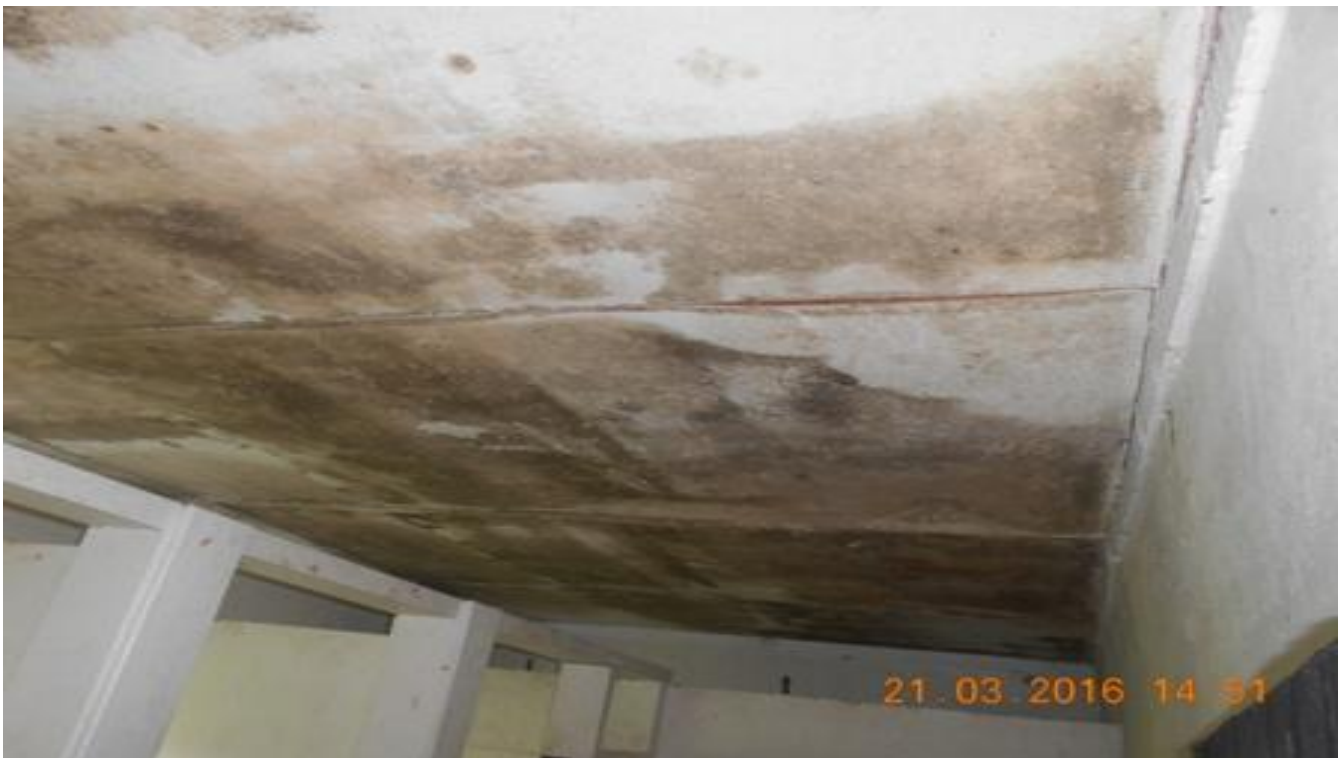
**Photo 11: Water Damaged Ceiling**

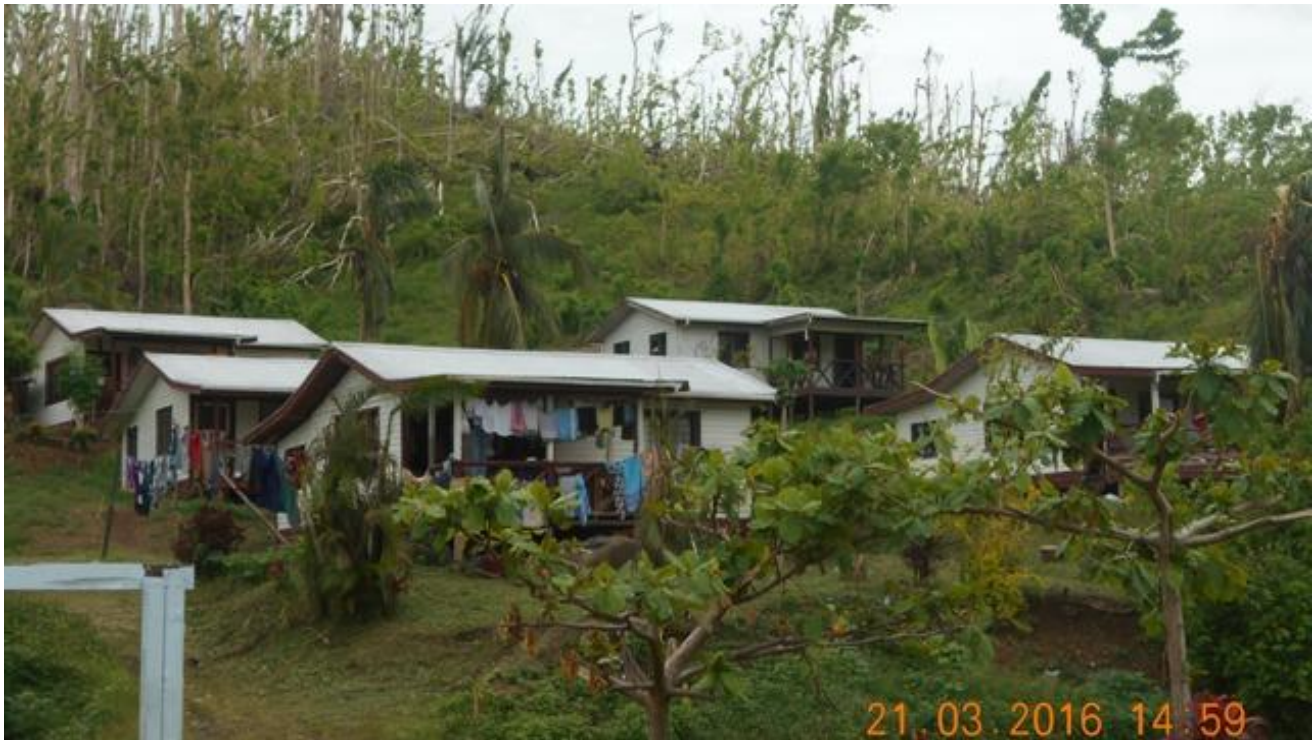
**Photo 12: Showing Overall View of Staff Quarters- Very Minor Damage- Guttering, Downpipes ,Flashings**

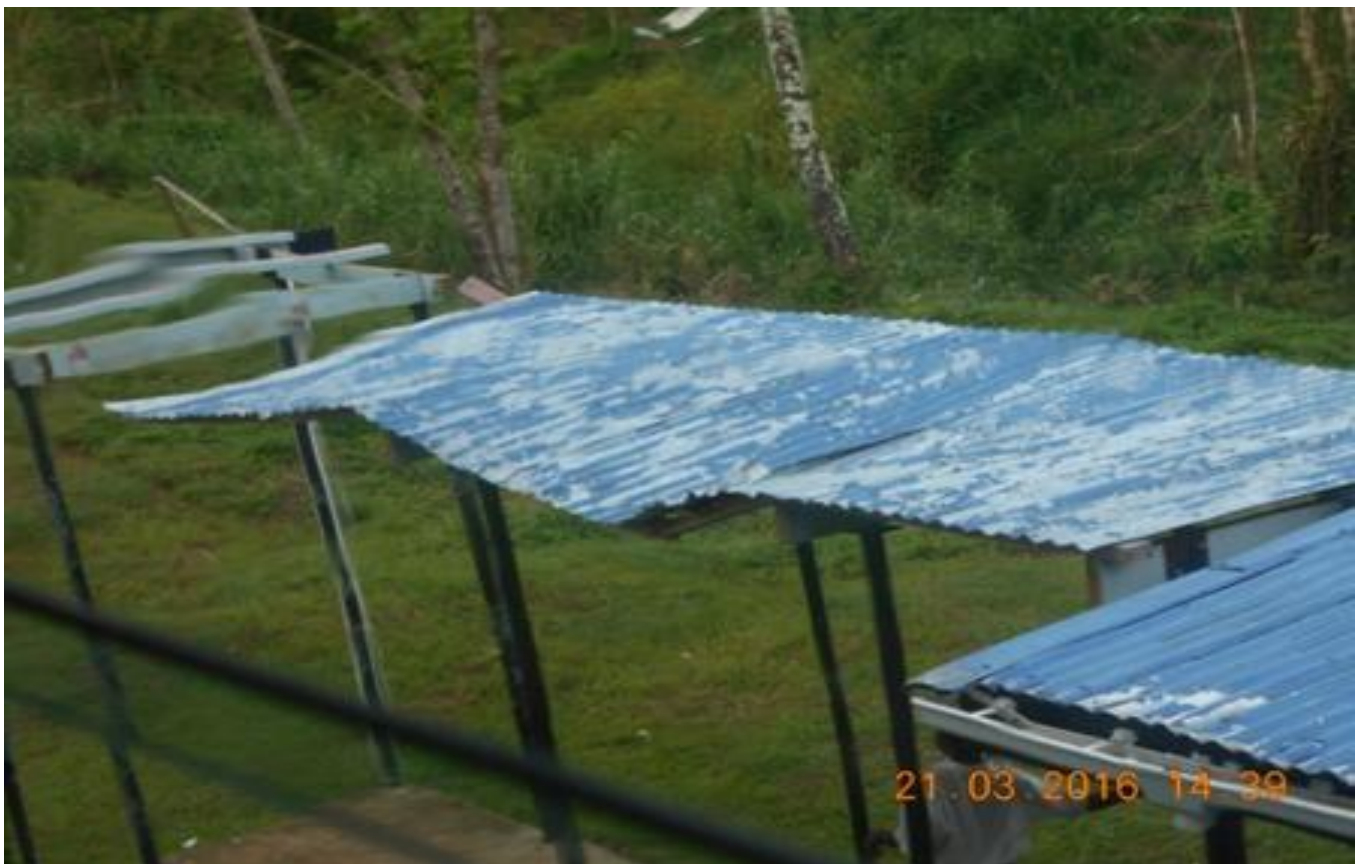
1 FENCING / GATES / DRIVEWAY / RETAINING WALLS ETC (INCLUDE TYPE / LENGTH ETC)	
Walkway from the main highway to the school building has whole roof completely blown out (13.6m x 3.5m)	
Stairs leading from the ground floor to the top floor has roof completely blown out (7.5m x 3.5m)	
Walkway from the main school building to the toilet block is damaged ( 20m x 2.6m )	
Walkway at the rear of the main building has some damages ( 18m x 1.2)	
2 WATER TANKS/METERS/PLUMBING	
3 POWER LINES / METERS / WIRING	
power line is broken	
4 OTHER ITEMS	
Currently, all the classes are running in the ground floor and in the ablution blocks. Long term solution would require decent time of 6 to 9 months of staged construction depending on material availability for a complete long term solution subject to additional cost consideration. Depending on immediate need and capacity, minimum 6 months to construct the new roof for the main building for full use again and 1 month to construct the roof for the ablution block, 1 month for the re-construction of the dining block roof and 1 month to repair the walkway, and the 3 weeks to repair the staff quarters which only require minor repairs. Staff quarters has minor damages done such as flashings, gutters, downpipes, etc and repairing it will take 2 weeks. Re-construction of both the bus stops will take 1 month to complete.

**Photo 14: Showing Damaged Walkway**
