**CYCLONE WINSTON PRELIMINARY ASSESSMENT
SCHOOLS, HEALTH FACILITIES AND PUBLIC BUILDINGS
FOR
FIJI INSTITUTION OF ENGINEERS &
DEPARTMENT OF NATIONAL PLANNING
(MINISTRY OF FINANCE)**

NAME OF FACILITY: Nailuva District School
TYPE: Primary School
LOCATION: Rakiraki
DATE OF ASSESSMENT: 22 March 2016

JOB NO: 16-110
GOVERNMENT FACILITY NUMBER: GFN-120

**RAPID ASSESSMENT TEMPLATE: CYCLONE WINSTON DAMAGED BUILDINGS
SCHOOLS, PUBLIC BUILDINGS & HEALTH FACILITIES**

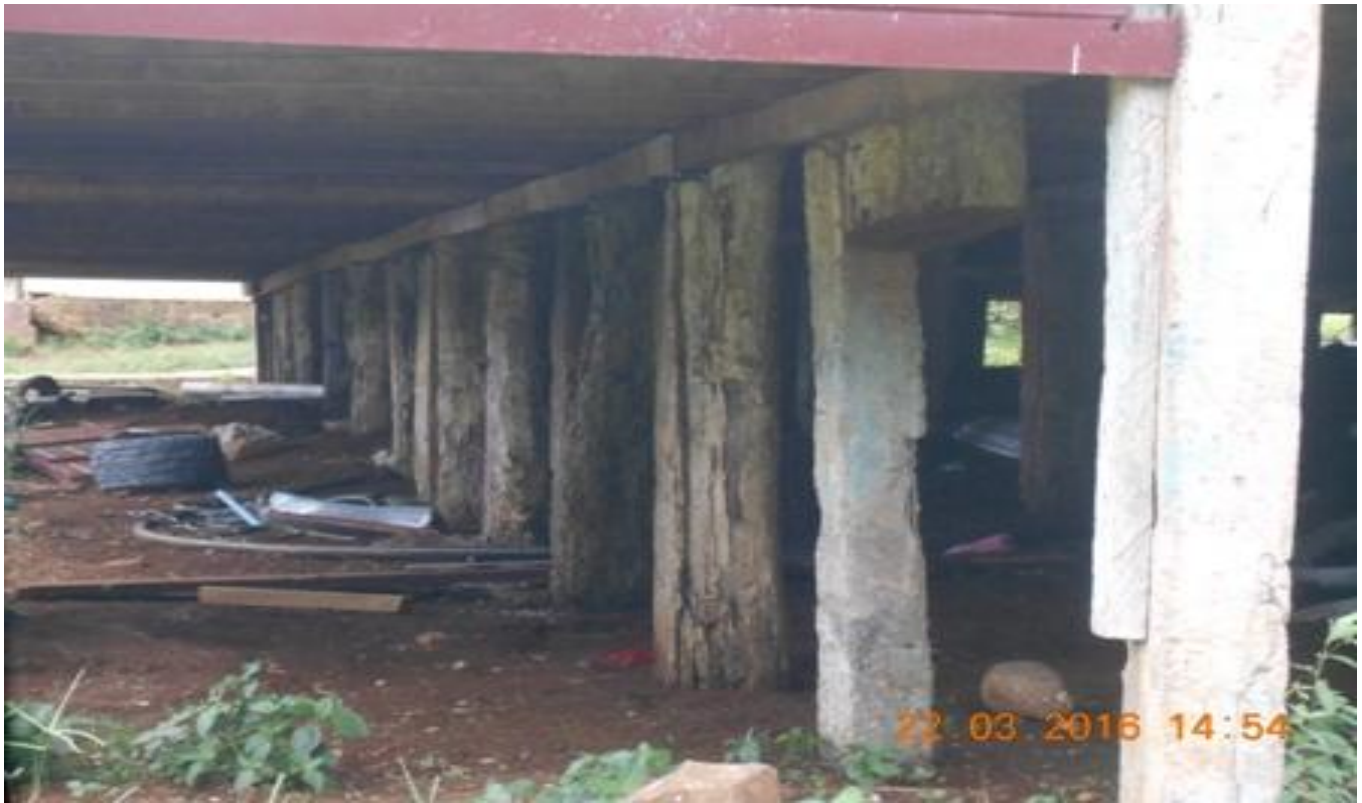
Photo 1: View of the Concrete and Timber Piles

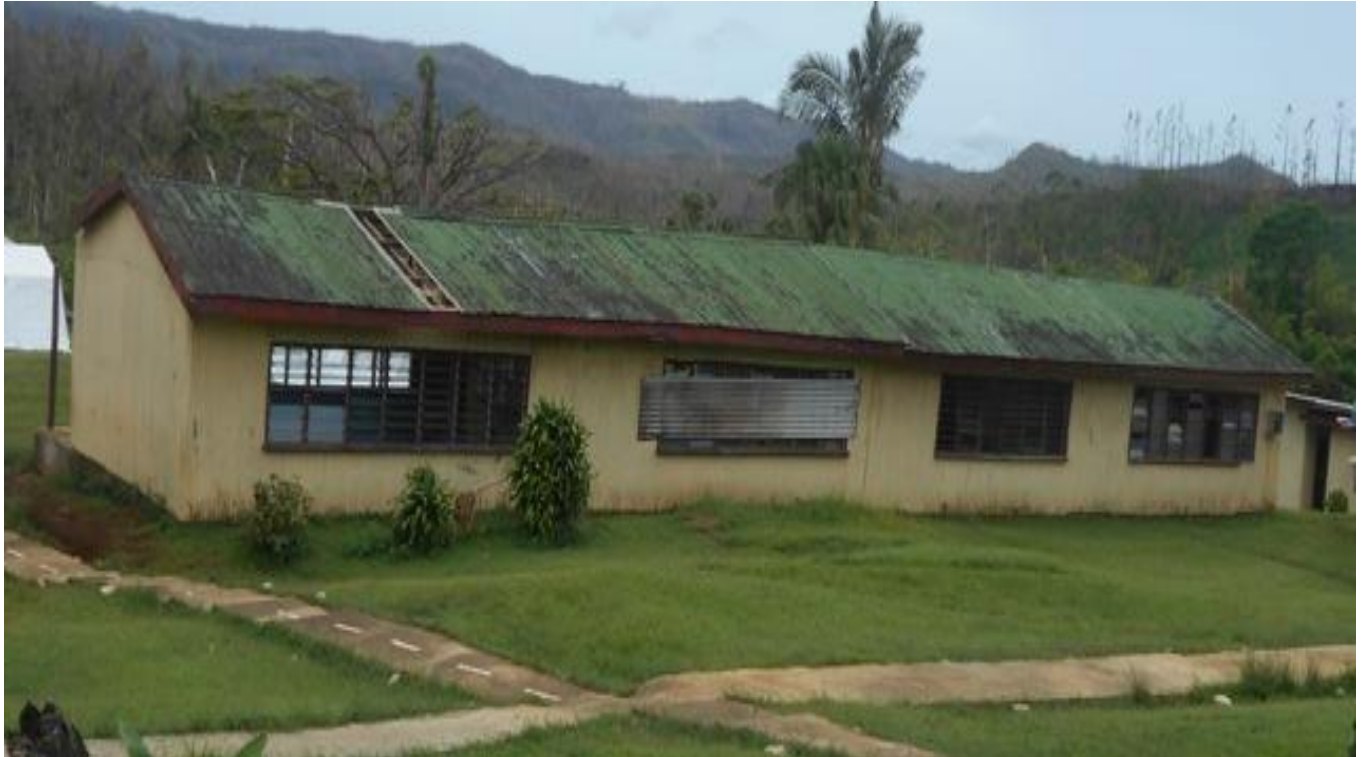
Hydraulics	None	1 Good 2 Average 3 Poor	N/A	N/A	
Windows/Doors	louver windows on standard carriers typically for all windows and timber doors.	1 Good 2 Average 3 Poor	100% damage on old blocks.	2	N/A
Shutters	50 x 50mm mesh observed for a few windows - no shutters also observed to a few windows	1 Good 2 Average 3 Poor	100% damage on old blocks.	4	2,3,5
Ceilings	Ply board ceiling typically throughout- 80% of the ceiling blown out and the remainin of the ceiling is water damaged-painted for the old block	1 Good 2 Average 3 Poor	100% damage on old blocks.	4	5
Terraces/Verandah	wooden floor with 100mm x 50mm timber post and 100% of the roof is blown out for the old building verandah.	1 Good 2 Average 3 Poor	100% damage on old blocks.	4	3,4
Tiles/Floor Covering	Concrete plaster	1 Good 2 Average 3 Poor	100% damage on old blocks.	4	N/A
Gutters	Standard PVC gutters with proprietary PVC straps fixed to the outside of the gutter.	1 Good 2 Average 3 Poor	100% damage on old blocks. 50% damage in the new block	4	2,3,4

Downpipes	100mm PVC downpipes with PVC straps fixed to the columns at 9m crs.	1 Good 2 Average 3 Poor	100% damage on old blocks. 50% damage in the new block	4	2,3,4
Fascia Boards	250x30mm timber fascia board.	1 Good 2 Average 3 Poor	100% damage on old blocks.	4	2,3,4
Furniture/Desks etc.		1 Good 2 Average 3 Poor			
Possible Intermediate Solution	Demolish the timber blocks and re-construct the whole building in accordance to the NBCF.				
Possible Long Term Solution	N/A

Photo 2: View of Corrugated Cladding Building

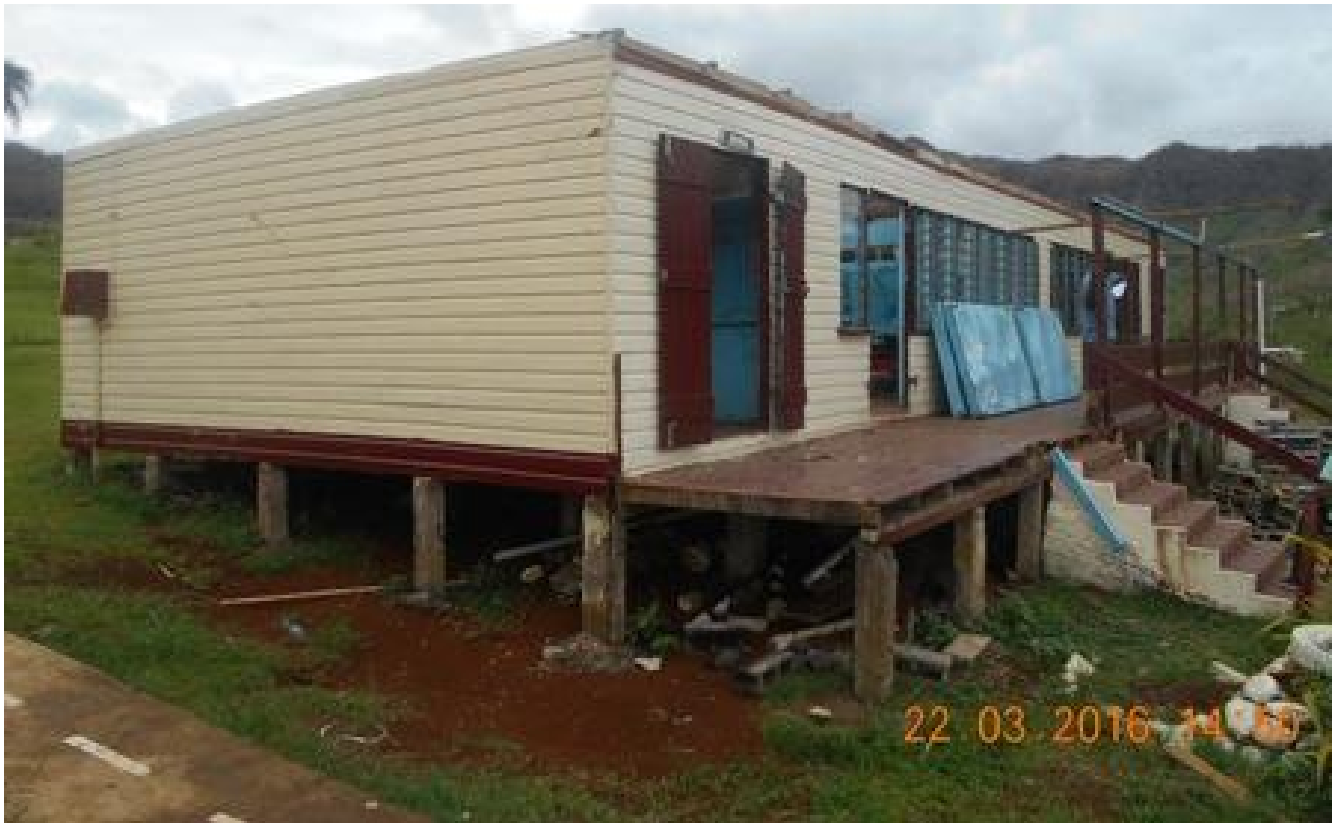
Photo 3: View of Timber Cladding Building

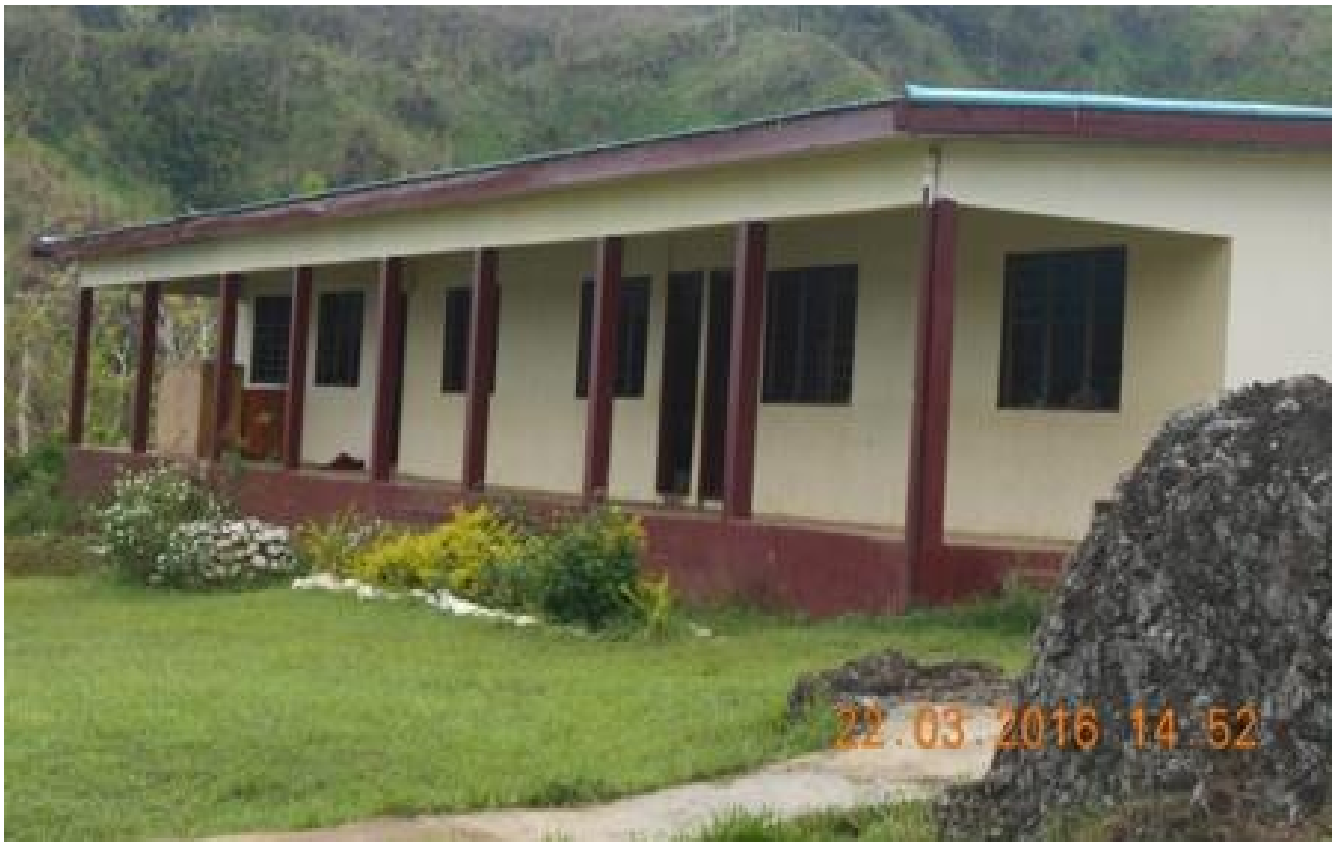
Photo 4:View of New Concrete Blockwall Building

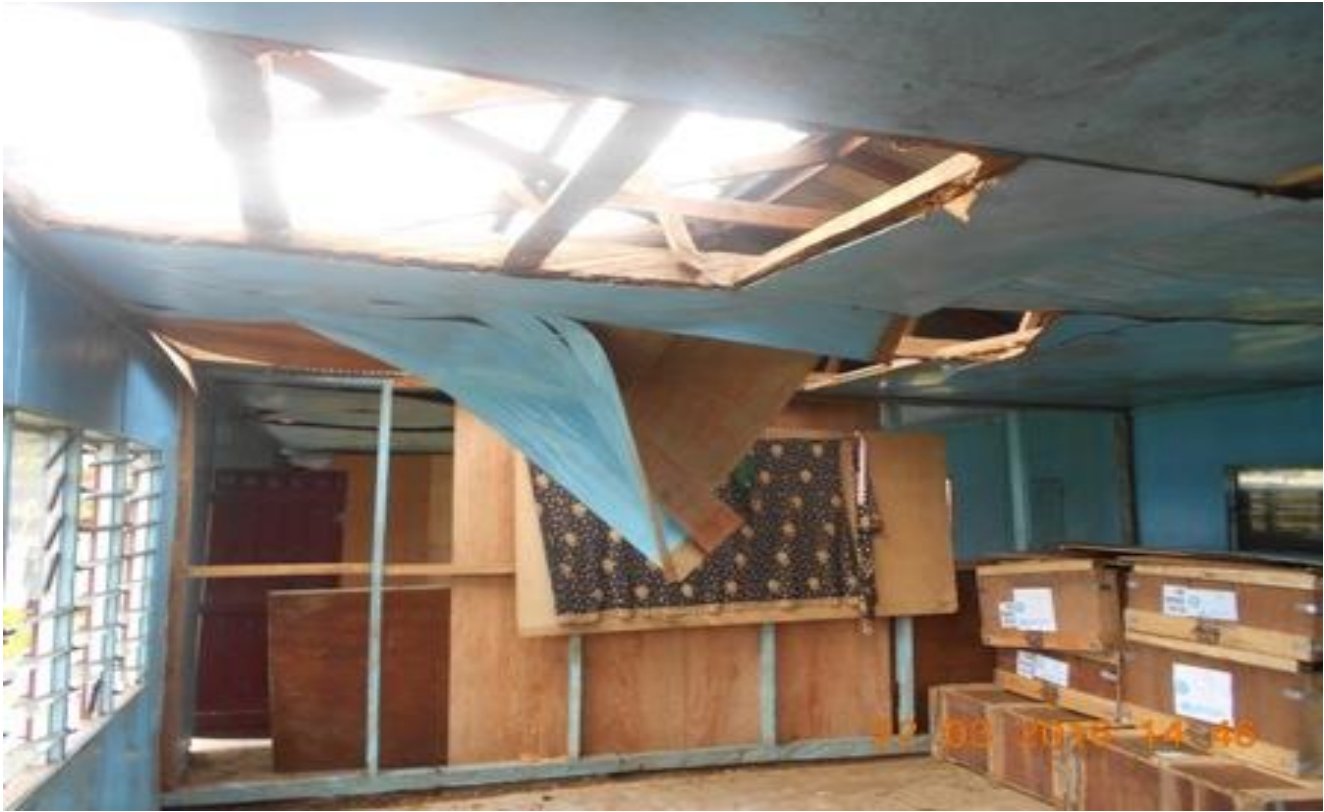
Photo 5: Overall View of Water Damaged Ceiling

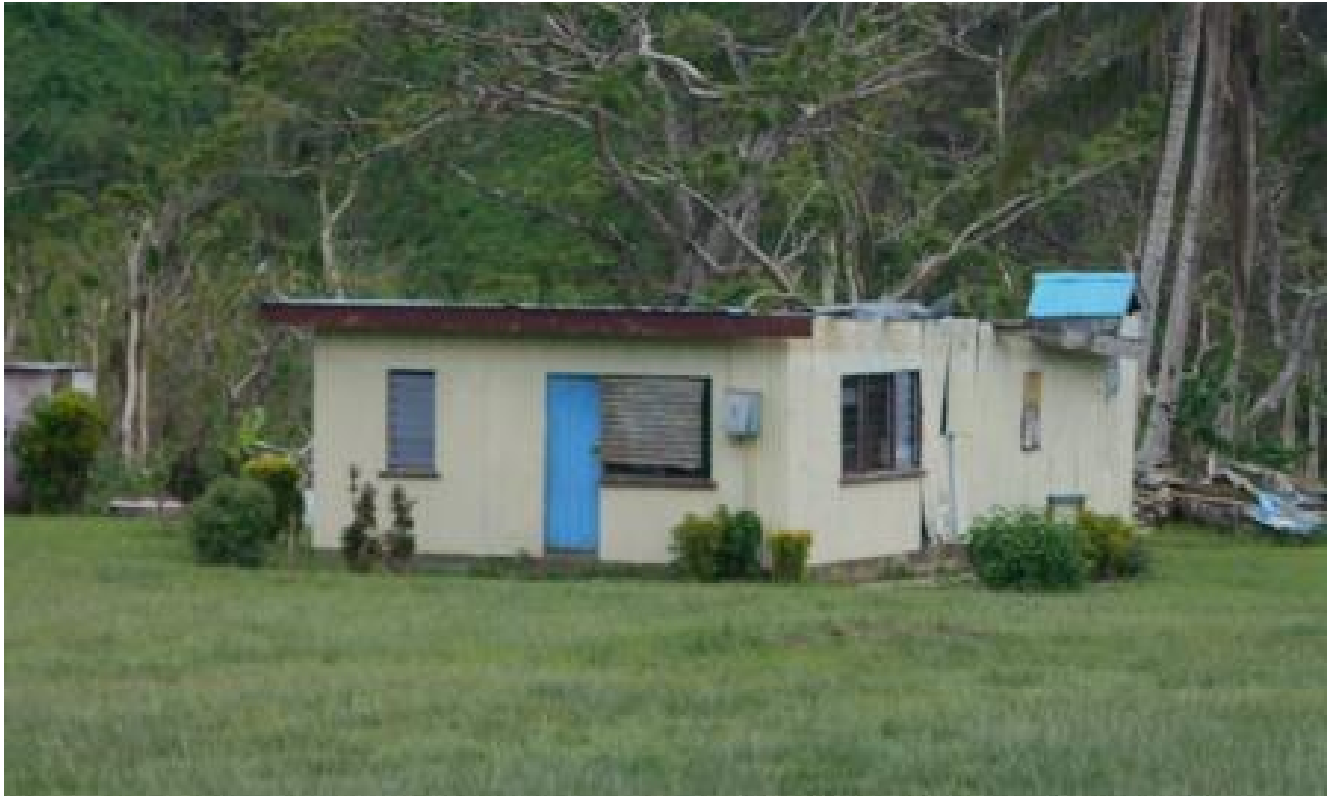
Hydraulics	None	1 2 3	Good Average Poor	N/A	N/A	N/A
Windows/Doors	louver windows on standard carriers typically for all windows and timber doors.	1 2 3	Good Average Poor	2 quarters 100% damaged	2	6,7
Shutters	50 x 50mm mesh observed for a few windows - no shutters also observed to a few windows	1 2 3	Good Average Poor	2 quarters 100% damaged	4	6,7
Ceilings	Ply board ceiling typically throughout- 80% of the ceiling blown out and the remainin of the ceiling is water damaged-painted for the old block	1 2 3	Good Average Poor	2 quarters 100% damaged	4	N/A
Terraces/Verandah	wooden floor with 100mm x 50mm timber post and 100% of the roof is blown out for the old building verandah.	1 2 3	Good Average Poor	2 quarters 100% damaged	4	N/A
Tiles/Floor Covering	Concrete plaster	1 2 3	Good Average Poor	2 quarters 100% damaged	4	N/A
Gutters	Standard PVC gutters with proprietary PVC straps fixed to the outside of the gutter.	1 2 3	Good Average Poor	2 quarters 100% damaged 50% damage in the new block	4	6,7

Downpipes	100mm PVC downpipes with PVC straps fixed to the columns at 9m crs.	1 2 3	Good Average Poor	2 quarters 100% damaged 50% damage in the new block	4	6,7
Fascia Boards	250x30mm timber fascia board.	1 2 3	Good Average Poor	2 quarters 100% damaged	4	6,7
Furniture/Desks etc.		1 2 3	Good Average Poor			
Possible Intermediate Solution	Demolish the timber blocks and re-construct the whole building in accordance to the NBCF with new roof trusses, walls, foundation, purlins, gutters, downpipes, fascia. Damaged buildings to have new flashings, fascia, gutterings, downpipes.					
Possible Long Term Solution	N/A

Photo 6: View of Corrugated Teachers Quarters with Damaged Roof

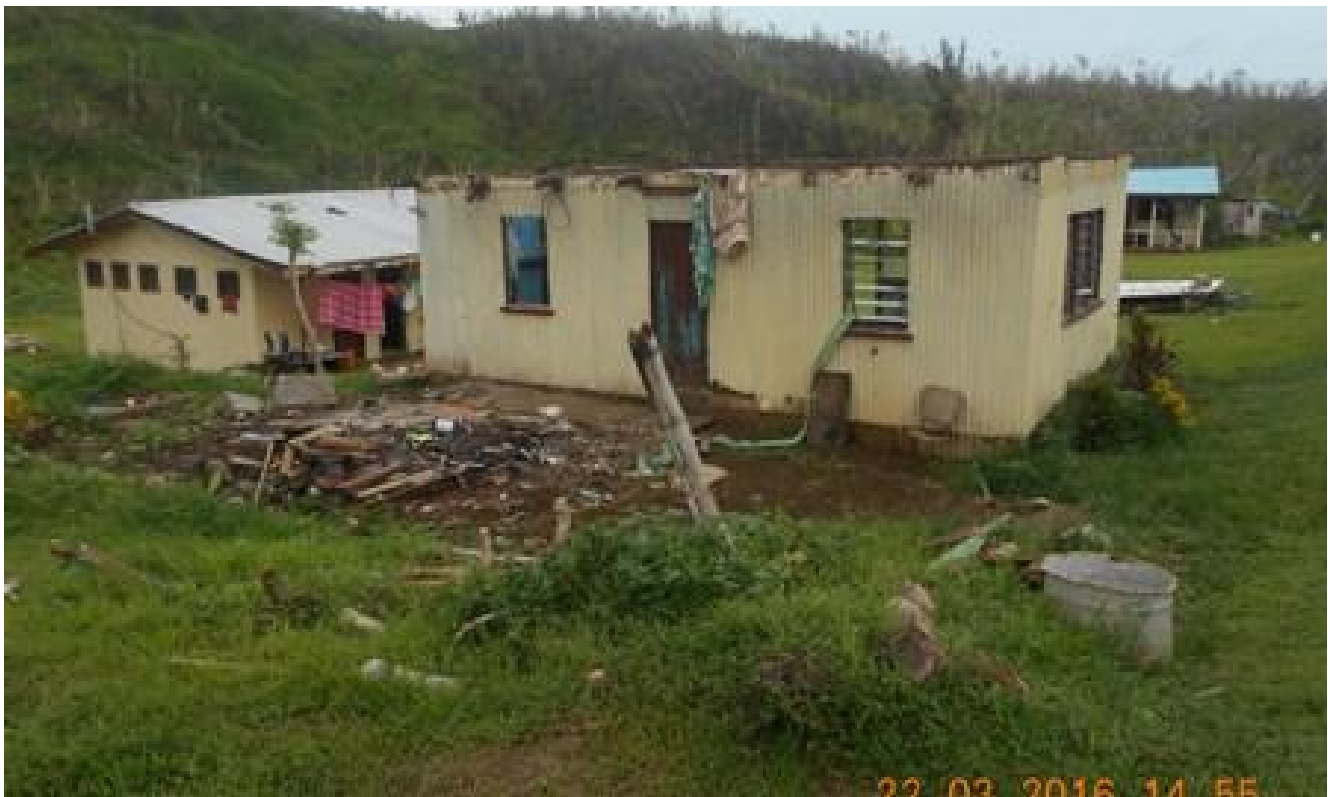
Type of Construction	Description	Build Quality		Damage	Extent of Damage Rating	Photo No.
Floor	new quarters have reinforced concrete slab on ground and old quarters is on timber floor	1 2 3	Good Average Poor	2 quarters 100% damaged	4	7
Foundations	old quarters is on concrete piles and the new quarters is not visible.	1 2 3	Good Average Poor	No visible damage -concealed 2 quarters 100% damaged	4	7
Walls	150mm blockwall for the new quarters and with corrugated cladding for the old quarters	1 2 3	Good Average Poor	2 quarters 100% damaged	4	6,7
Rafters	100x50 timber rafter	1 2 3	Good Average Poor	2 quarters 100% damaged	4	N/A
Purlins	75x50 timber purlins	1 2 3	Good Average Poor	2 quarters 100% damaged	4	N/A
Roof	corrugated roof cladding	1 2 3	Good Average Poor	2 quarters 100% damaged with roof blown out for some	4	7
Electrical	typical standard switches, GPO's and fluorescent tubelights and bulbs.	1 2 3	Good Average Poor	2 quarters 100% damaged	4	N/A

Photo 7: View of the Water Damaged Ceiling

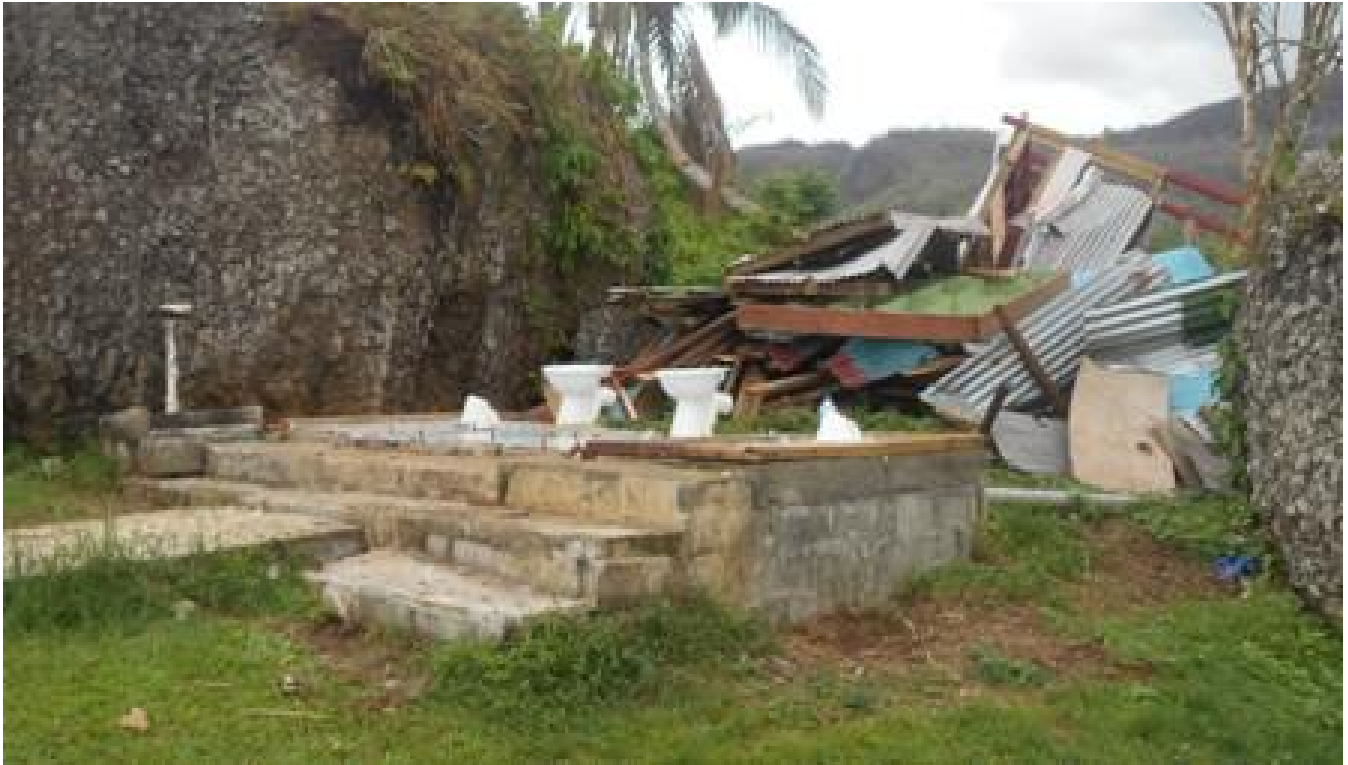
Type of Construction	Description	Build Quality	Damage	Extent of Damage Rating	Photo No.
Floor	reinforced concrete slab on ground.	1 Good 2 Average 3 Poor	Cracks observed	4	8
Foundations	Not visible	1 Good 2 Average 3 Poor	Not Visible - concealed	4	N/A
Walls	Not visible	1 Good 2 Average 3 Poor	100% damaged	4	8
Rafters	Not visible	1 Good 2 Average 3 Poor	100% damaged	4	N/A
Purlins	Not visible	1 Good 2 Average 3 Poor	100% damaged	4	N/A
Roof	Not visible	1 Good 2 Average 3 Poor	100% damaged	4	N/A
Electrical	Not visible	1 Good 2 Average 3 Poor	100% damaged	4	N/A
Hydraulics	N/A	1 Good 2 Average 3 Poor	N/A	N/A	N/A
Windows/Doors	Not visible	1 Good 2 Average 3 Poor	100% damaged	4	N/A
Shutters	Not visible	1 Good 2 Average 3 Poor	100% damaged	4	N/A
Ceilings	Not visible	1 Good 2 Average 3 Poor	100% damaged	4	N/A
Terraces/Verandah	Not visible	1 Good 2 Average 3 Poor	100% damaged	4	N/A
Tiles/Floor Covering	Not visible	1 Good 2 Average 3 Poor	100% damaged	4	N/A

Photo 8: View of the Toilet Blocks

Gutters	Not visible	1 Good 2 Average 3 Poor	100% damaged	4	N/A
Downpipes	Not visible	1 Good 2 Average 3 Poor	100% damaged	4	N/A
Fascia Boards	Not visible	1 Good 2 Average 3 Poor	100% damaged	4	N/A
Furniture/Desks etc.		1 Good 2 Average 3 Poor			
Possible Intermediate Solution	Re-construct the whole of the toilet block in accordance to the NBCF.				
Possible Long Term Solution	N/A

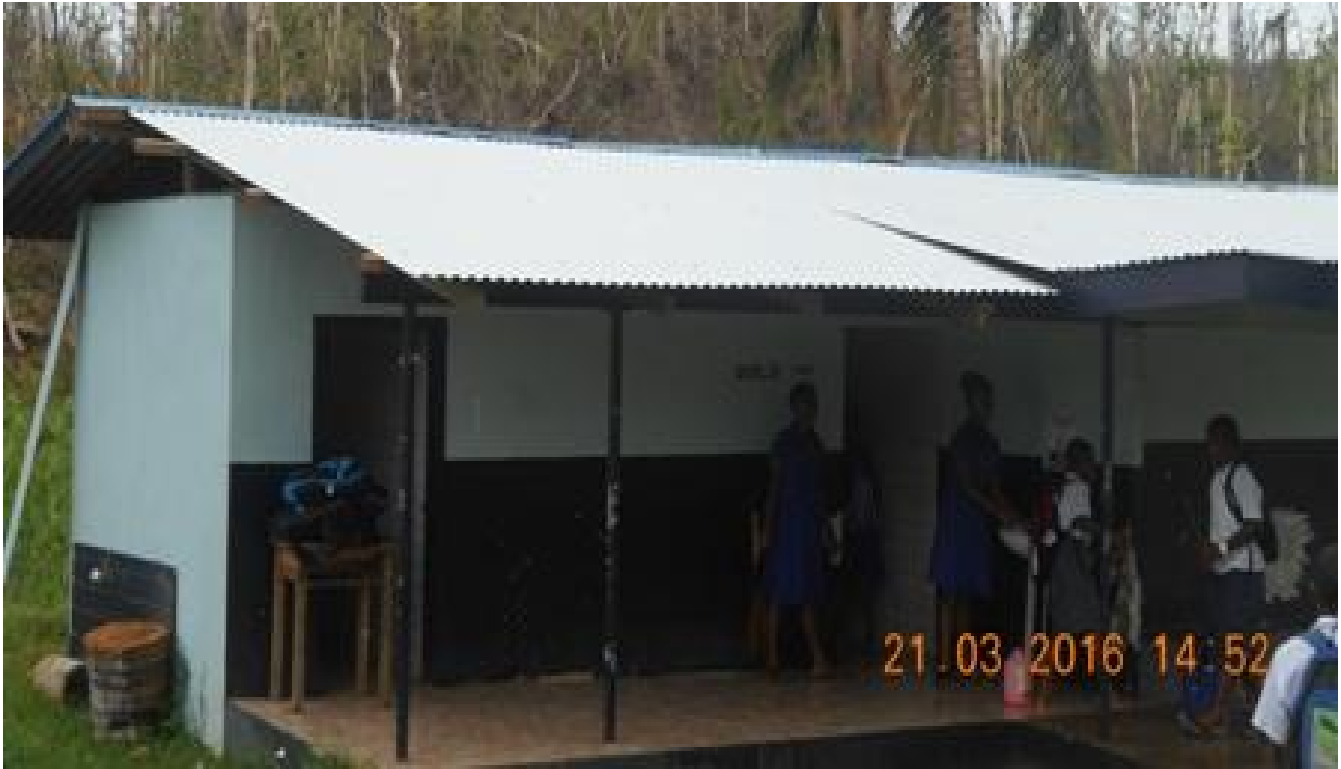
Photo 10: View of the Toilet Block

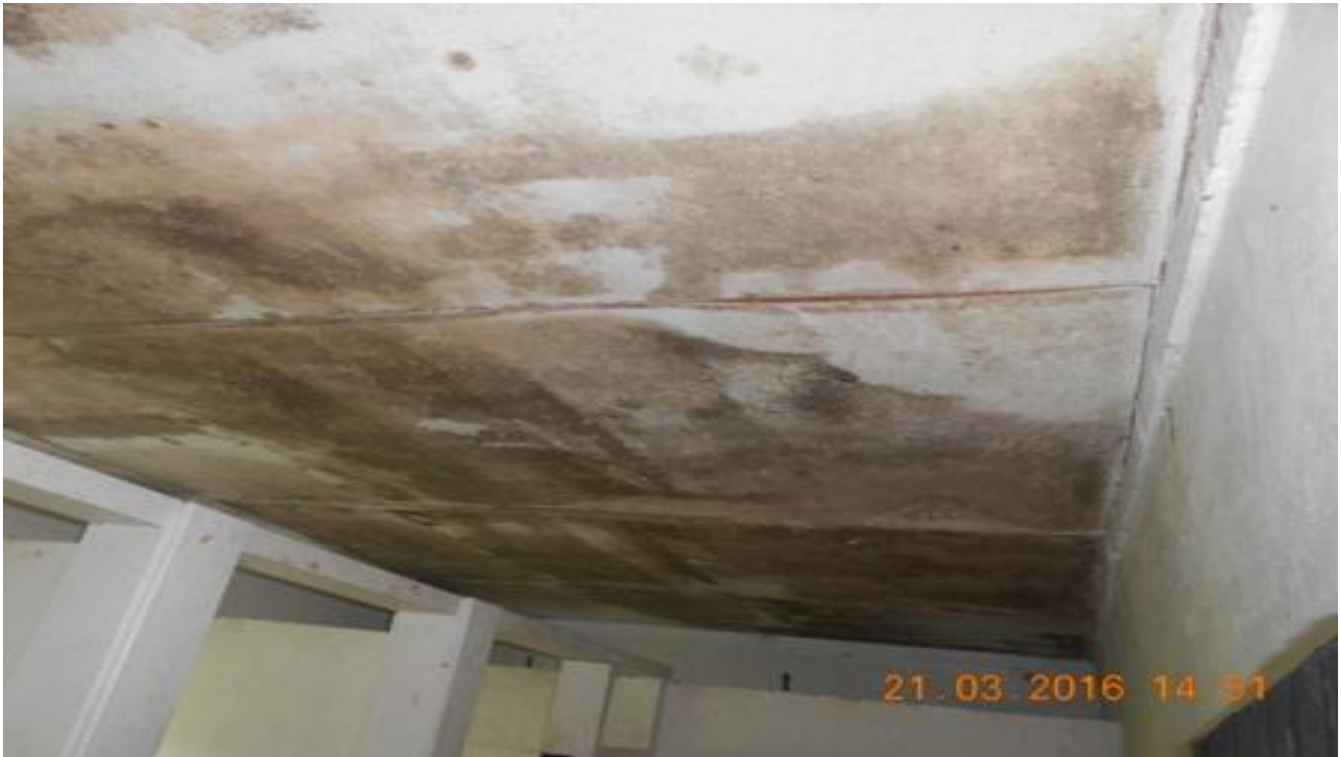
Photo 11: Water Damaged Ceiling

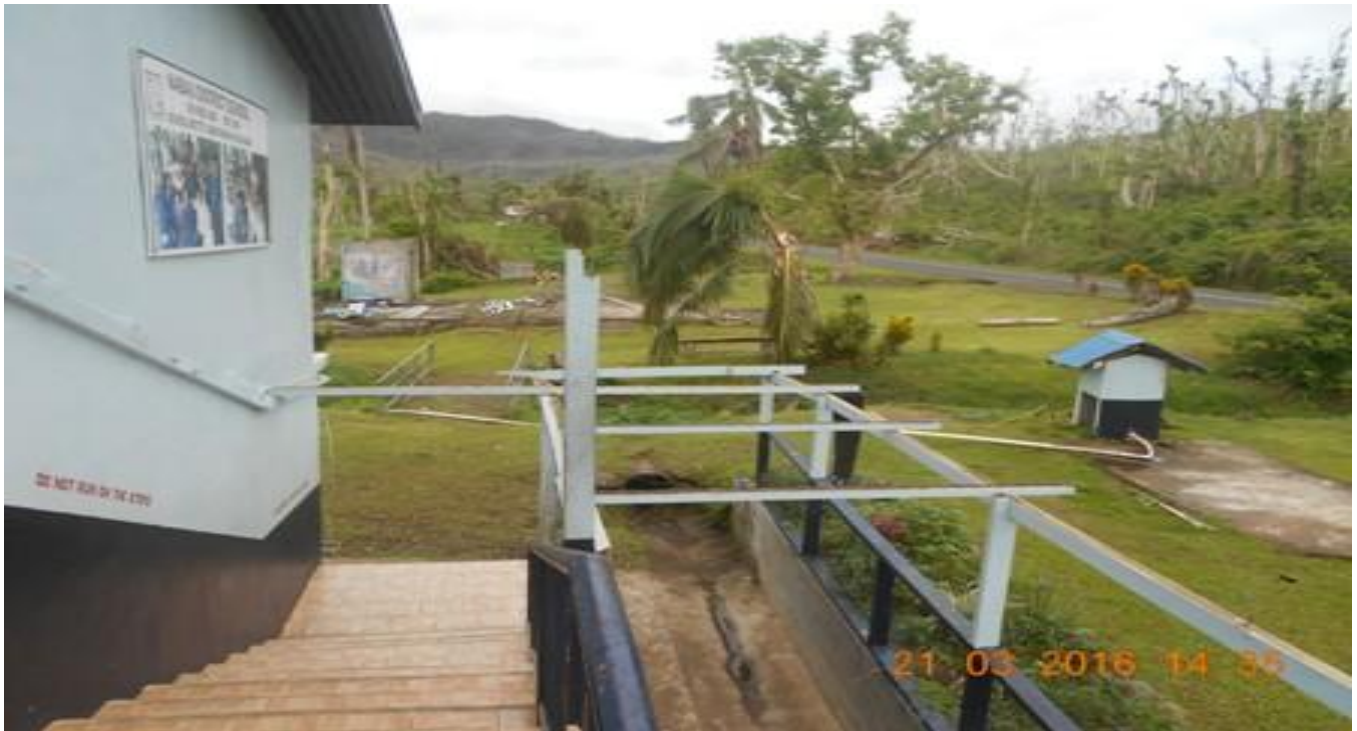
Photo 13: Showing Damaged Walkway
