**CYCLONE WINSTON PRELIMINARY ASSESSMENT
SCHOOLS, HEALTH FACILITIES AND PUBLIC BUILDINGS
FOR
FIJI INSTITUTION OF ENGINEERS &
DEPARTMENT OF NATIONAL PLANNING
(MINISTRY OF FINANCE)**

NAME OF FACILITY: Vunikavikaloa Arya School
TYPE: College
LOCATION: Rakiraki
DATE OF ASSESSMENT: 21 March 2016

JOB NO: 16-118
GOVERNMENT FACILITY NUMBER: GFN-122

**RAPID ASSESSMENT TEMPLATE: CYCLONE WINSTON DAMAGED BUILDINGS
SCHOOLS, PUBLIC BUILDINGS & HEALTH FACILITIES**

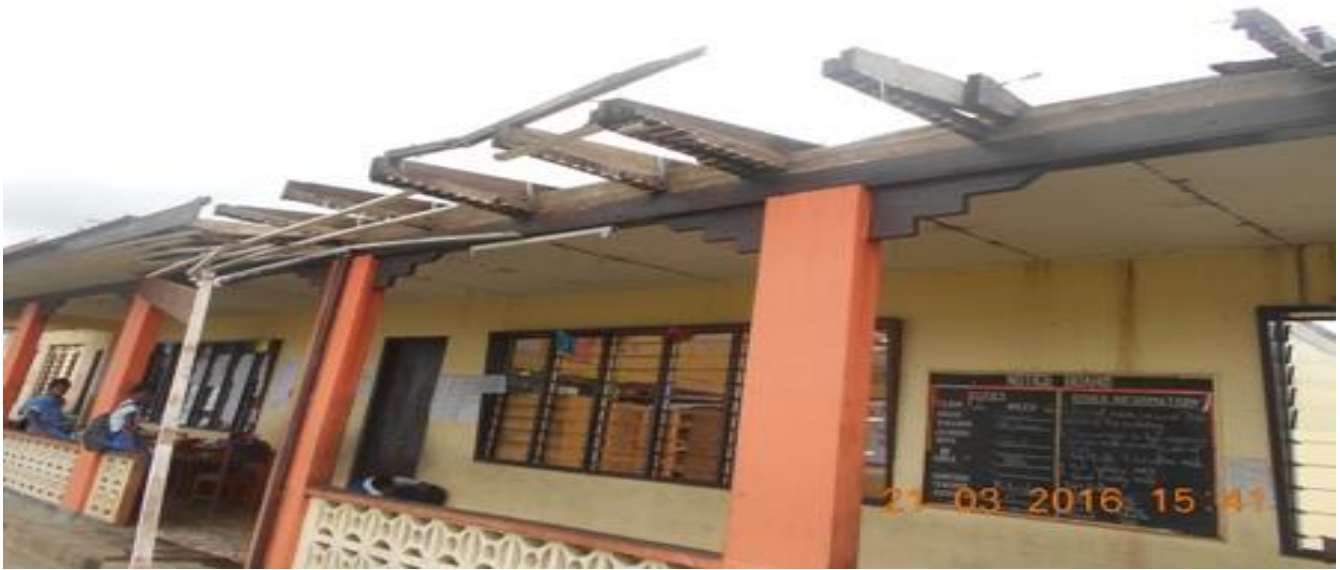
Photo 1: Verandah Portion has been blown away

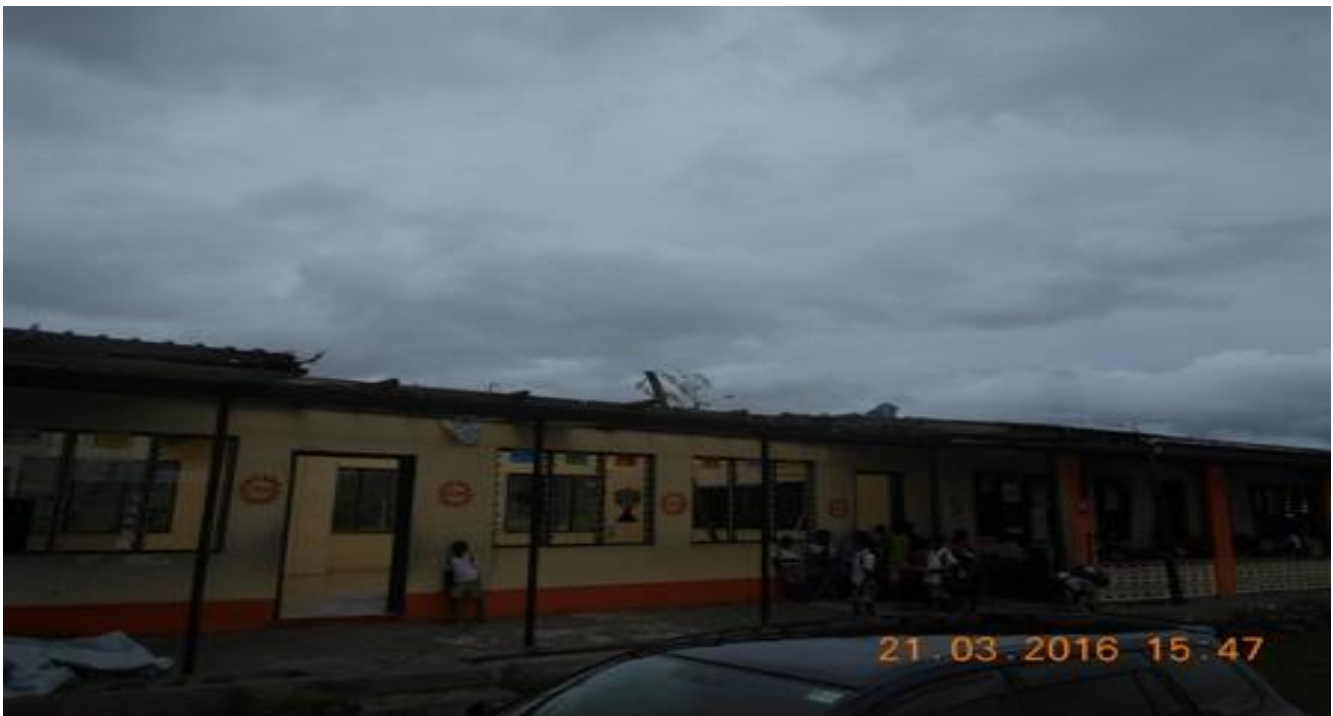
Photo 2: View of the Damaged Building

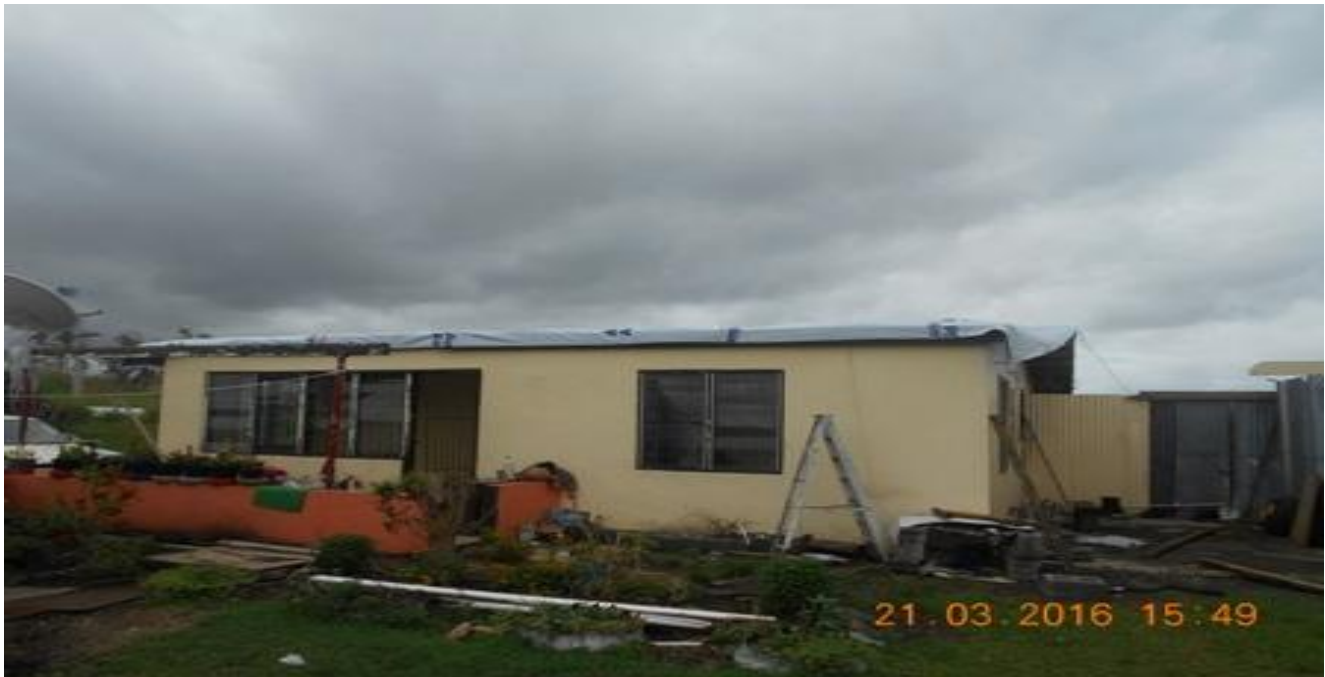
Photo 3: View of the Teachers Quarters

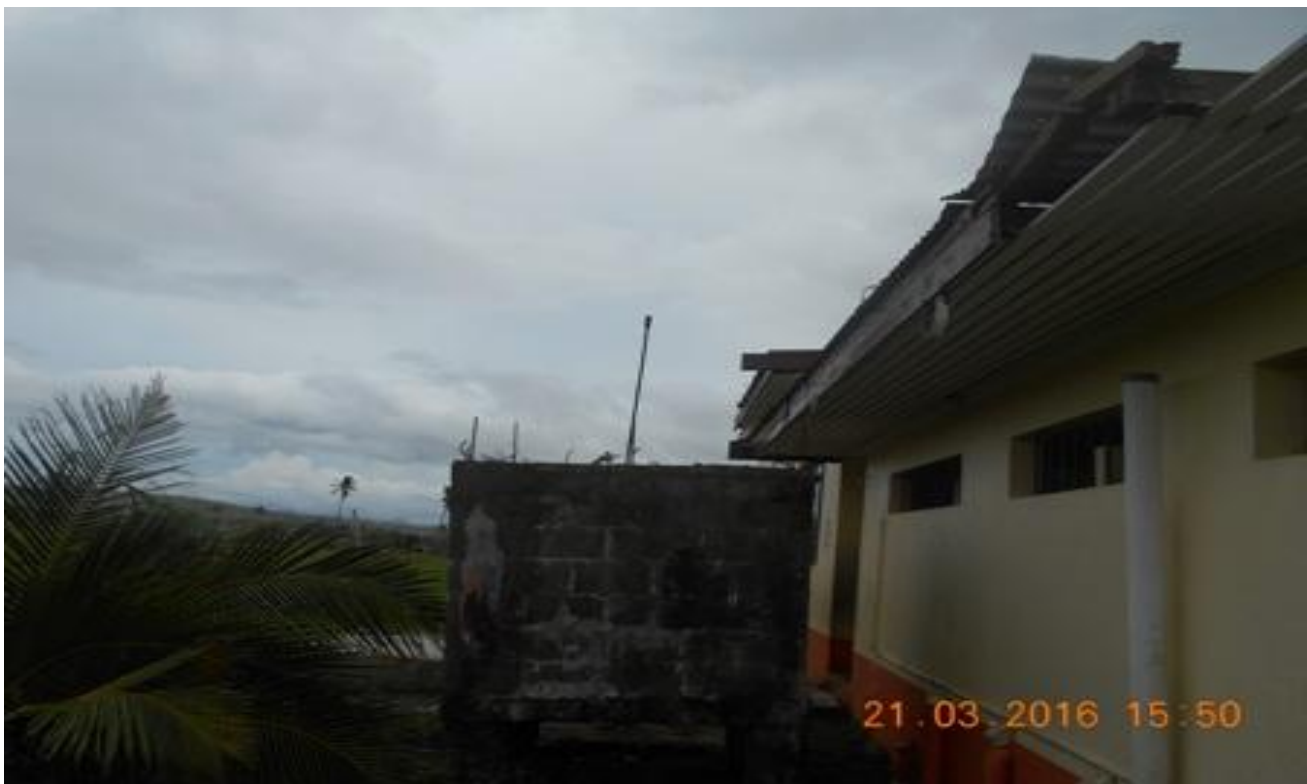
Photo 4: View of the Toilet
