**CYCLONE WINSTON PRELIMINARY ASSESSMENT
SCHOOLS, HEALTH FACILITIES AND PUBLIC BUILDINGS
FOR
FIJI INSTITUTION OF ENGINEERS &
DEPARTMENT OF NATIONAL PLANNING
(MINISTRY OF FINANCE)**

NAME OF FACILITY: Naweni District School
TYPE: Primary School
LOCATION: Naweni, Vanua Levu
DATE OF ASSESSMENT: 21 March 2016

JOB NO: 16-119
GOVERNMENT FACILITY NUMBER: GFN-194

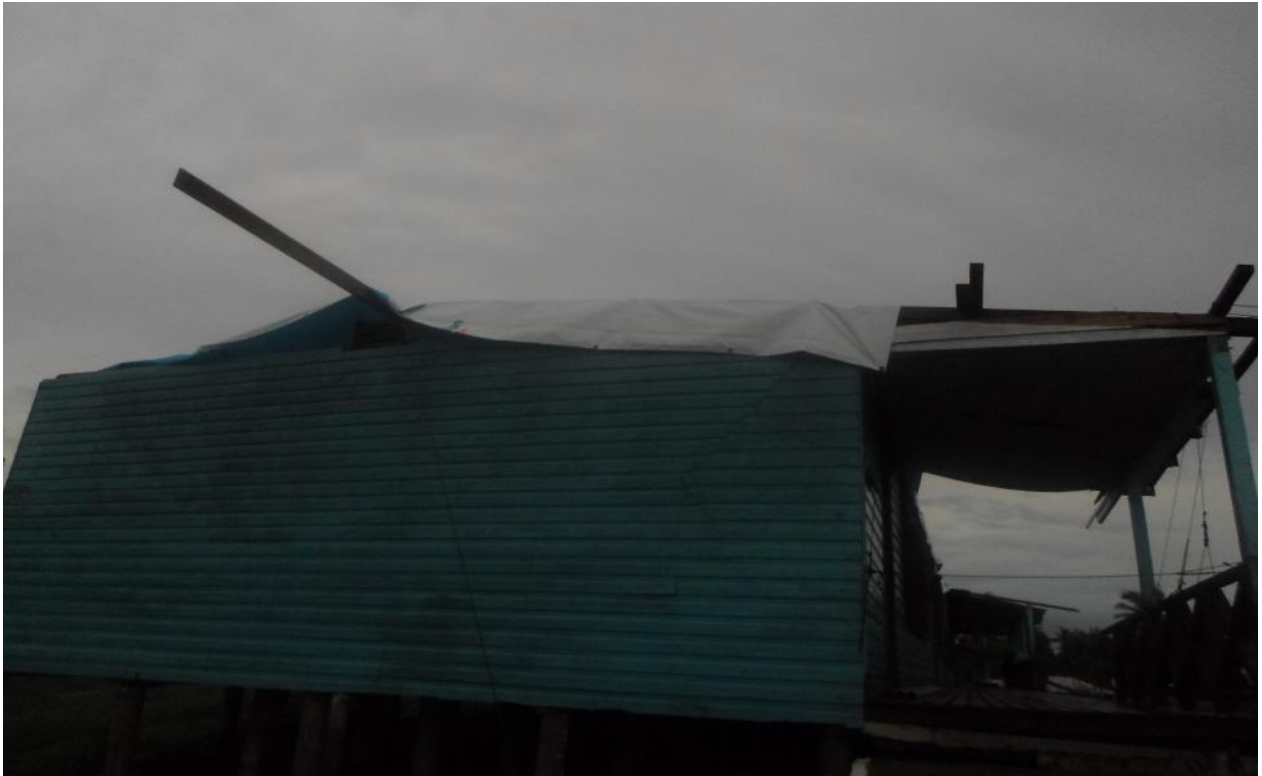
Photo 1: Side view of the building that is damaged

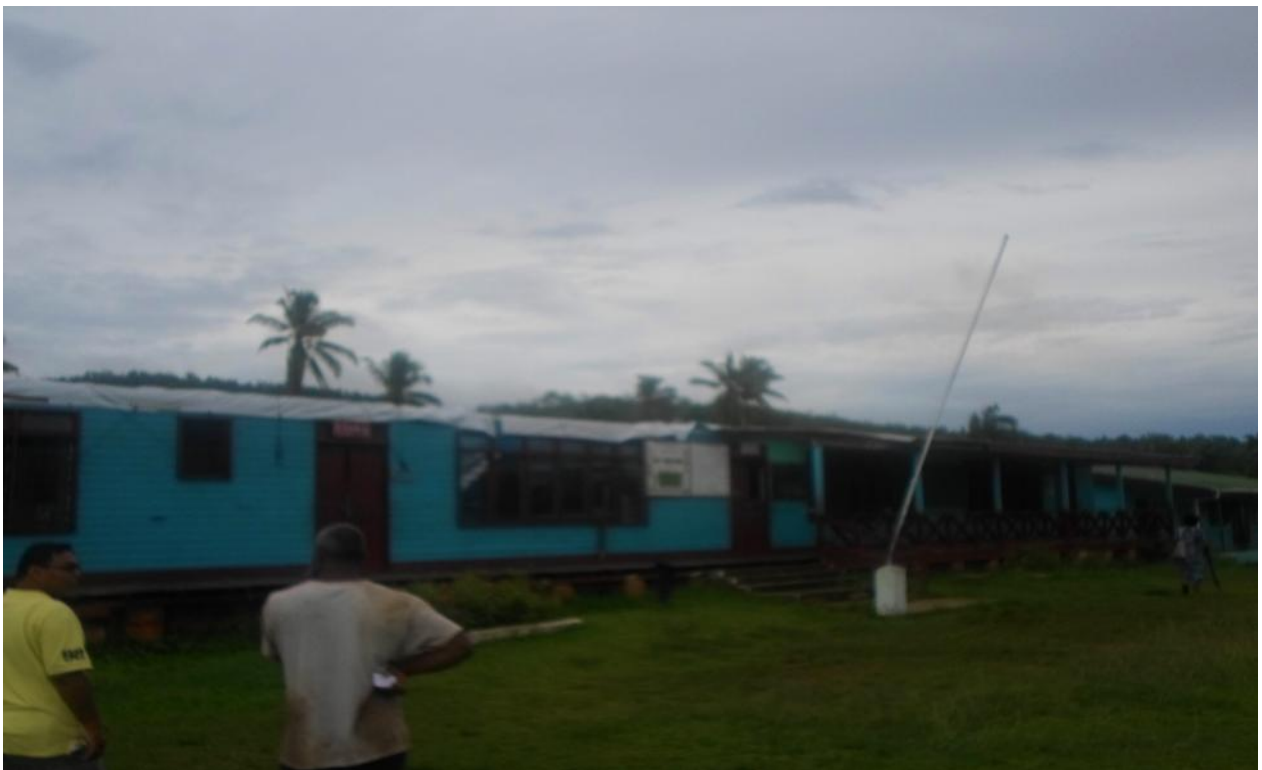
Photo 2: Overall frontage view of the building that is damaged

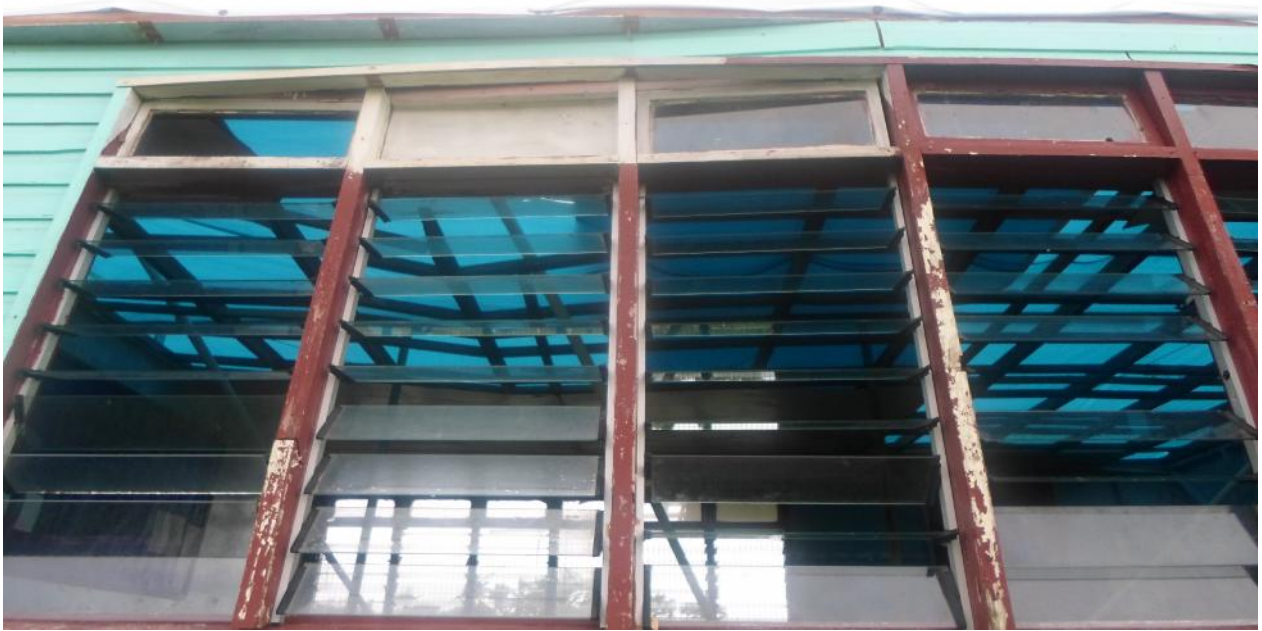
Photo 3: Enlarge view of the damage walls

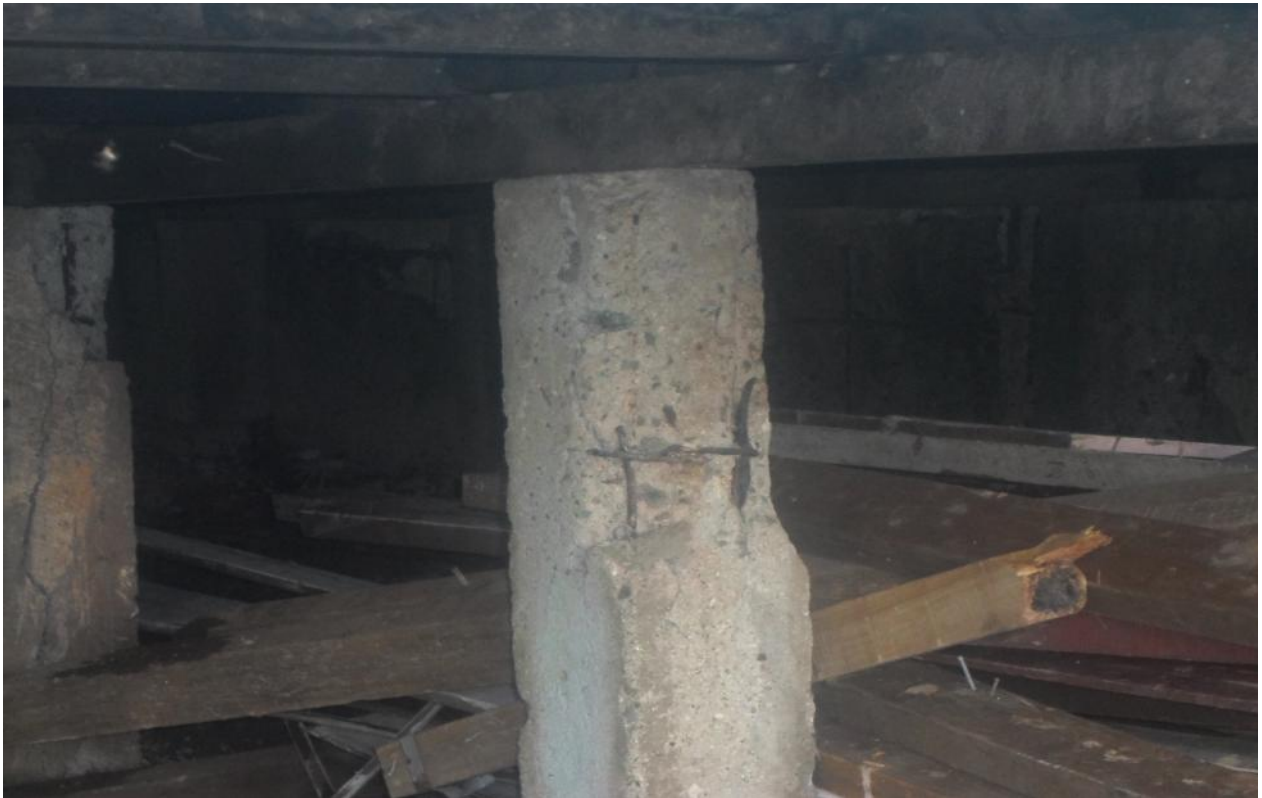
Photo 4: Damaged concrete post

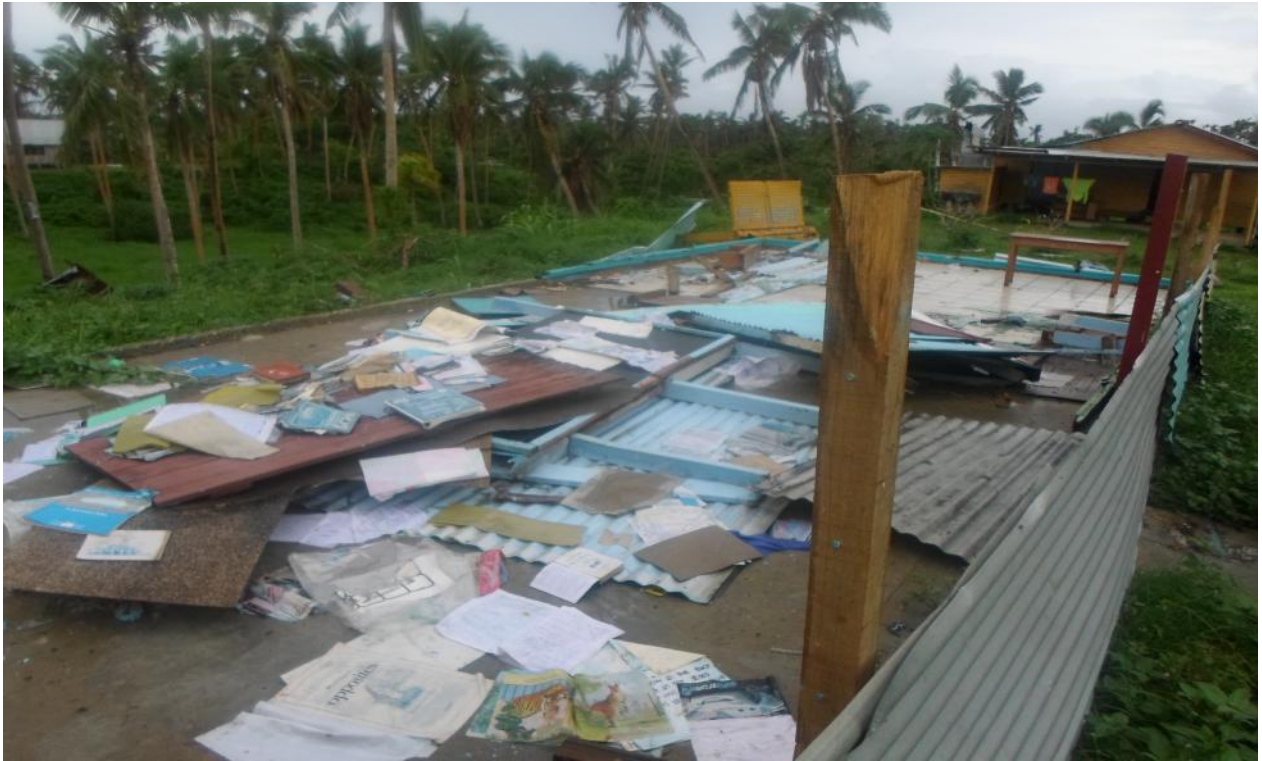
Photo 5: Overall building photos that totally blown away

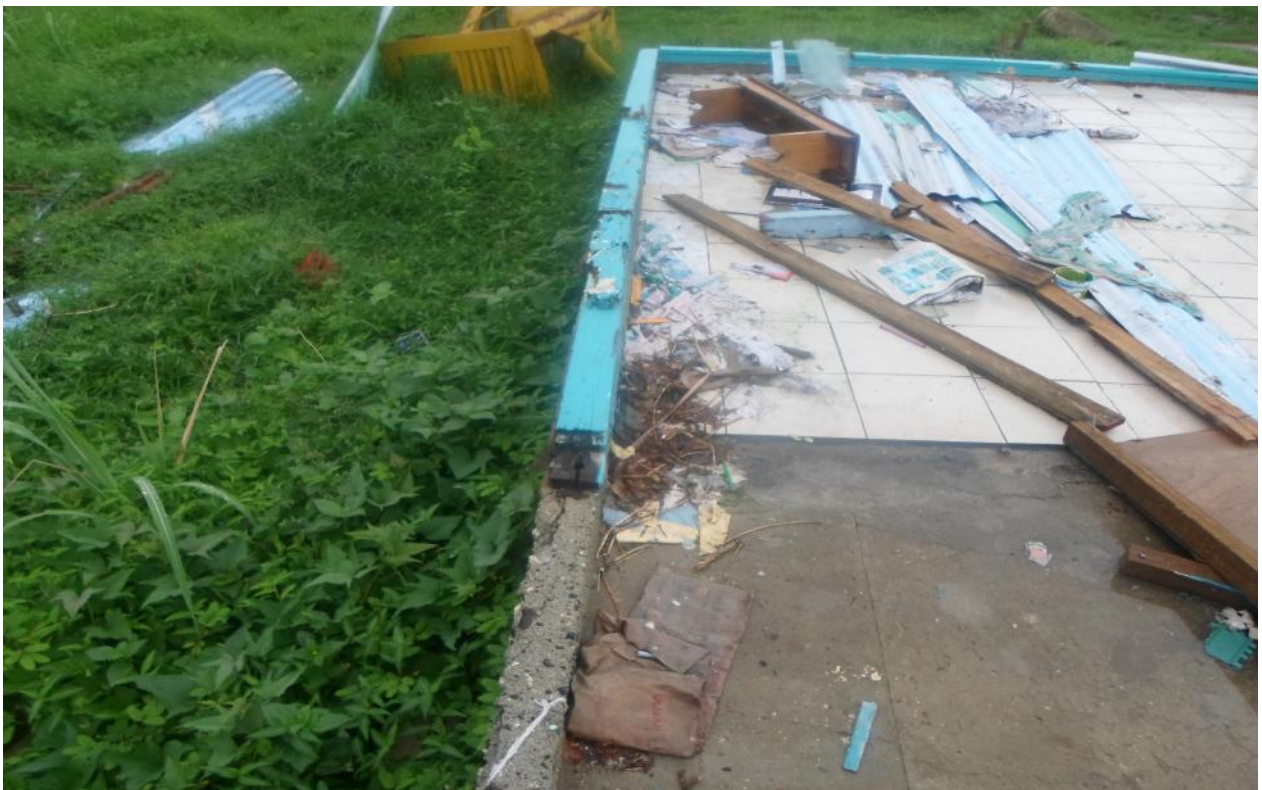
Photo 6: Enlarge view of the that was blown away

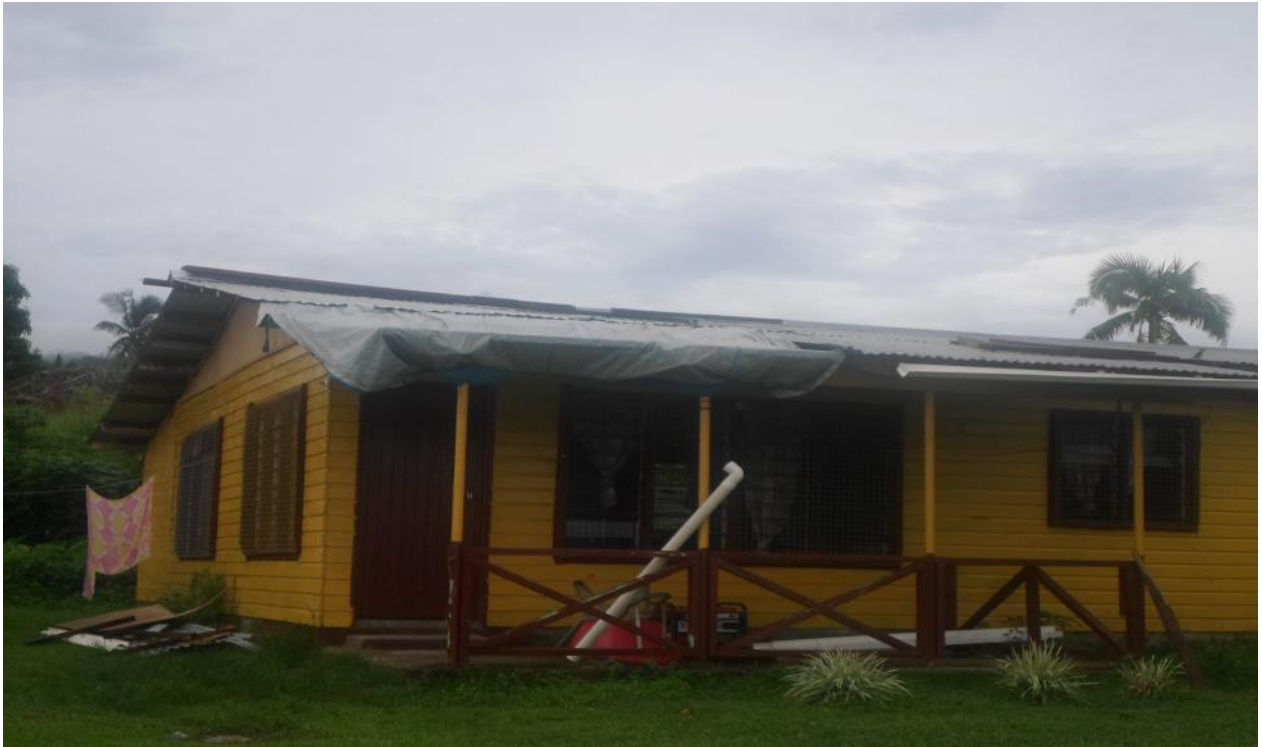
Photo 7: Overall building photos that totally blown away

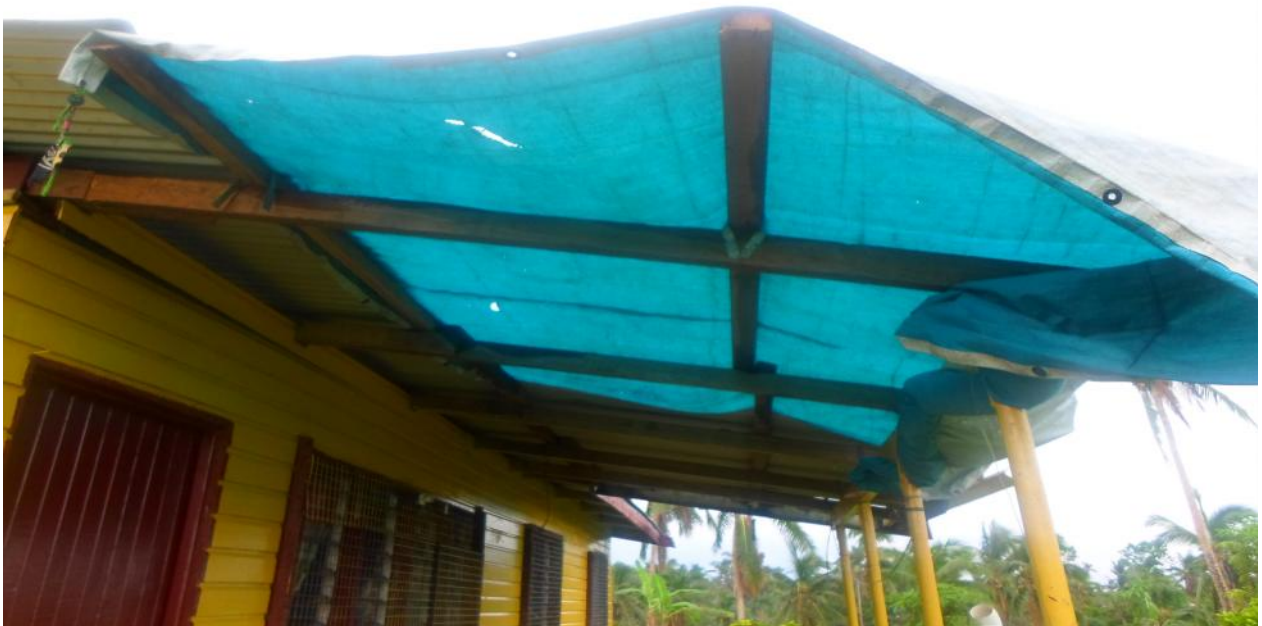
Photo 8: View of verandah the that was blown away

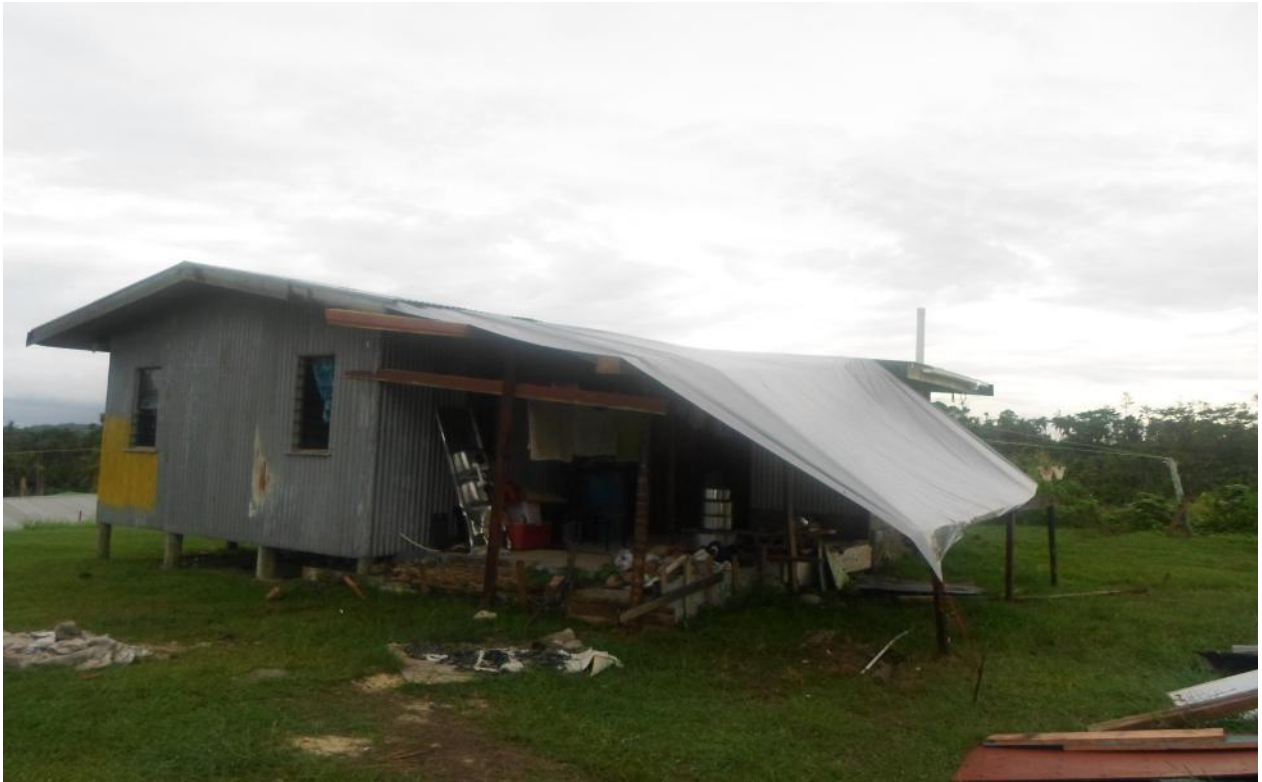
Photo 9: Overall building photos for partly damaged staff quarters

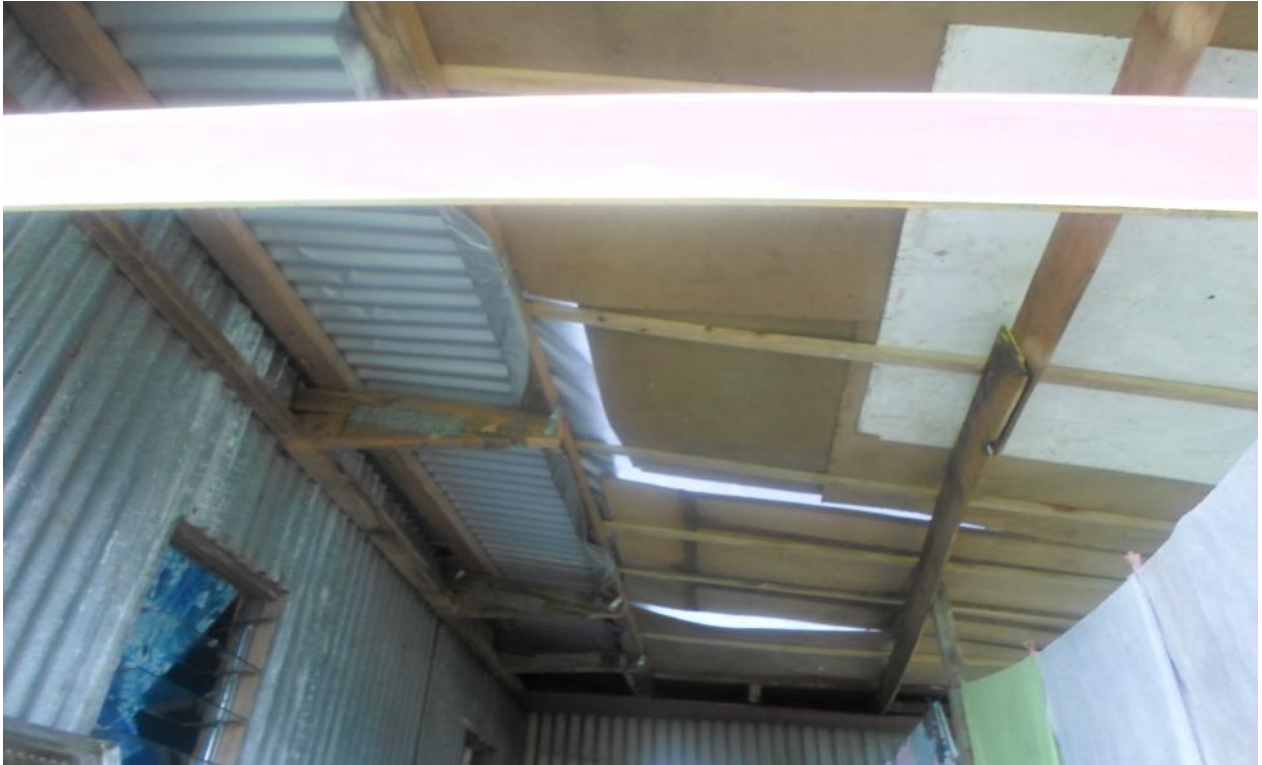
Photo 10: Enlarge view of the part that was blown away
