**CYCLONE WINSTON PREMILIARY ASSEMENT
SCHOOLS, HEALTH FACILITIES AND PUBLIC BUILDINGS
FOR
FIJI INSTITUTION OF ENGINEERS &
DEPARTMENT OF NATIONAL PLANNING
(MINISTRY OF FINANCE)**

NAME OF FACILITY: Viani Primary School
TYPE: Primary School
LOCATION: Viani, Vanua Levu
DATE OF ASSESMENT: 21 March 2016

JOB NO: 16-123
GOVERNMENT FACILITY NUMBER: GFN-195

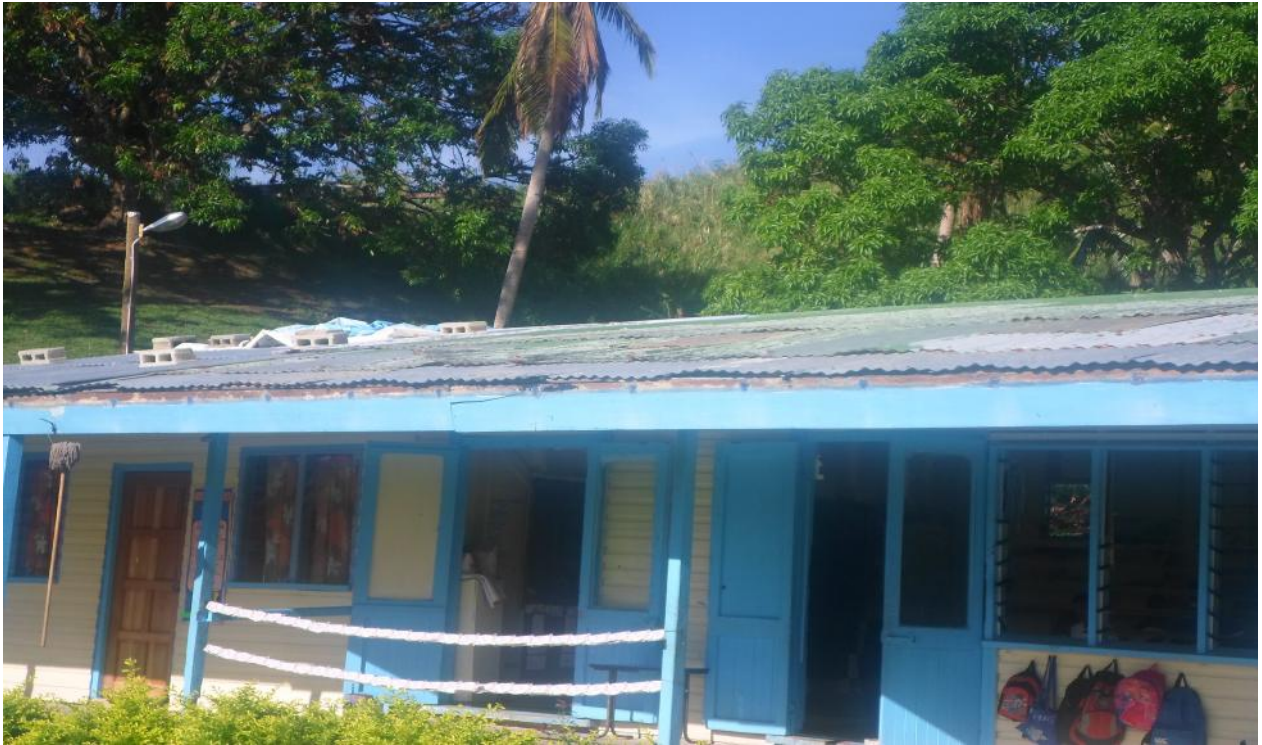
Photo 1: Side view of the building that is damaged

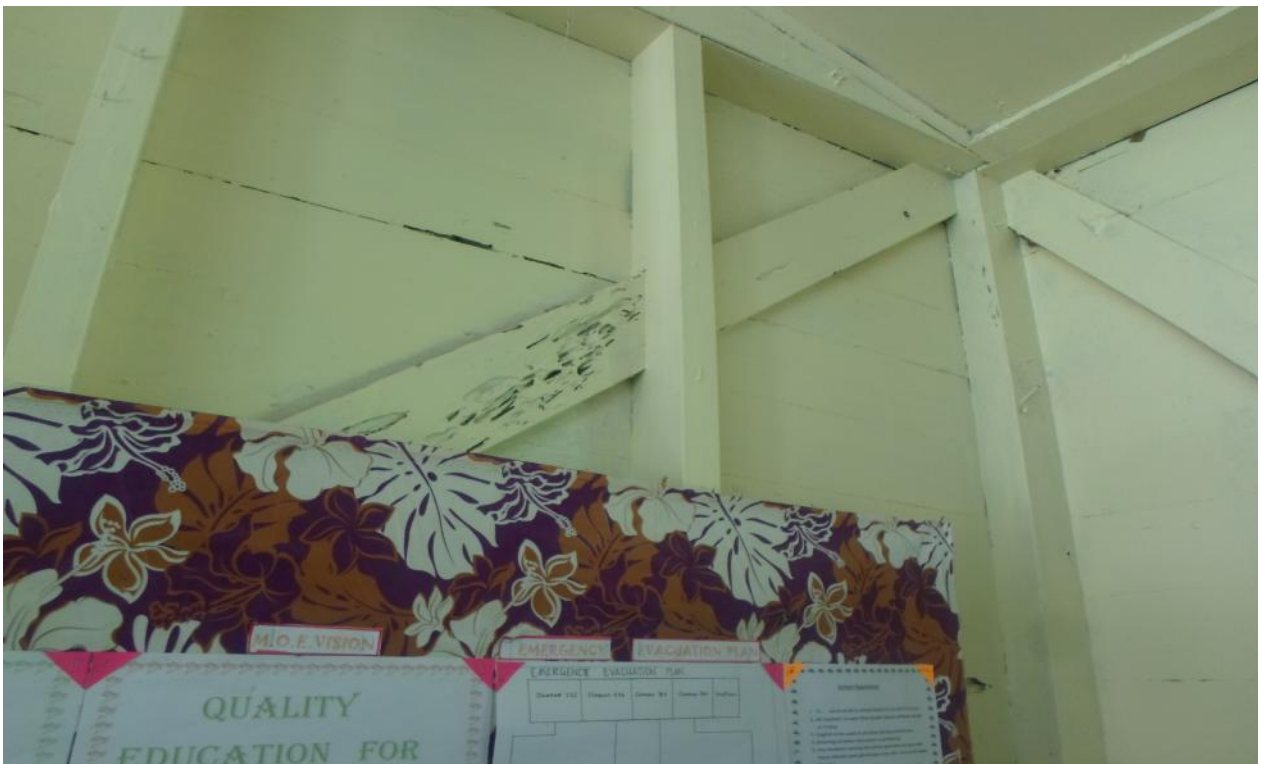
Photo 2: inside wall of the building that is damaged

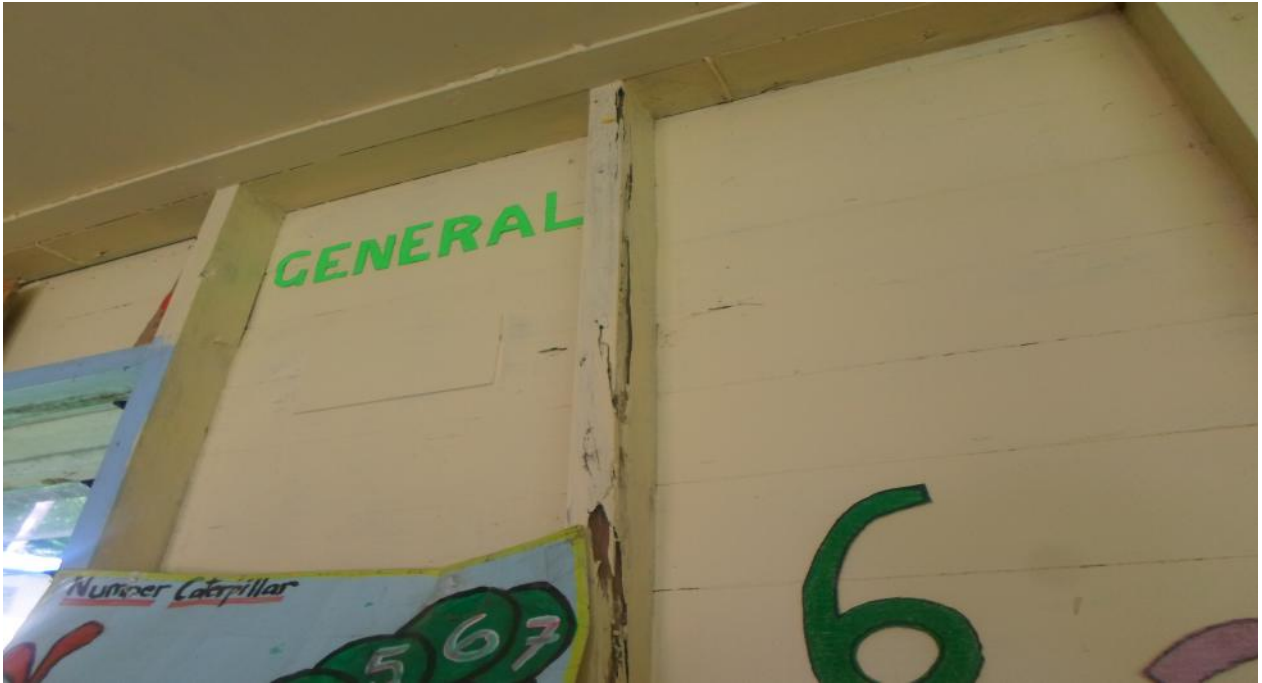
Photo 3: Inside members of wall of the building that was damaged

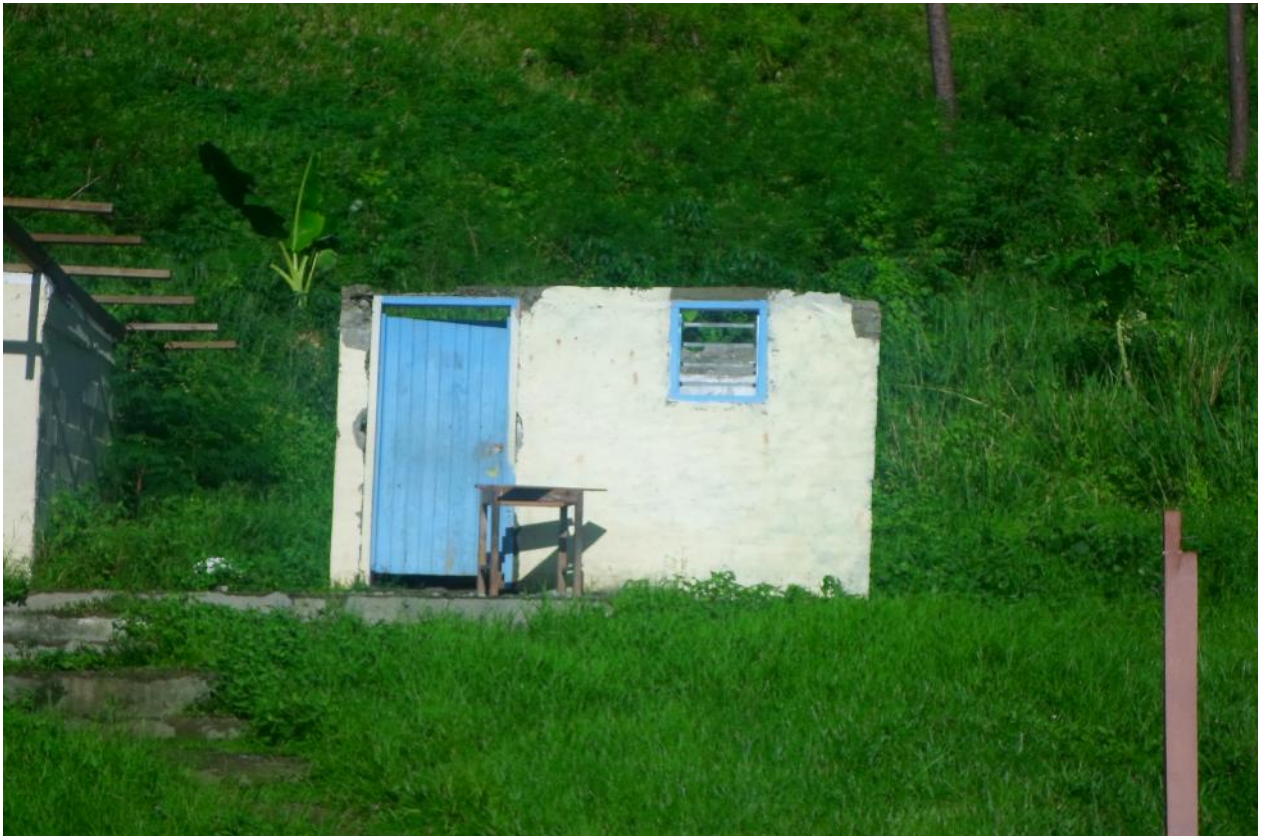
Shutters	Temperately 225 mesh shutters	1 Good 2 Average 3 Poor	100% blown away	0	N/A
Ceilings	Ply board ceilings throughout	1 Good 2 Average 3 Poor	100% blown away	3	N/A
Terraces/Verandah	Verandah with timber post and beam	1 Good 2 Average 3 Poor	100% blown away	3	4
Tiles/Floor Covering	Floor carpet has water damages	1 Good 2 Average 3 Poor	100% carpets has water damages	3	N/A
Gutters	Not visible -must have been blown away	1 Good 2 Average 3 Poor	100% blown away	3	N/A
Downpipes	Not visible -must have been blown away	1 Good 2 Average 3 Poor	100% blown away	3	N/A
Fascia Boards	Timber fascia board	1 Good 2 Average 3 Poor	100% blown away	3	N/A
Furniture/Desks etc.	N/A	1 Good 2 Average 3 Poor	N/A	0	N/A
Possible Intermediate Solution	Hole building to be rebuild (15x 5m).				
Possible Long Term Solution	Intermediate solution is the long tem solution

Photo 4: Toilet block that was damaged in cyclone

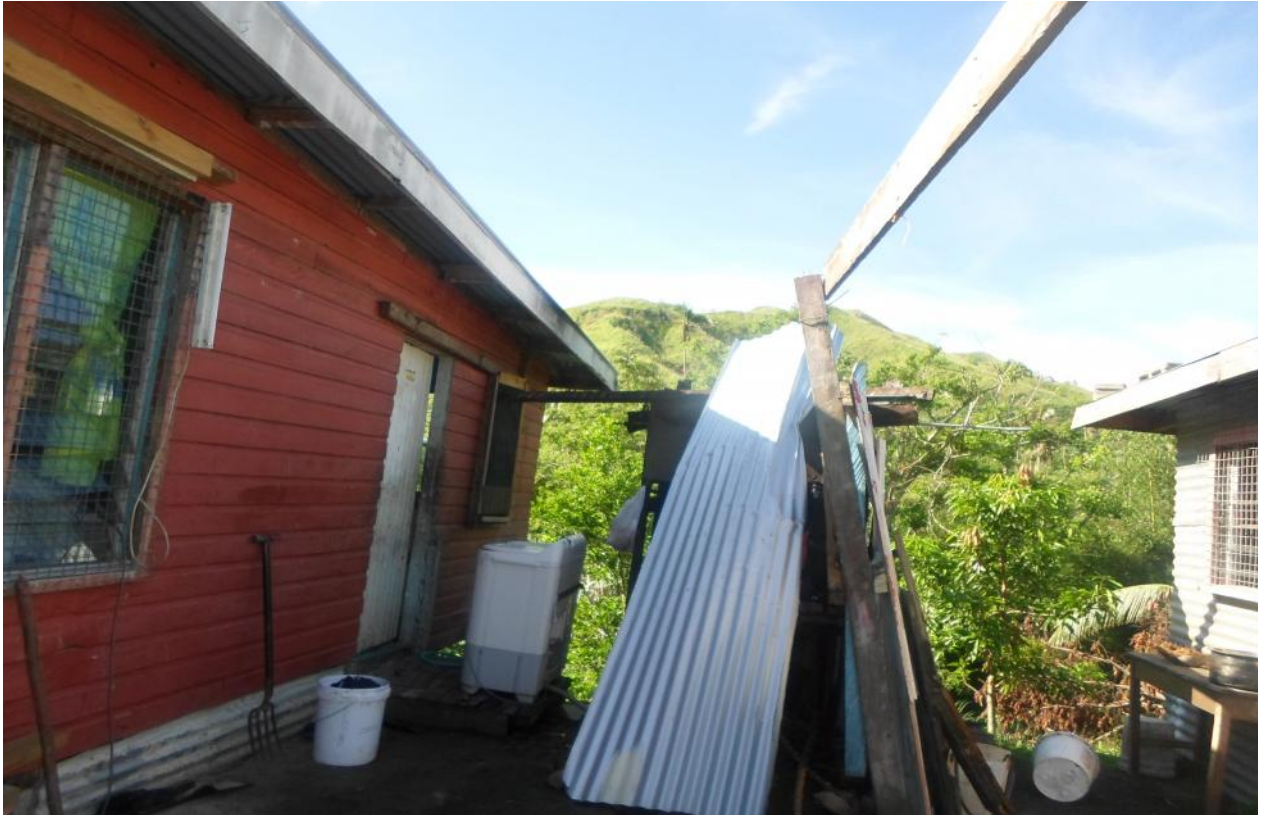
Photo 5: Outdoor kitchen for the staff quarters that was blown away
