**CYCLONE WINSTON PRELIMINARY ASSESSMENT
SCHOOLS, HEALTH FACILITIES AND PUBLIC BUILDINGS
FOR
FIJI INSTITUTION OF ENGINEERS &
DEPARTMENT OF NATIONAL PLANNING
(MINISTRY OF FINANCE)**

NAME OF FACILITY: Vatuvonu Adventist Secondary School
TYPE: Secondary School
LOCATION: Vatuvonu, Vanua Levu
DATE OF ASSESSMENT: 21 March 2016

JOB NO: 16-125
GOVERNMENT FACILITY NUMBER: GFN-203

**RAPID ASSESSMENT TEMPLATE: CYCLONE WINSTON DAMAGED BUILDINGS
SCHOOLS, PUBLIC BUILDINGS & HEALTH FACILITIES**

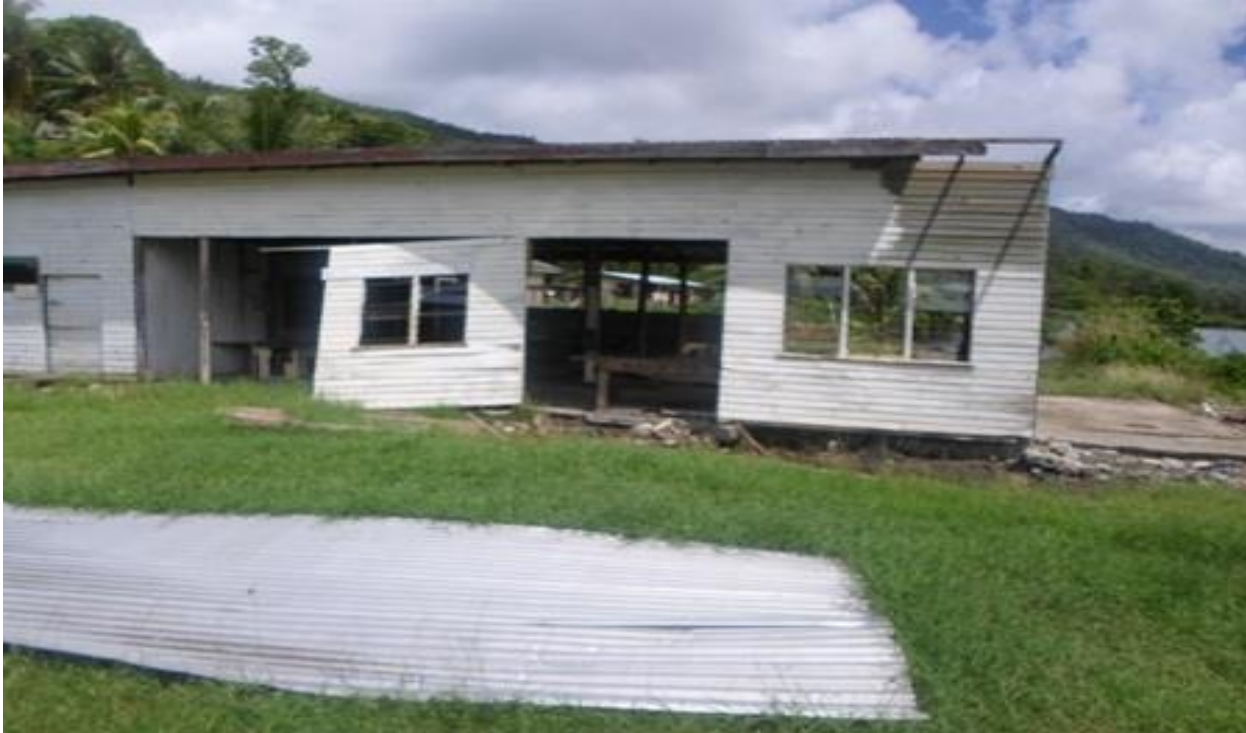
| Type of Construction | Description | Build Quality | Damage | Extent of Damage Rating | Photo No. |
|---|---|---|---|---|---|
| Floor | reinforced concrete slab on ground | 1 Good 2 Average 3 Poor | No visible damage | 0 | 1 |
| Walls | timber cladding | 1 Good 2 Average 3 Poor | 100% damage | 0 | 1,2 |
| Roof | corrugated roof cladding | 1 Good 2 Average 3 Poor | 30% blown out | 0 | 1 |
| Windows/Doors | louver windows on standard carriers typically for all windows and timber doors. | 1 Good 2 Average 3 Poor | Louvers are missing | 2 | 1,2 |
| Fascia Boards | 250x30mm timber fascia board. | 1 Good 2 Average 3 Poor | at least 40% fascia board are damage | 3 | 1 |

Photo 1:Rear View of Main School Block

| Type of Construction | Description | Build Quality | Damage | Extent of Damage Rating | Photo No. |
|---|---|---|---|---|---|
| Possible Intermediate Solution | Re-construct the whole walls and the roof with new guttering, downpipes, flashing,fascia board and new roofing iron in accordance with NBCF. | | | | |
| Possible Long Term Solution | Detailed investigation for roof framing recommended along with checks on wall capacity for uplift/lateral loads for more tolerance towards Cat.4. Much dependent upon detailed investigation by an Engineer. Considering the building age and with walls damaged, possibly demolish and re-built the whole building to comply with NBCF. Option also exist to retrofit cost permitting,Estimated cost currently around \$150,000.00 to \$300,000.00 (new construction) for long term solution. | | | | |

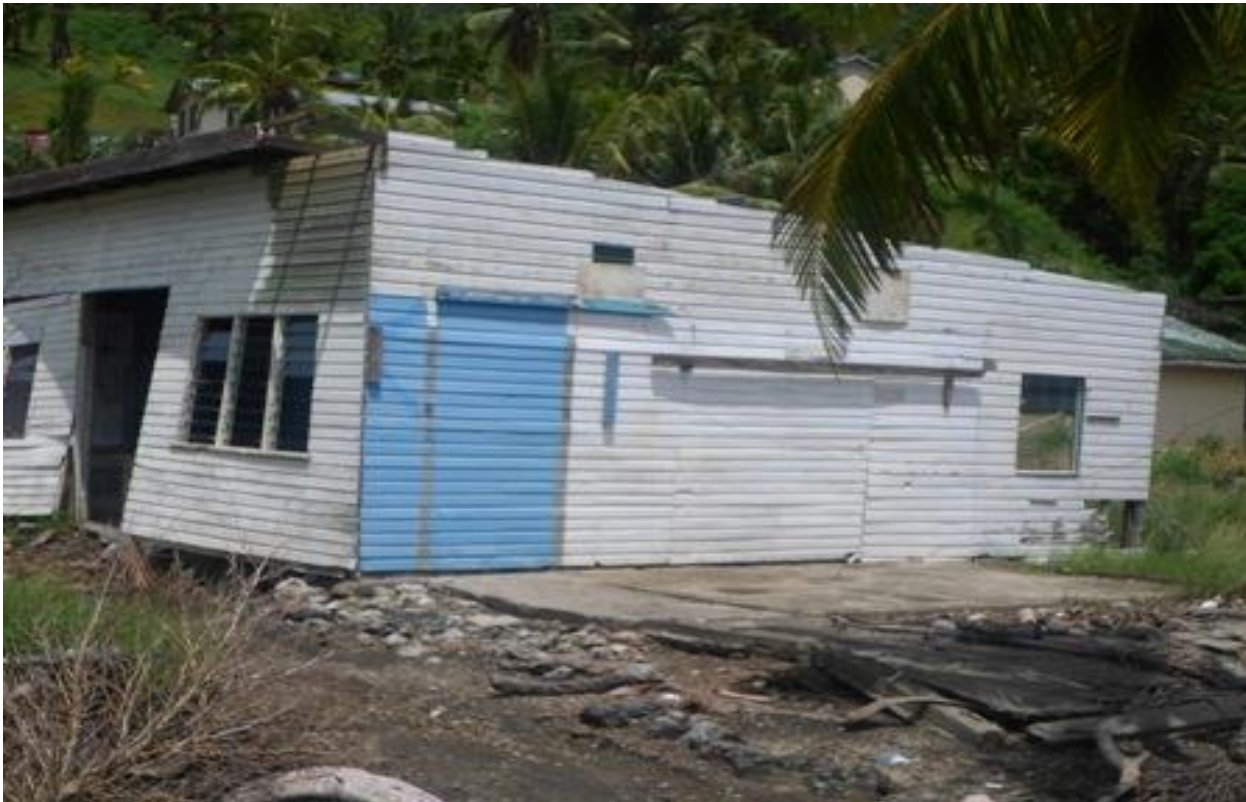
Photo 2: View of Main School Block
