**CYCLONE WINSTON PRELIMINARY ASSESSMENT
SCHOOLS, HEALTH FACILITIES AND PUBLIC BUILDINGS
FOR
FIJI INSTITUTION OF ENGINEERS &
DEPARTMENT OF NATIONAL PLANNING
(MINISTRY OF FINANCE)**

NAME OF FACILITY: Nagigi SDA Primary School
TYPE: Primary School
LOCATION: Nagigi, Vanua Levu
DATE OF ASSESSMENT: 21 March 2016

JOB NO: 16-124
GOVERNMENT FACILITY NUMBER: GFN-189

**RAPID ASSESSMENT TEMPLATE: CYCLONE WINSTON DAMAGED BUILDINGS
SCHOOLS, PUBLIC BUILDINGS & HEALTH FACILITIES**

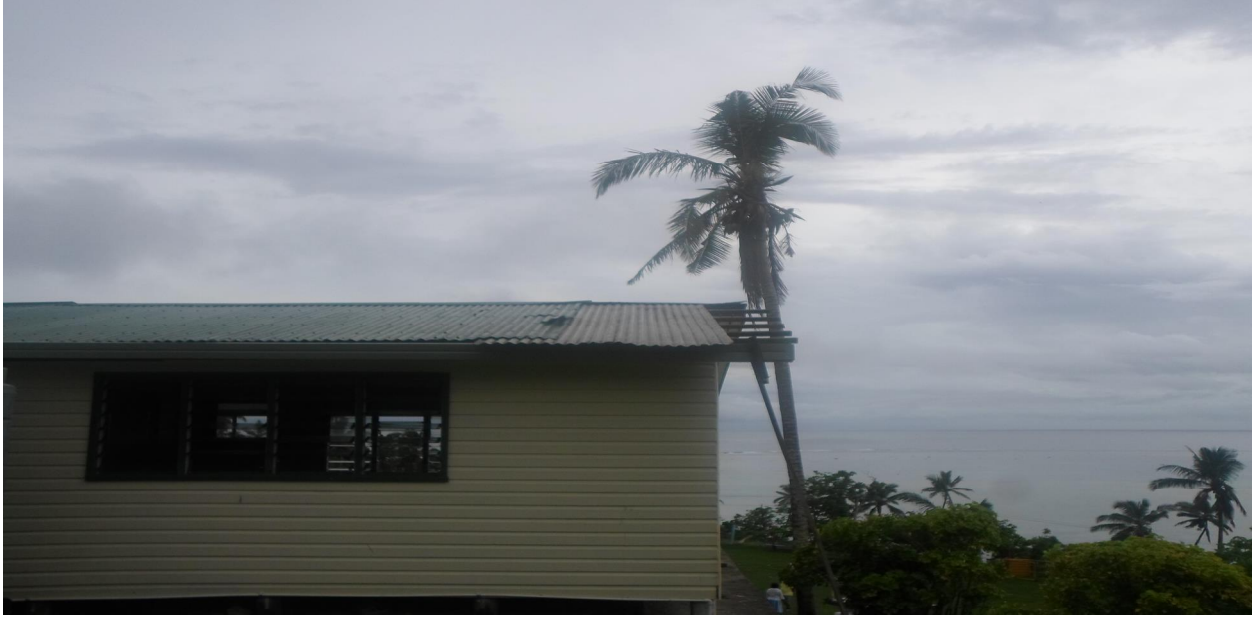
Terraces/Verandah	none	1 Good 2 Average 3 Poor	N/A	0	N/A
Tiles/Floor Covering	timber floor	1 Good 2 Average 3 Poor	water damage	1	N/A
Gutters	Standard GI gutters	1 Good 2 Average 3 Poor	At least 30% guttering and down-pipes damaged	3	1
Downpipes	100mm PVC downpipes with PVC straps fixed to the 50mm steel post.	1 Good 2 Average 3 Poor	Guttering and down pipe damaged	3	1
Fascia Boards	250x30mm timber fascia board.	1 Good 2 Average 3 Poor	at least 40% fascia board are damage	3	1
Furniture/Desks etc.		1 Good 2 Average 3 Poor			
Possible Intermediate Solution	Re-construct the guttering, downpipes, flashing,fascia board and new roofing iron in accordance with NBCF.				
Possible Long Term Solution	Detailed investigation for roof framing recommended along with checks on wall capacity for uplift/lateral loads for more tolerance towards Cat.4. Much dependent upon detailed investigation by an Engineer. Considering the building age and with no major damages found, possibly repair the whole building to comply with NBCF. Option also exist to retrofit cost permitting,Estimated cost currently around \$100,000.00 to \$300,000.00 (new construction) for long term solution.

Photo 1:Rear View of Main School Block

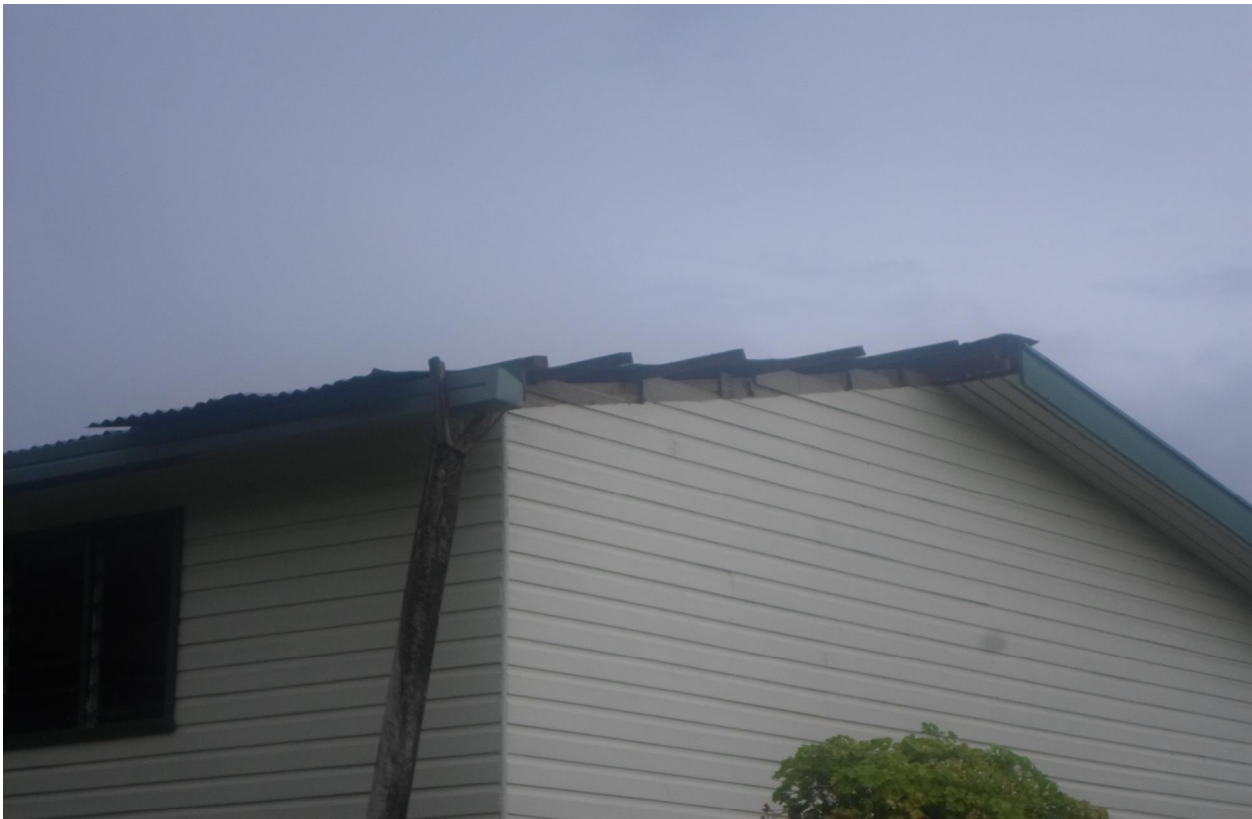
Photo 2: View of Main School Block
