CYCLONE WINSTON PRELIMINARY ASSESSMENT SCHOOLS, HEALTH FACILITIES & PUBLIC BUILDINGS

NAME OF FACILITY: Delana Methodist Primary School
TYPE: Primary School
LOCATION: Levuka, Ovalau
DATE OF ASSESSMENT: 19th March 2016
DATE OF REPORT: 01st April 2016

Cyclone Winston Damage Assessment – Delana Methodist Primary School

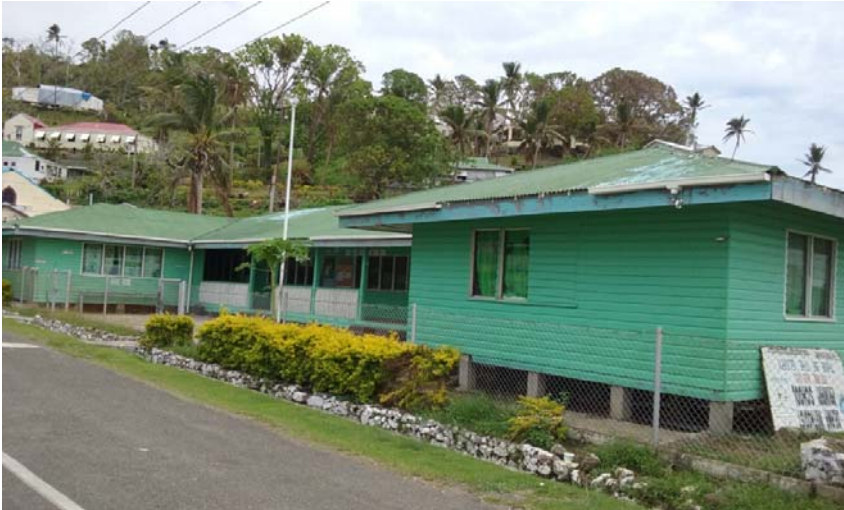
Photo 1: Front View

| Type of Construction | Description | Build Quality | Damage | Extent of | Photo No. |
|---|--|---|---|---|---|
| Gutters | Typical PVC guttering | 1 Good 2 Average 3 Poor | All gutters & downpipes blown out 25% damage noted | 4 | |
| Downpipes | Typical PVC downpipes | 1 Good 2 Average 3 Poor | All gutters & downpipes blown out 25% damage noted | 4 | |

| Type of Construction | Description | Build Quality | Damage | Extent of | Photo No. |
|---|--|---|---|---|---|
| Possible Intermediate Solution | Detailed review of the existing roof framing is recommended. All damage roof framing member are to be replaced and fixed in accordance with the Fiji Building Code Standard. Roofing iron to be fixed with roofing screws throughout the entire roof on every 2nd crest. All electrical & hydraulics works to be reviewed in detail. New guttering & downpipes are to be installed. Estimated damage to repair back to pre cyclone condition: \$20,000 | | | | |
| Possible Long Term Solution | Detailed investigations recommended for the whole structure for more tolerance towards category 4 cyclones. Re-design of roof structure is recommended. Estimated cost for long term solution would be around \$20,000 | | | | |

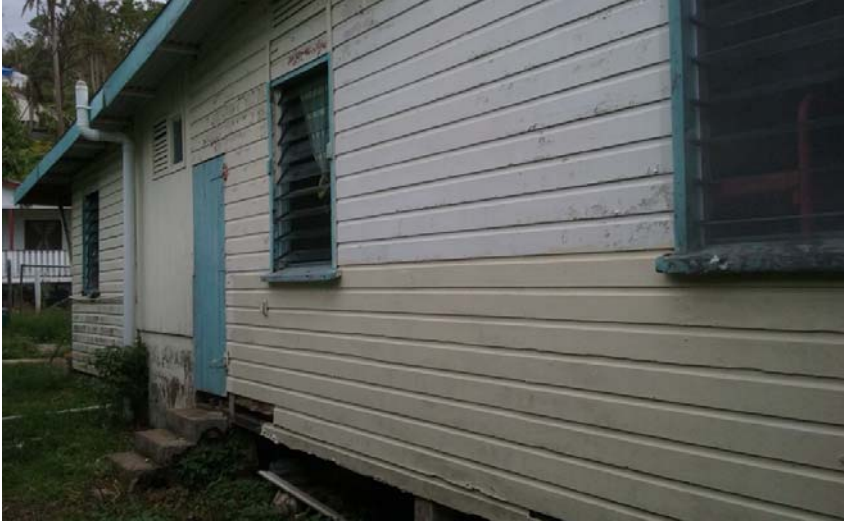
Photo 3: Front View

| Type of Construction | Description | Build Quality | Damage | Extent of | Photo No. |
|---|--|---|---|---|---|
| Foundations | Concrete | 1 Good 2 Average 3 Poor | severe cracks noted | 4 | N/A |
| Walls | Timber Walls | 1 Good 2 Average 3 Poor | 35% deterioration noted | 4 | N/A |
| Windows/Doors | Timber doors and louvered windows | 1 Good 2 Average 3 Poor | Damages in form of broken louvere blades noted 15% as noted. Deterioration on timber doors noted. | 4 | N/A |
| Gutters | Unknown | 1 Good 2 Average 3 Poor | Severe damage noted 100% blown out | 4 | N/A |
| Fascia Boards | Timber fascia boards | 1 Good 2 Average 3 Poor | Severe damage noted 30% blown out | 4 | N/A |

| Type of Construction | Description | Build Quality | Damage | Extent of | Photo No. |
|---|--|---|---|---|---|
| Possible Intermediate Solution | Severe damages noted. Demolish and rebuild of structure recommended. Estimated damage to repair back to pre cyclone condition: \$30,000 | | | | |
| Possible Long Term Solution | Severe damages noted. Demolish and rebuild of structure recommended for more tolerance towards category 4 cyclones. Estimated cost for long term solution would be around: \$150,000 | | | | |
