CYCLONE WINSTON PRELIMINARY ASSESSMENT SCHOOLS, HEALTH FACILITIES & PUBLIC BUILDINGS

**THE FIJI INSTITUTION OF ENGINEERS & DEPARTMENT OF
NATIONAL PLANNING (MINISTRY OF FINANCE)**

NAME OF FACILITY:	Levuka Special School (Norah Frazer School for Special Education)
TYPE:	Special School
LOCATION:	LevukaOvalau
DATE OF ASSESSMENT:	19 th March 2016
DATE OF REPORT:	01 st April 2016
JOB NO:	9213.1
GOVERNMENT FACILITY NO:	173

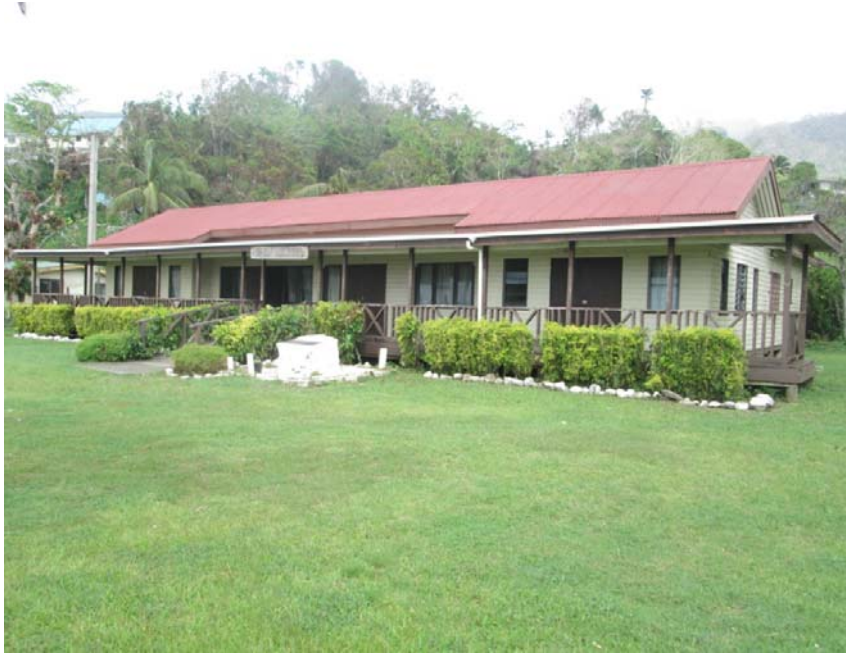
Photo 1: View of Building 1 Frontage

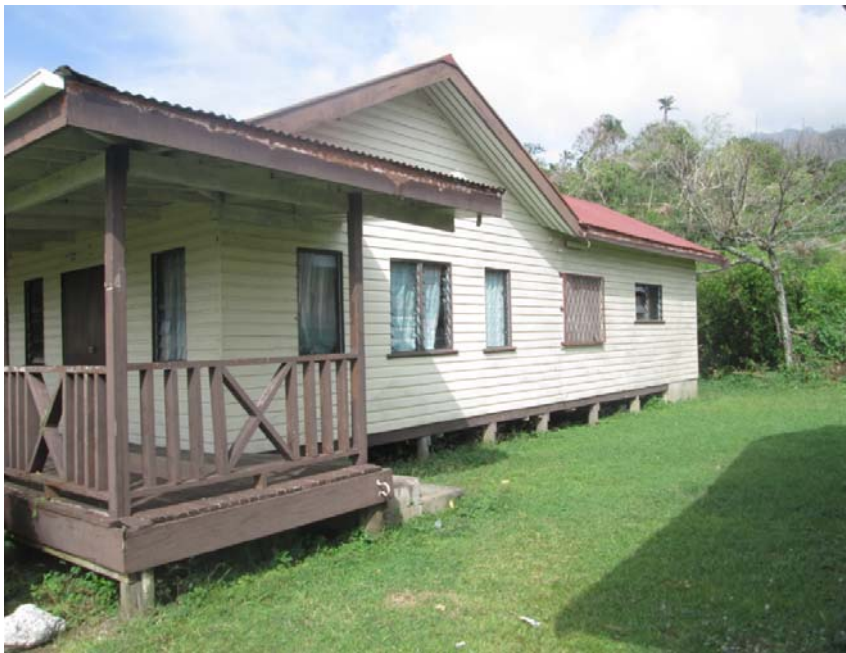
Type of Construction	Description	Build Quality	Damage	Extent of	Photo No.
Floor	Timber flooring	1 Good 2 Average 3 Poor	No visible damage	0	N/A
Foundations	Concrete	1 Good 2 Average 3 Poor	No visible damage	0	N/A
Walls	Timber walls	1 Good 2 Average 3 Poor	No visible damage	0	1,2,3,4
Rafters	Timber rafters	1 Good 2 Average 3 Poor	No visible damage	0	N/A
Purlins	Timber purlins	1 Good 2 Average 3 Poor	No visible damage	0	N/A
Roof	CGI roof cladding nail fixed	1 Good 2 Average 3 Poor	No visible damage	0	N/A
Electrical	Typically standard switches & fluorescent tube lights	1 Good 2 Average 3 Poor	Detailed review required	N/A	N/A
Hydraulics	Typical piping system	1 Good 2 Average 3 Poor	Detailed review required	N/A	N/A
Windows/Doors	Timber doors and louvered windows	1 Good 2 Average 3 Poor	1 timber door noted to be damaged	0	1,2,3,4
Shutters	2 x 2 mesh shutters only on 20% of window openings	1 Good 2 Average 3 Poor	No visible damage	0	N/A

Photo 2: Side View of building 1- Showing Missing Flashing, Guttering & Deteriorated Fascia

Ceilings	Masonite board ceiling typically throughout	1 Good 2 Average 3 Poor	No visible damage	0	N/A
Terraces/Verandah	Timber flooring, CGI roof Cladding on timber framing supported by 100 x 100 timber posts	1 Good 2 Average 3 Poor	No visible damage	0	N/A
Tiles/Floor Covering	N/A	1 Good 2 Average 3 Poor	N/A	N/A	N/A
Gutters	PVC guttering	1 Good 2 Average 3 Poor	Minor damages noted 20% blown out	4	1,2,3,4
Downpipes	PVC downpipes	1 Good 2 Average 3 Poor	Minor damages noted 20% blown out	4	1,2,3,4
Fascia Boards	Timber fascia boards	1 Good 2 Average 3 Poor	Minor damages noted 20% blown out	4	1,2,3,4
Furniture/Desks etc.	N/A	1 Good 2 Average 3 Poor	N/A	N/A	N/A
Possible Intermediate Solution	All roof framing member are to be fixed in accordance with the Fiji Building Code Standard. Roofing iron to be fixed with roofing screws throughout the entire roof on every 2nd crest. All electrical & hydraulics works to be reviewed in detail. New guttering, downpipes, fascia boards, shutters and door are to be installed. Estimated damage to repair back to pre cyclone condition: \$10,000

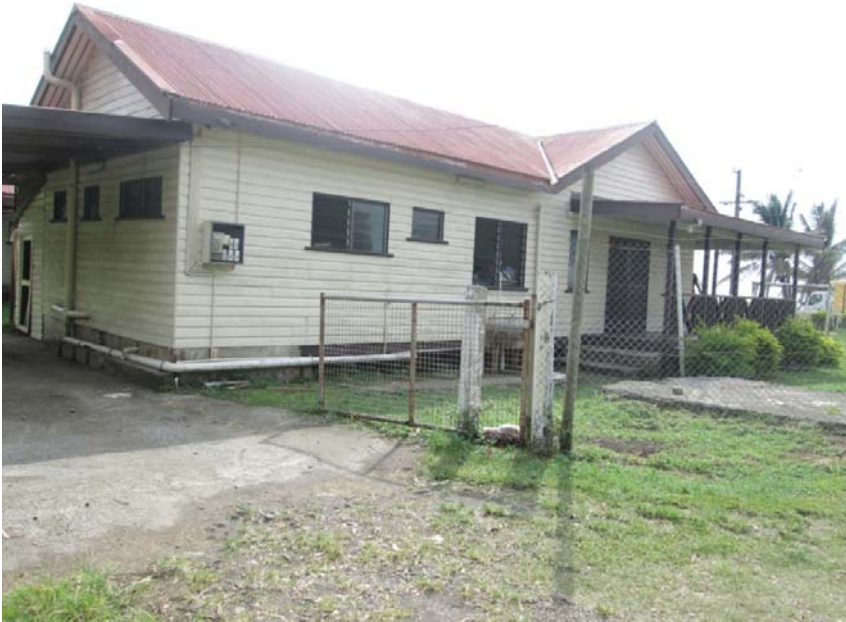
Photo 3: Side & Roof View of Building 1- Showing Missing Guttering

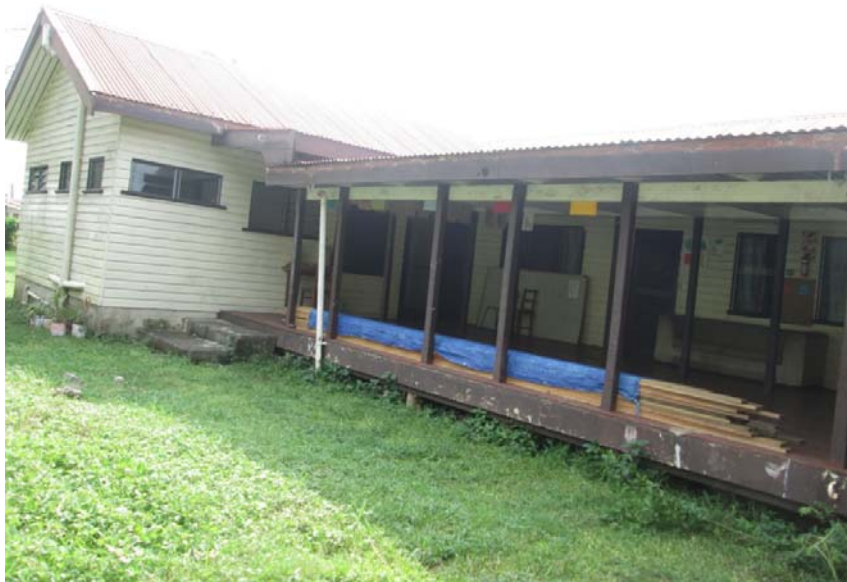
Photo 4: Rear View of Building 1- Showing Missing Guttering & Downpipes

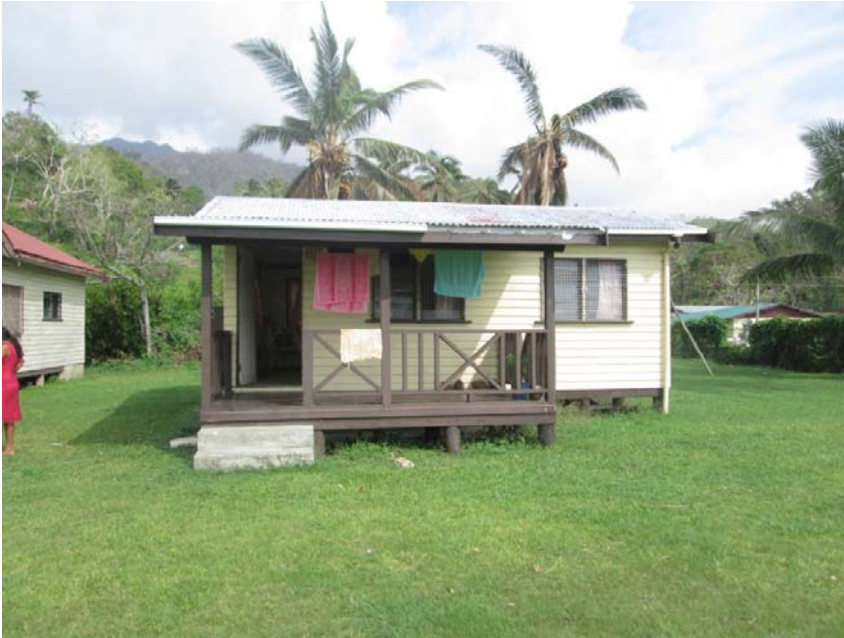
Terraces/Verandah	Timber flooring, CGI roof Cladding on timber framing supported by 100 x 100 timber posts	1 Good 2 Average 3 Poor	No visible damage	0	N/A
Tiles/Floor Covering	N/A	1 Good 2 Average 3 Poor	N/A	N/A	N/A
Gutters	PVC guttering	1 Good 2 Average 3 Poor	Minor damages noted 20% blown out	4	5,6,7
Downpipes	PVC downpipes	1 Good 2 Average 3 Poor	No visible damage	0	5,6,7
Fascia Boards	Timber fascia boards	1 Good 2 Average 3 Poor	No visible damage	0	5,6,7
Furniture/Desks etc.	N/A	1 Good 2 Average 3 Poor	N/A	N/A	N/A
Possible Intermediate Solution	All roof framing member are to be fixed in accordance with the Fiji Building Code Standard. Roofing iron to be fixed with roofing screws throughout the entire roof on every 2nd crest. All electrical & hydraulics works to be reviewed in detail. New guttering are to be installed. Estimated damage to repair back to pre cyclone condition: \$10,000				
Possible Long Term Solution	Detailed investigations recommended for the whole structure for more tolerance towards category 4 cyclones. Estimated cost for long term solution would be around \$30,000

Photo 5: Front View of building 2 – Showing Damaged Guttering

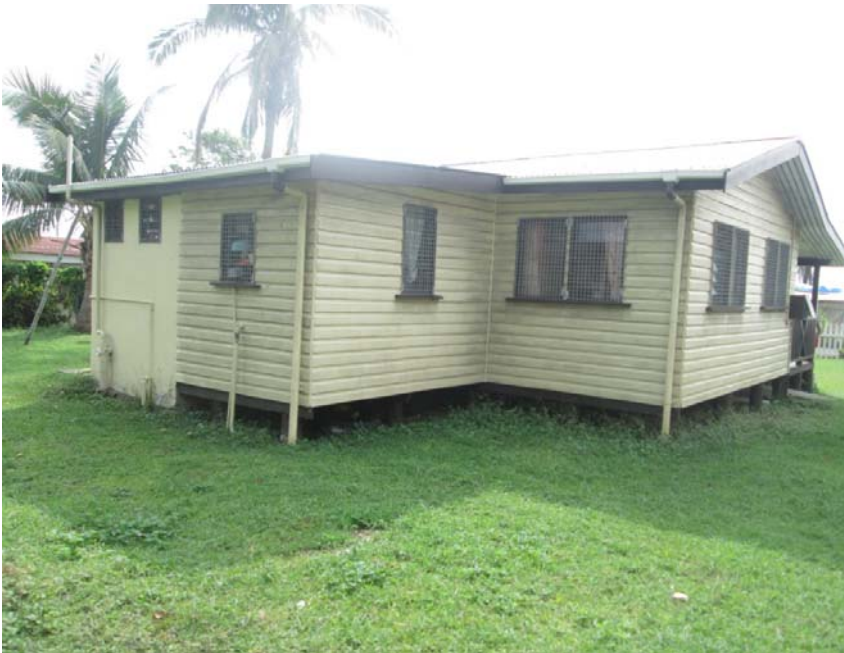
Photo 6: Side& Rear View of building 2

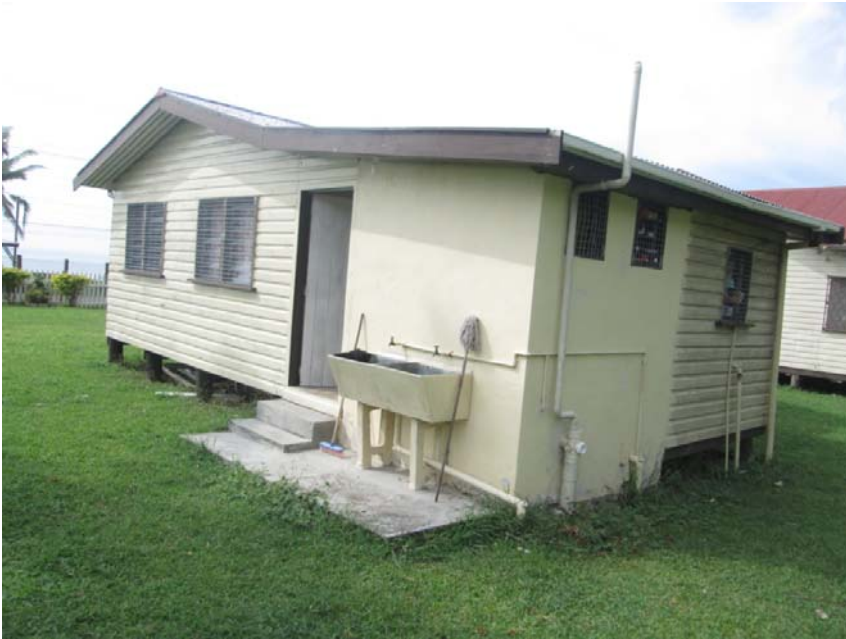
Photo 7: Side View of Building 2

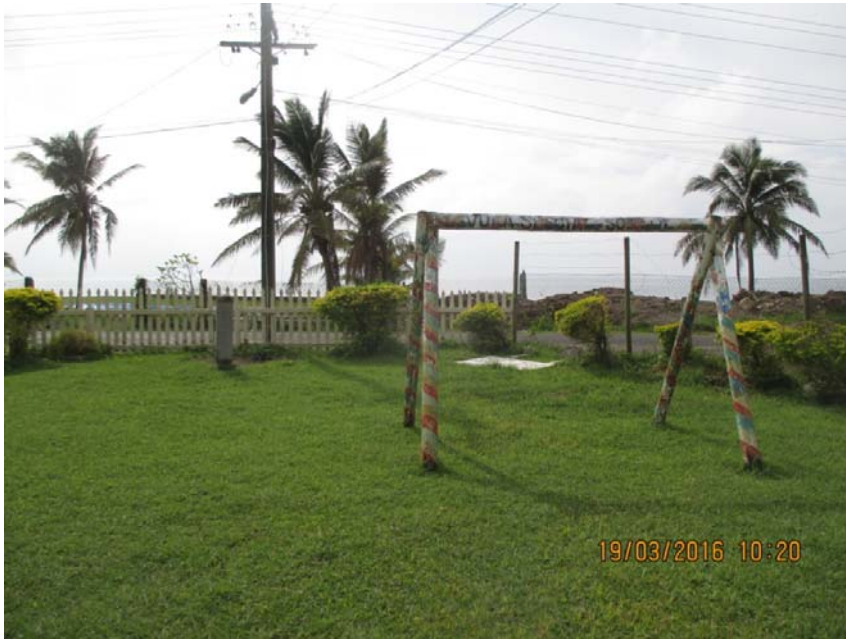
1 FENCING / GATES / DRIVEWAY / RETAINING WALLS ETC (INCLUDE TYPE / LENGTH ETC)
1. Typical chinlink fence on 100 diameter pin e post (400m perimeter of 1.8m height). Approximately 20m noted to be damaged. Front steel framed swinging gate damaged. Estimated cost for fence and gate fixing:.....
2 WATER TANKS/METERS/PLUMBING
No tanks noted on site
3 POWER LINES / METERS / WIRING
Power supply was normal on school premises
4 OTHER ITEMS
Not noted

Photo 8: Showing Typical Chain link & Picket Fence
